Event Analysis

Douglas L. Weisz, PE

Power Plant Protection Track
Thursday, August 7, 2025

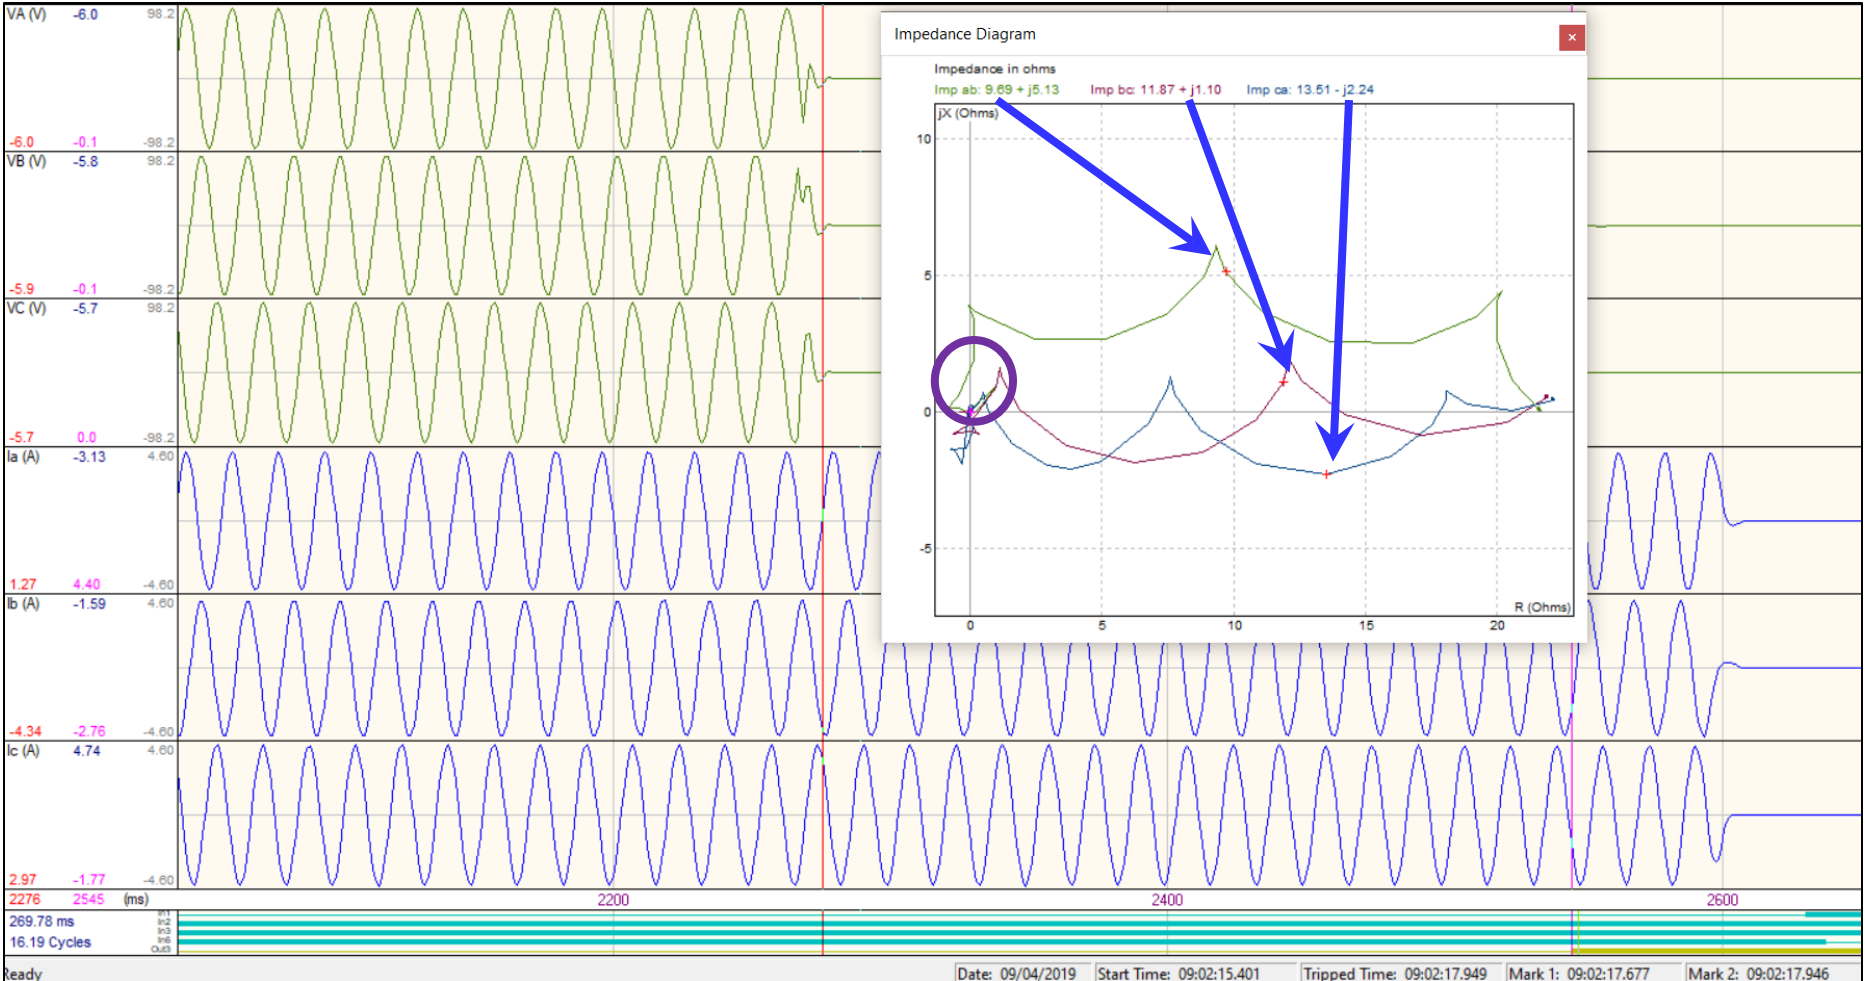
- Gen is on-line and running normally when all 3 voltages are lost which is consistent with the reported VT secondary thermal breaker operation.
- Here, the event loci (Zab, Zbc, Zca) are shown as they traverse from Zload or Zstart position towards the origin of the RX diagram which represents 0 V at the gen VT location:

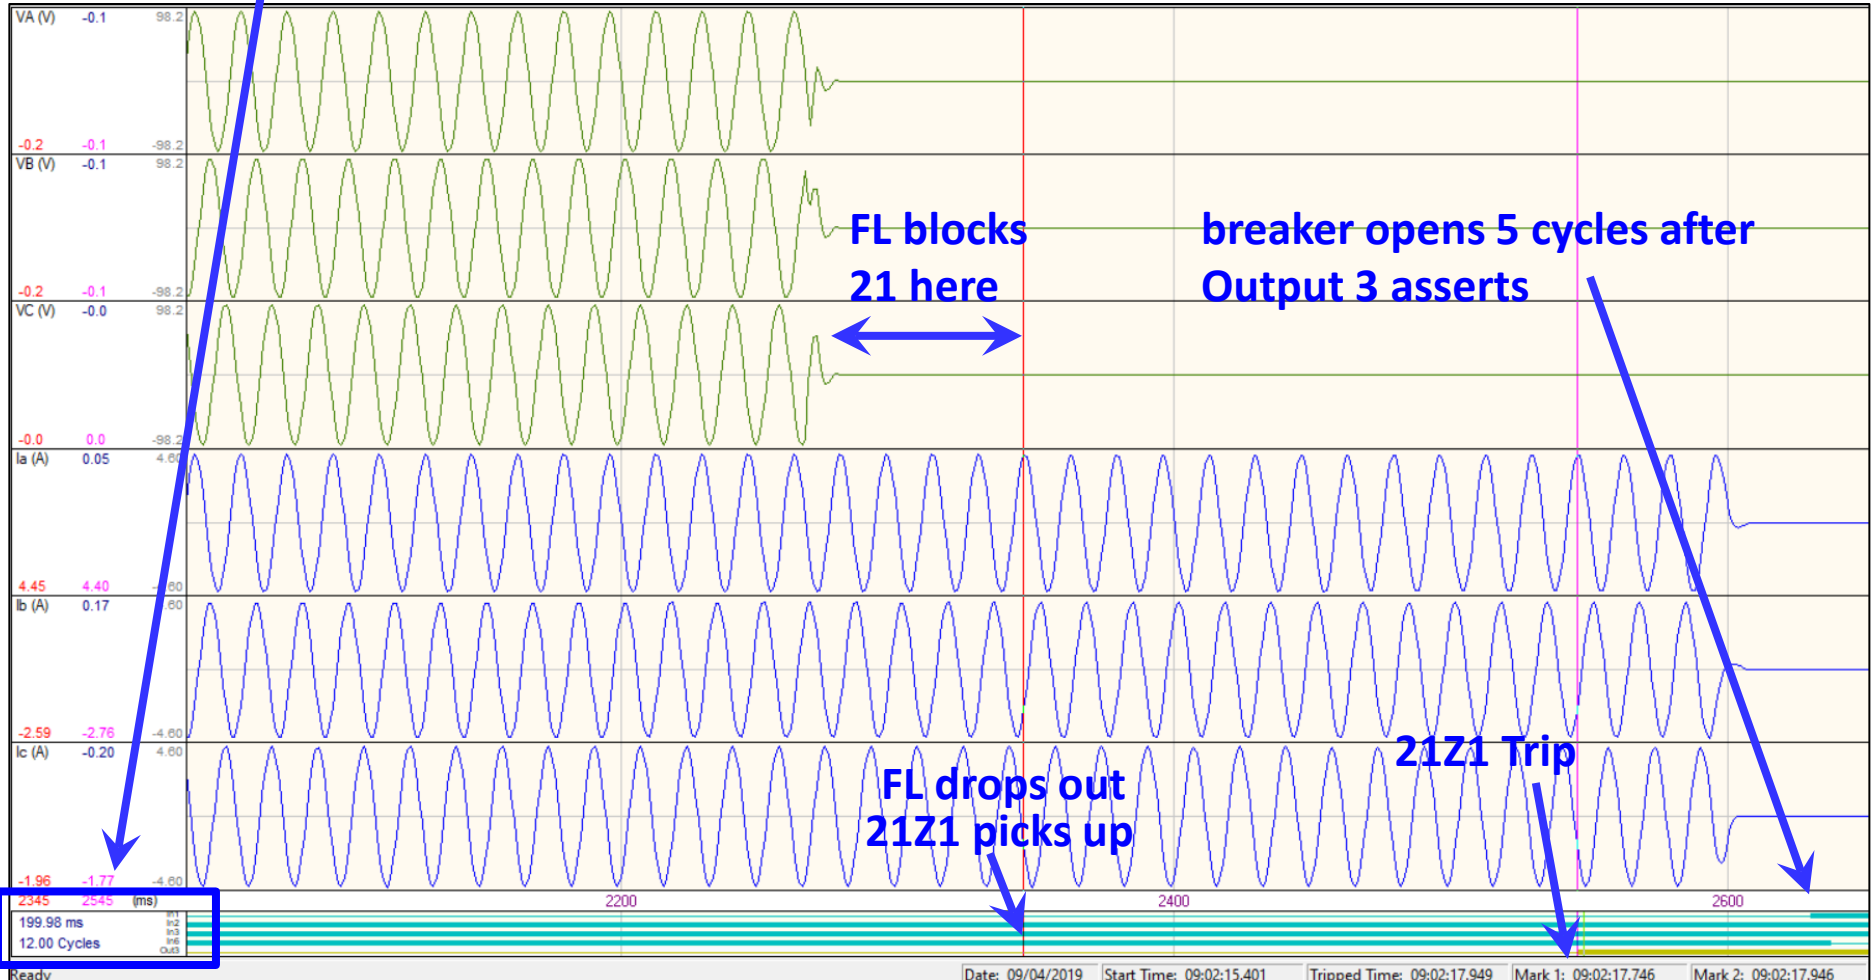
- But then a few cycles later, SOE shows that FL drops out and then 21 zone 1 and 2 pick up and 12 cycles later (equaling the 21 zone 1 time delay setting), 21 zone 1 times out and trips, asserting Output 3 as programmed:

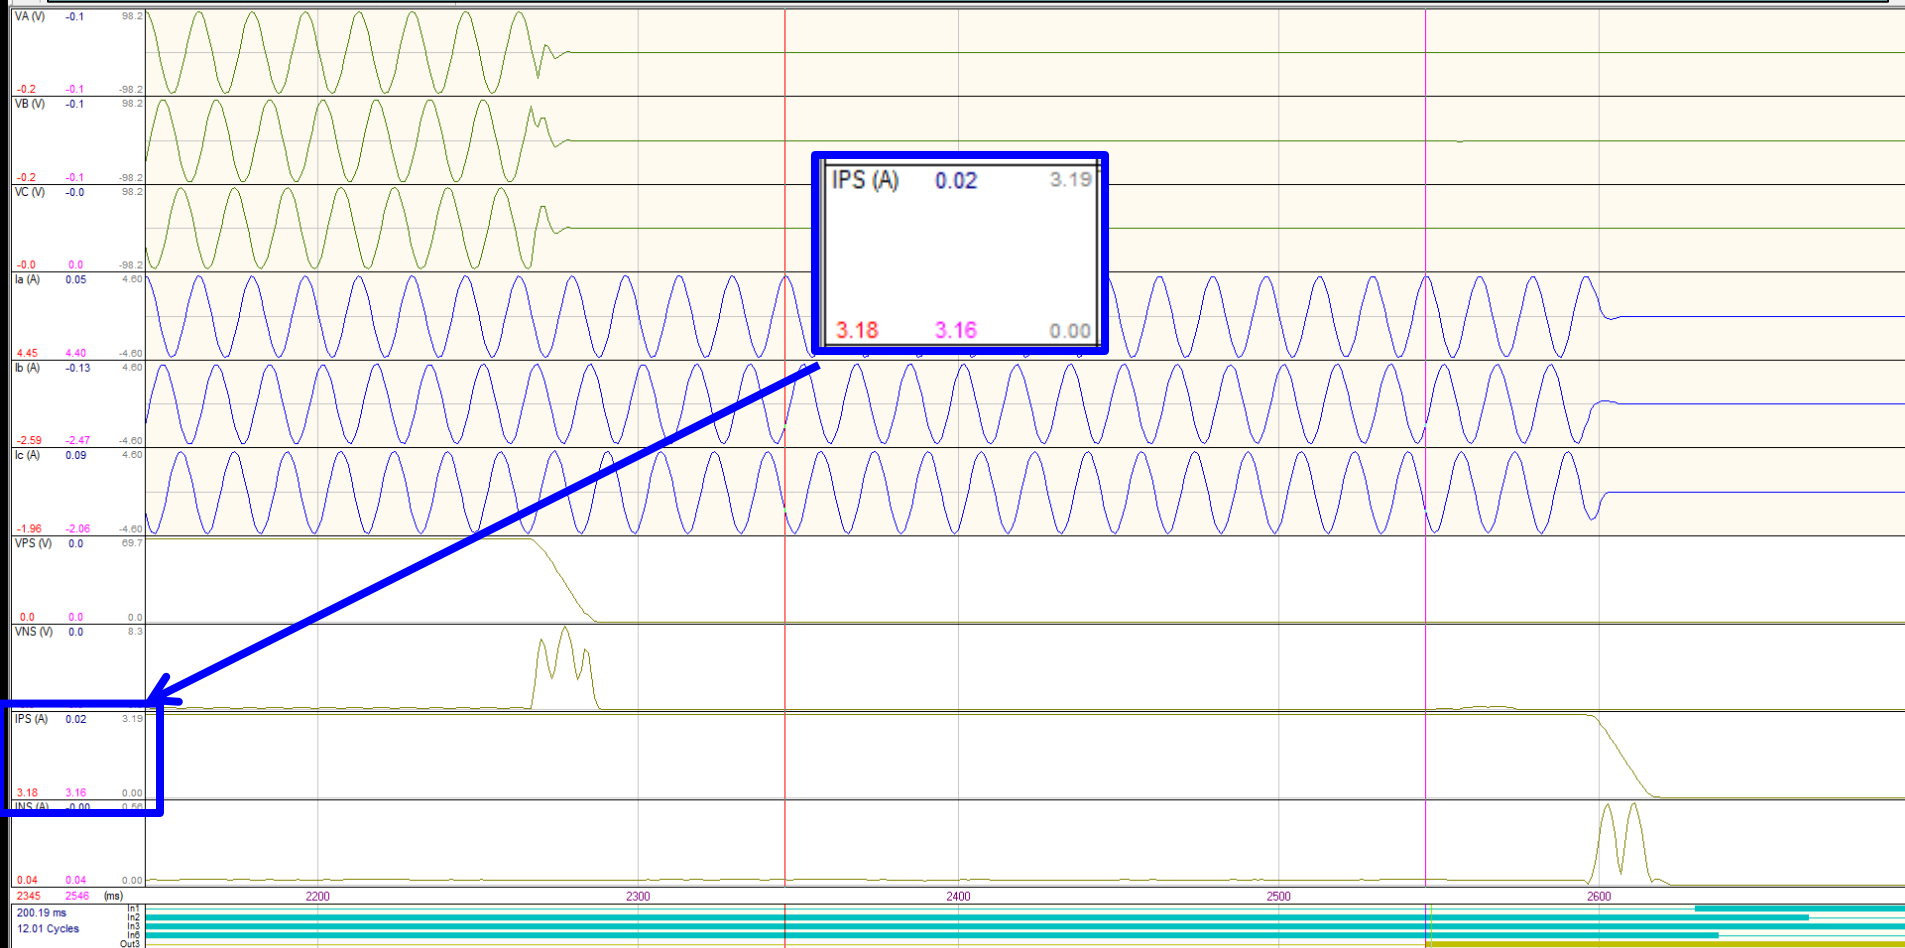
- $I_1 > 0.33 \text{ A}$? Yes, it is 3.18 A
- All 3 phase voltages $< 0.05 * V_{nom}$? We don't know what V_{nom} is, but likely yes
- All 3 currents $< 1.25 * I_{nom}$? We don't know what I_{nom} is, but likely yes
- So yes, the FL bit should have stayed picked up via 3 Φ FL logic and blocked 21.

- It is suspected that the 60FL setting “Three Phase Fuse Loss Detection” is Disabled in the settings that are installed on the relay.
- The native, “as-left” relay setting file in the mfg specific software format (e.g. .ips extension file) was not provided.
- The relay setting file should always be downloaded from the relay after the event (not a copy of the native, supposed “as-left” file from some storage location) along with all the other files: OSC, SOE, Target List, etc.
- The other possibility is that the relay operated incorrectly; however, this would be an odd failure mode i.e. failure of the relay code that represents the 60FL algorithm to execute in the manner as displayed in the 60FL logic diagram

- Check the applied relay settings to ensure that the 60FL “Three Phase Fuse Loss Detection” is really Enabled.
- However, if it is Enabled, then recommend secondary injection test the relay.
- Did not hear back from customer on what was found, although I assume my guess may have been correct; otherwise, I am sure I would have heard something.

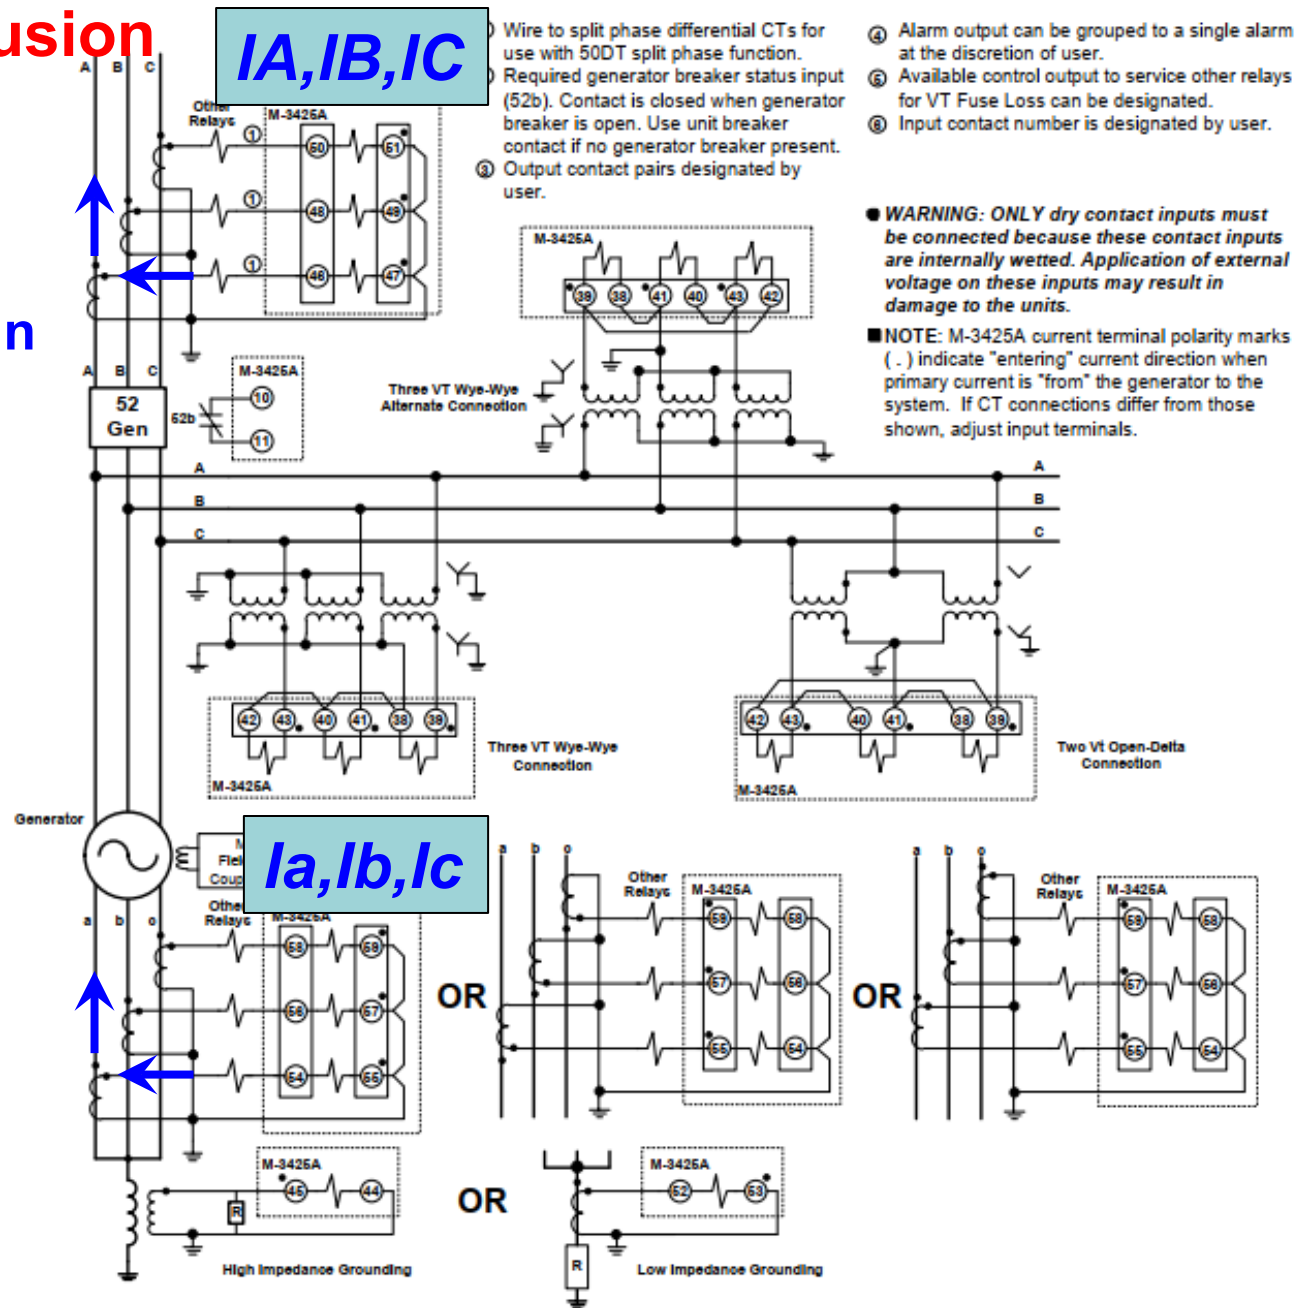
event caused by incorrect polarity wiring i.e. it is not wired per the 3-line in the M-3425A IB:

Because the operating current equation in the 87 algorithm subtracts the vector quantities of the current inputs from both sides of the stator winding, the CT and relay current input polarities need to be such that thru currents are in-phase with each other (enters relay polarity on both sides).

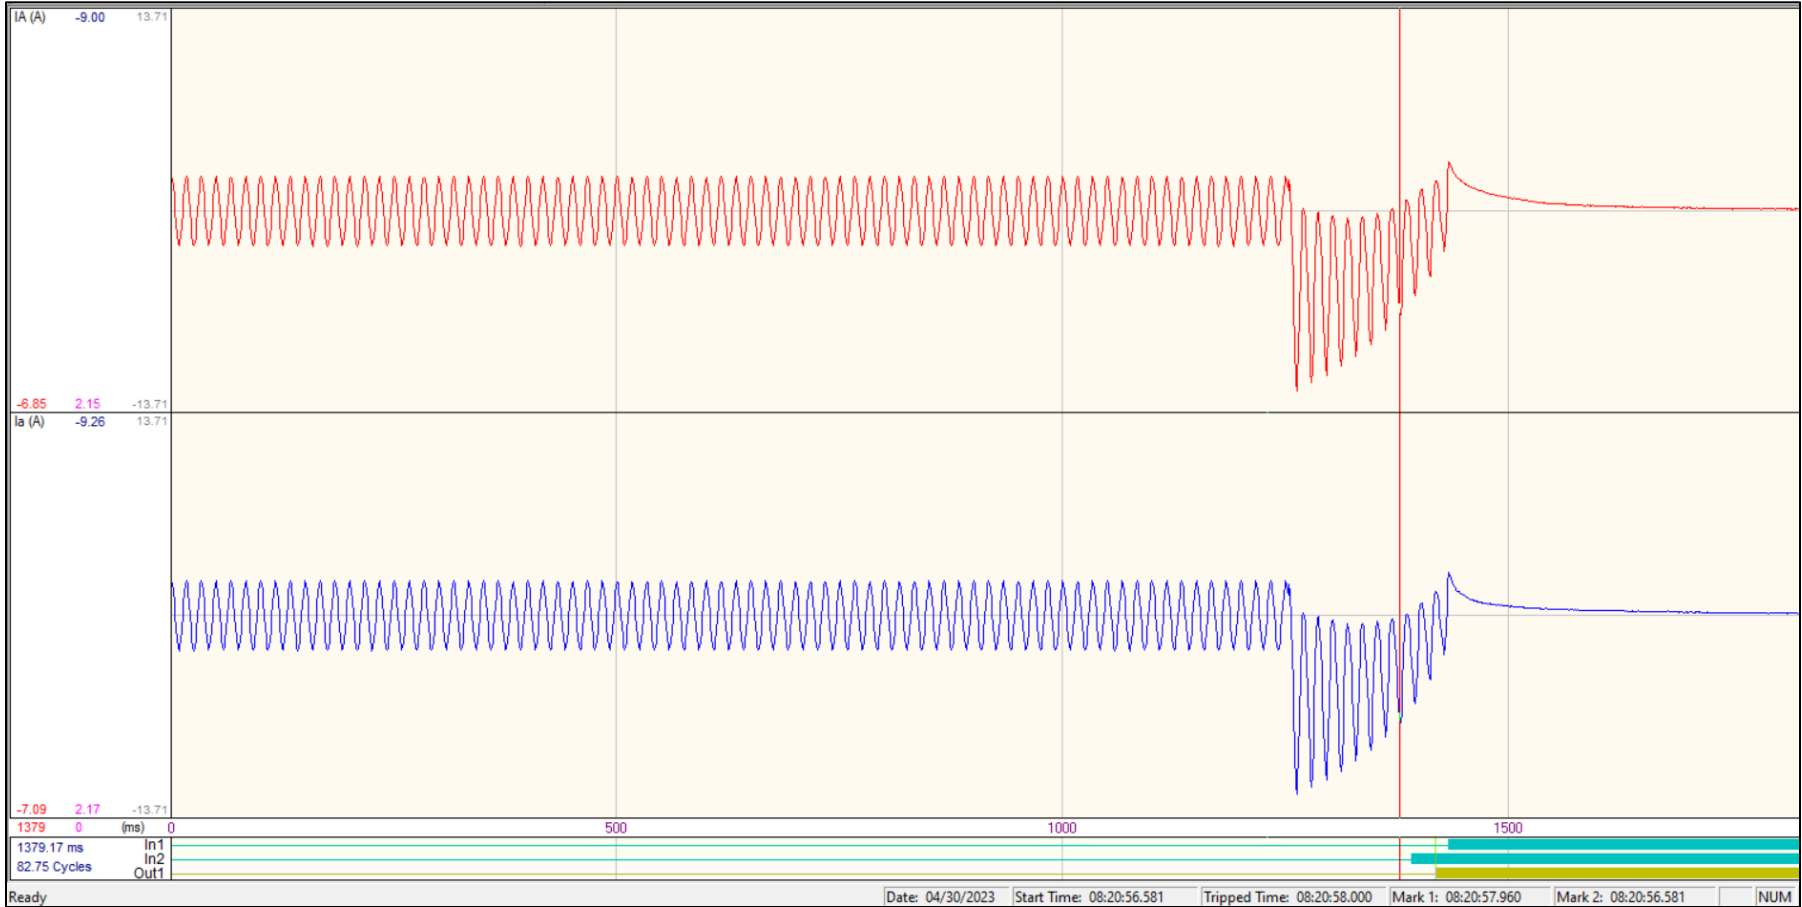
- The IA and Ia current waveforms both show DC offset current and they both enter saturation from the DC offset at about the same time; however, the rate at which each side comes out of saturation is slightly different:

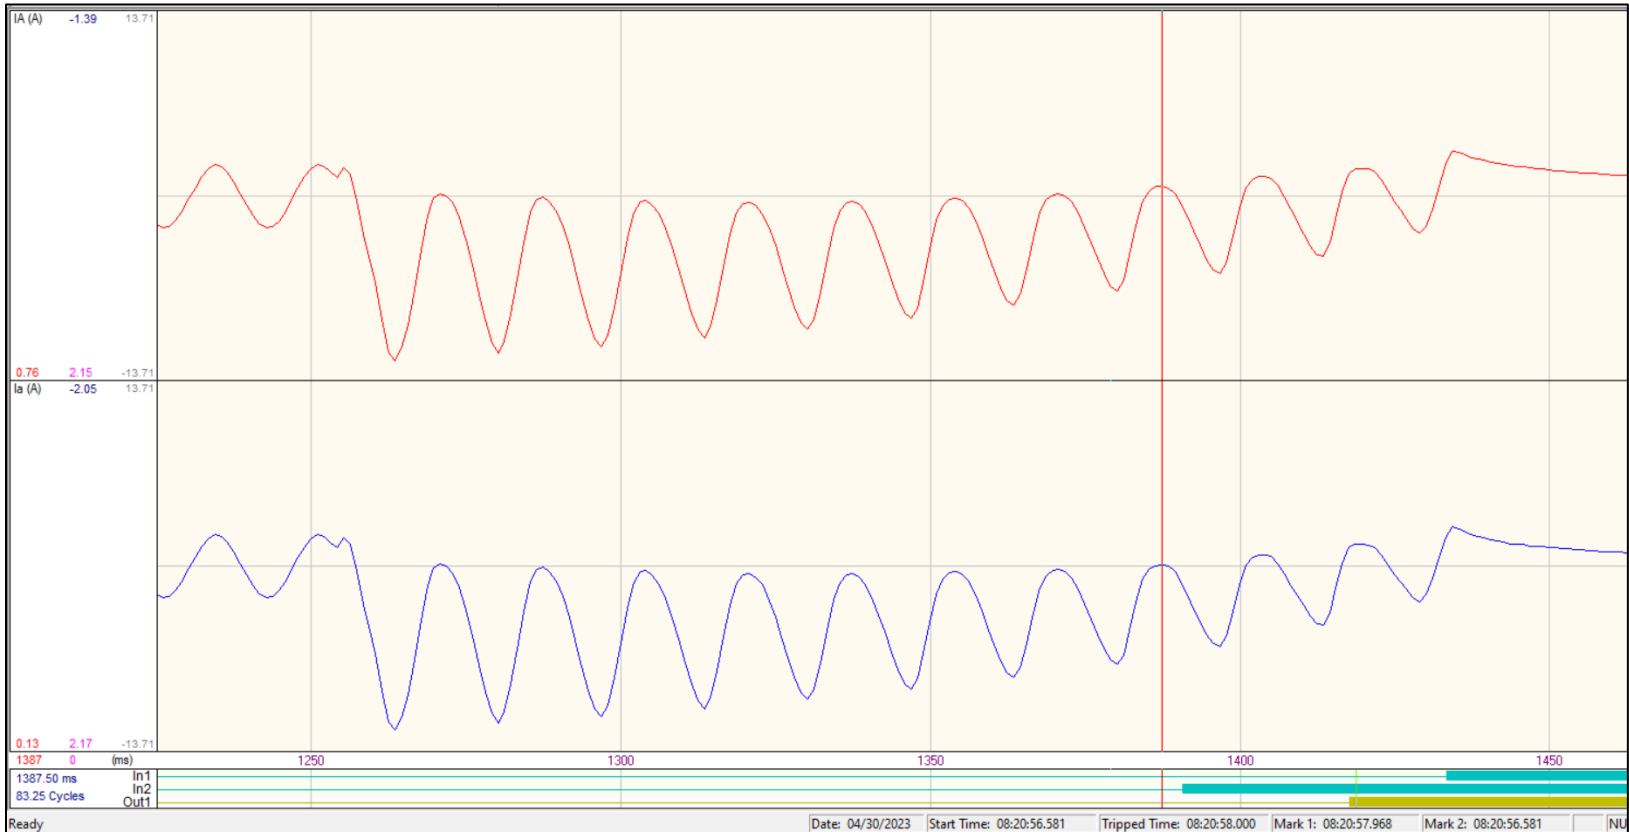
- Zoomed-in, the rate at which the DC offset decayed on each side is slightly different thus causing the 87 trip.
- The CTs on each side did not saturate evenly with respect to time i.e. they did not come out of saturation at the same rate.

- Cause: CT saturation performance mismatch.
- Remedy 1: Address CT saturation performance mismatch – perform CT saturation calculations, look at burdens on each side, CT class on each side, CT knee point voltage on each side, CT secondary winding resistance on each side, CT cable length and wire gauge used on each side, etc.

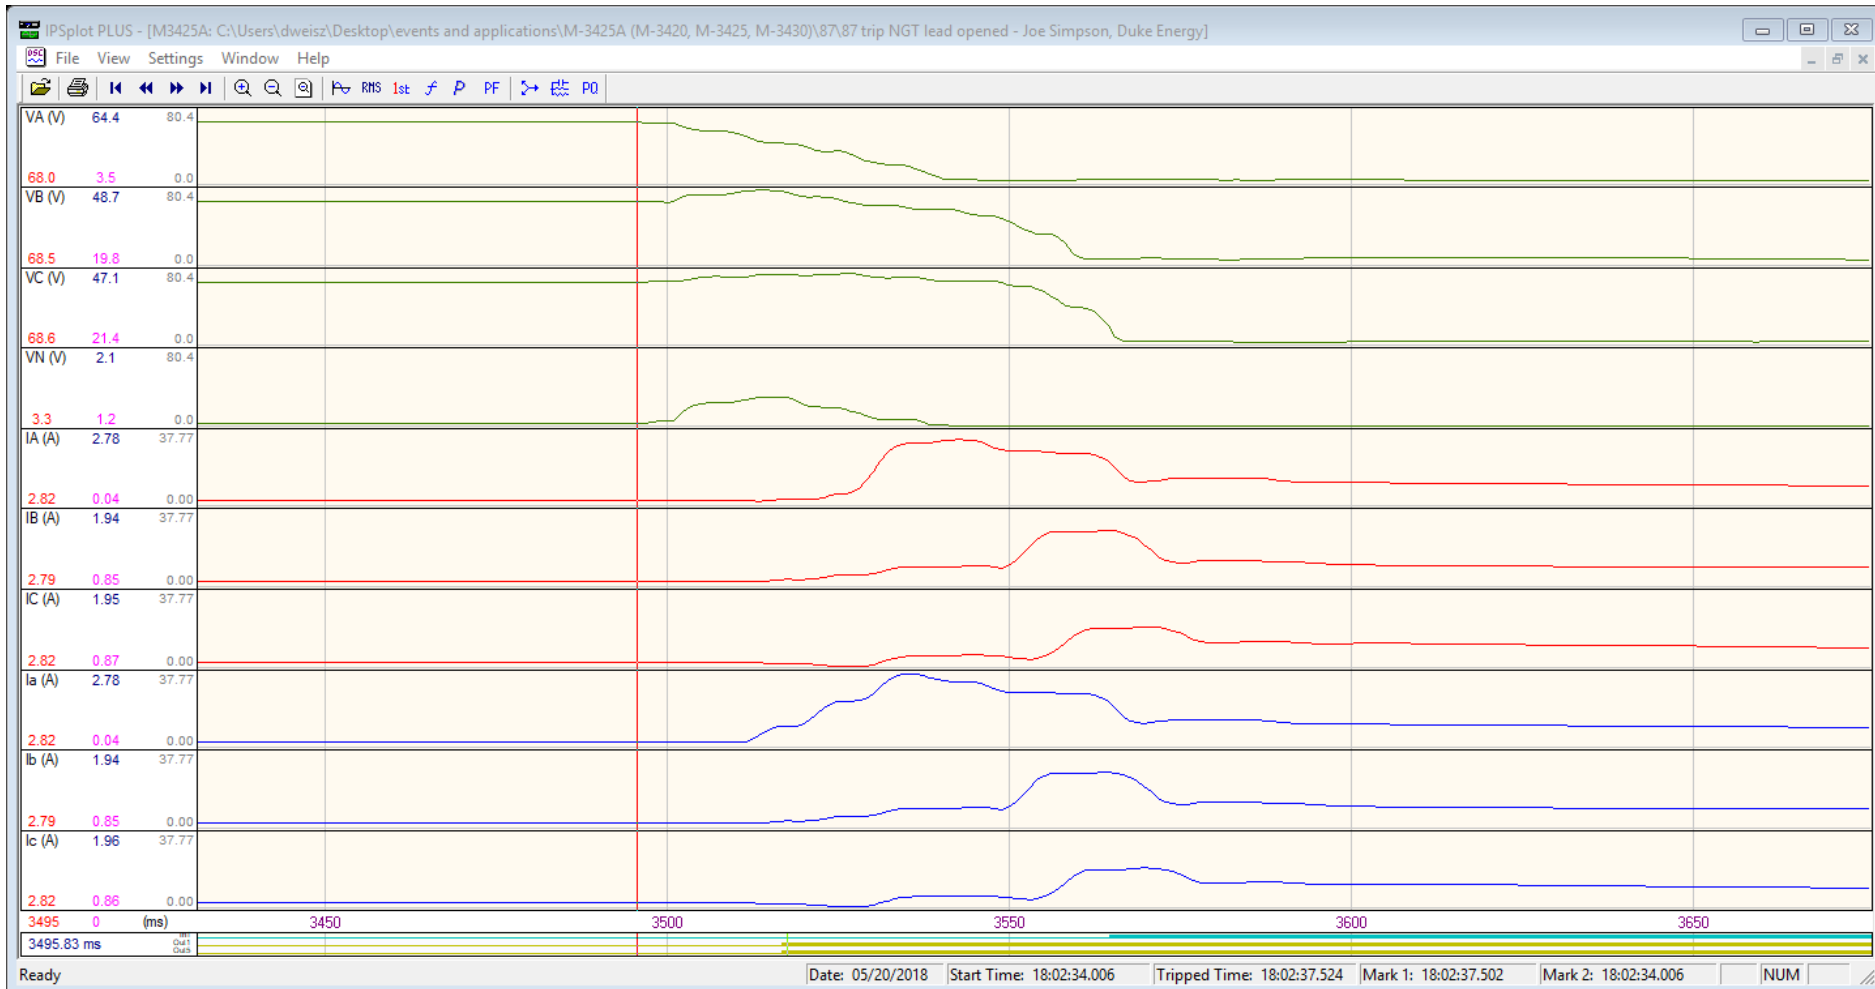
This is consistent with the neutral shift that is seen on high impedance grounded systems where the faulted phase decreases and the other 2 phases increase as well as the ground voltage.

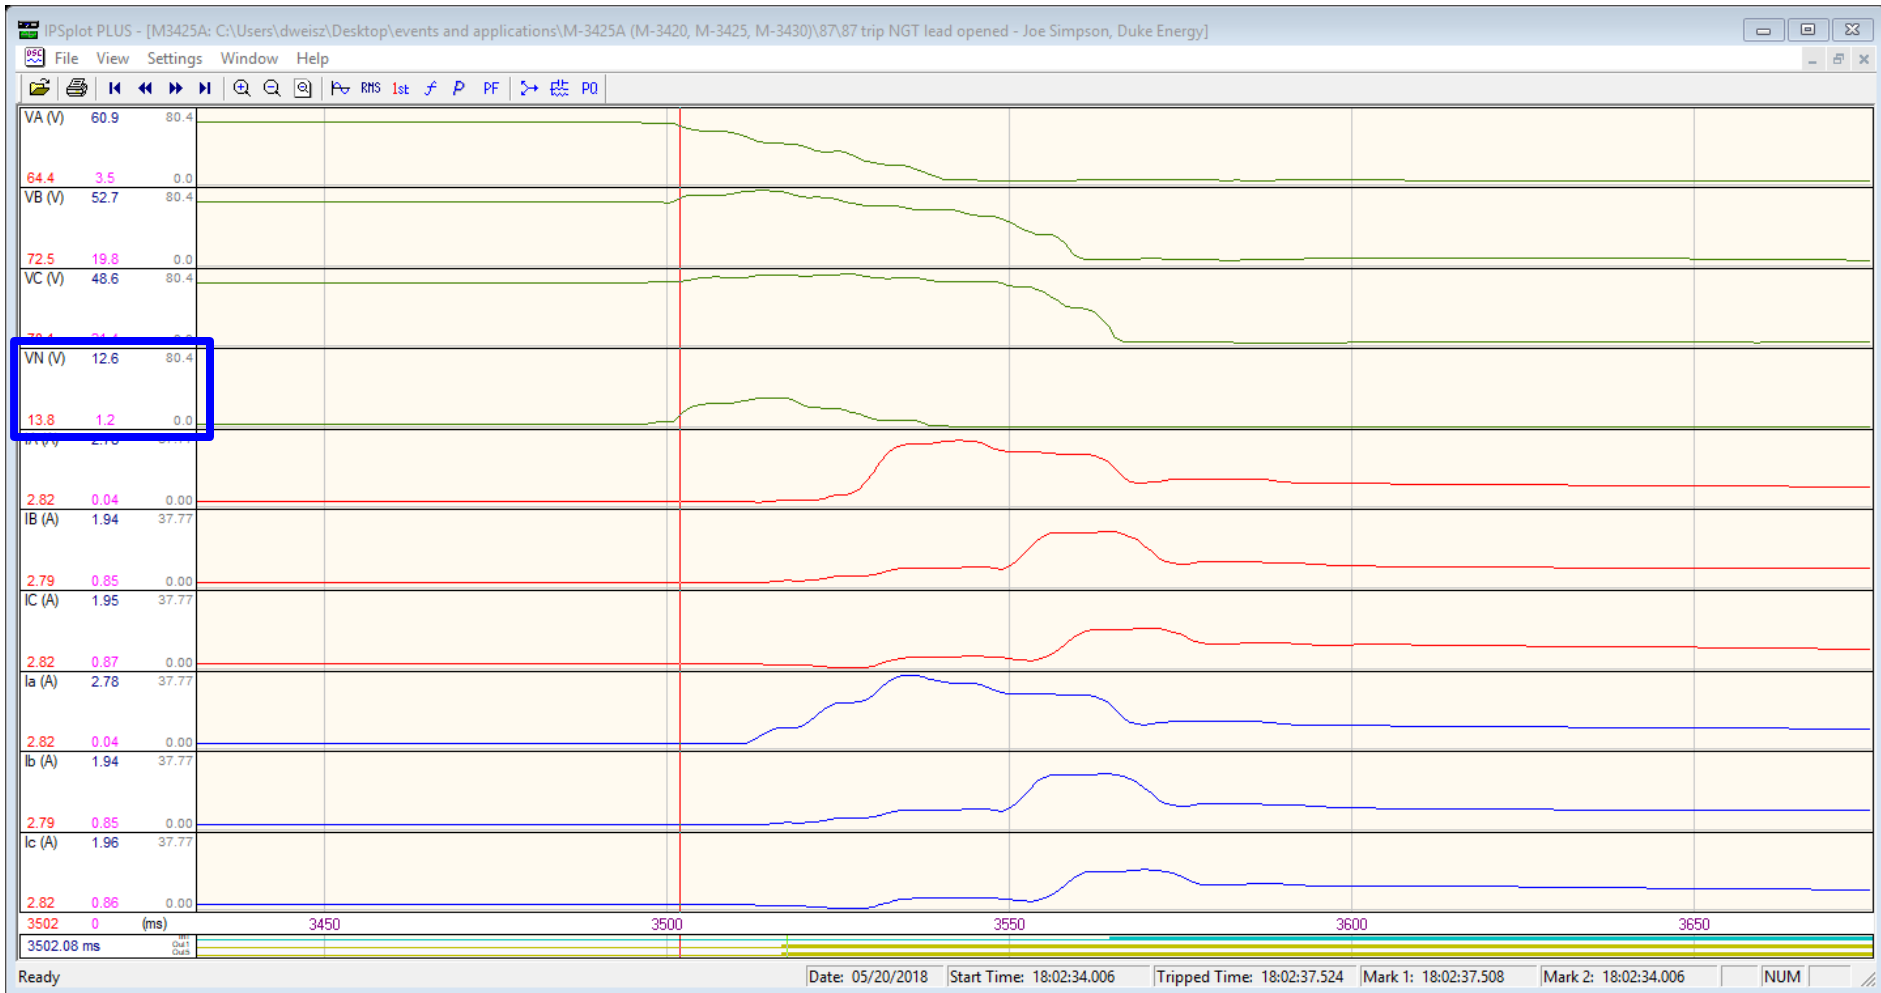
- 6 msec later, the measured VN value equaled 13.8 V, exceeding the 59N Pickup setting of 6.5 V. This started to increment the 59N timer. But with the time delay set at 60 cycles, this 59N function never timed out as 87 would trip first.

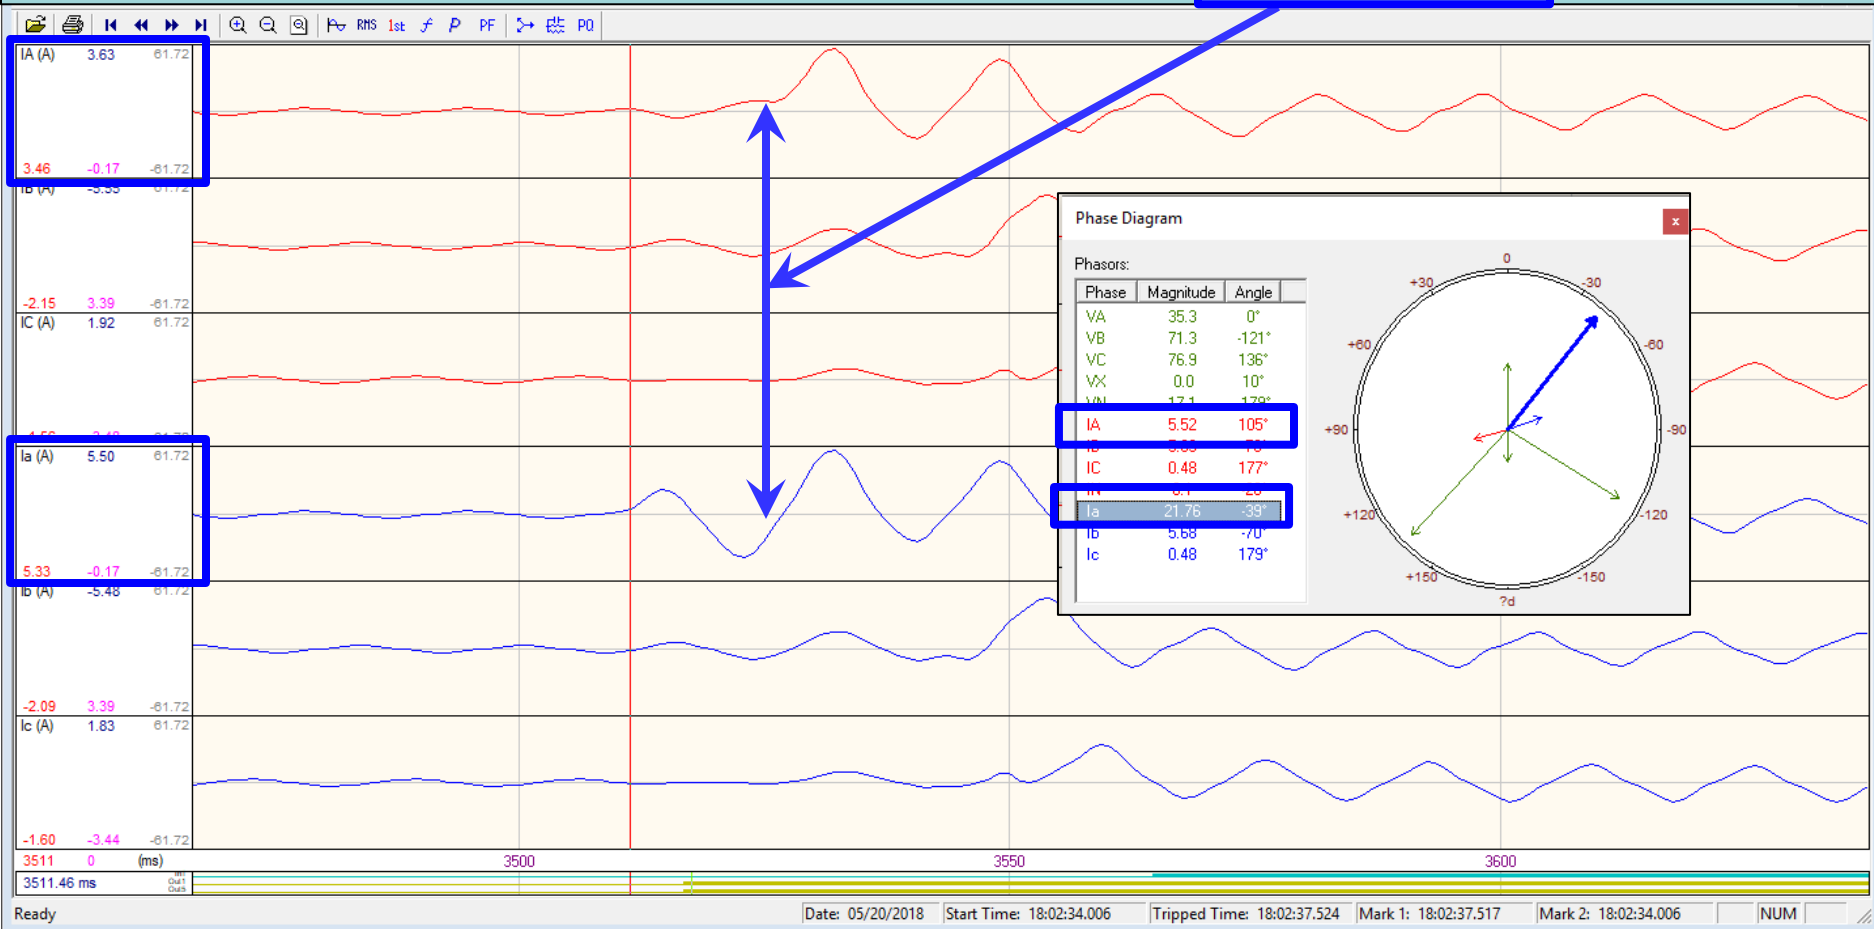
- 9 msec later or 15 msec after fault inception, the measured current begins to deviate from the pre-fault values and the calculated differential current on A-phase ($I_a - I_A = 5.33 - 3.46 = 1.87$ A) first exceeds the 87 Pickup setting of 0.20 A. Specifically, I_a , the a-phase current measured on the neutral side of the generator is the first current to begin to deviate.
 - This is where the NGT failed and became a short circuit, solidly grounding the machine.
 - a-phase current goes from thru load current, to an internal fault i.e. I_a and I_A go from being in-phase with each other to being approximately 180° out of phase

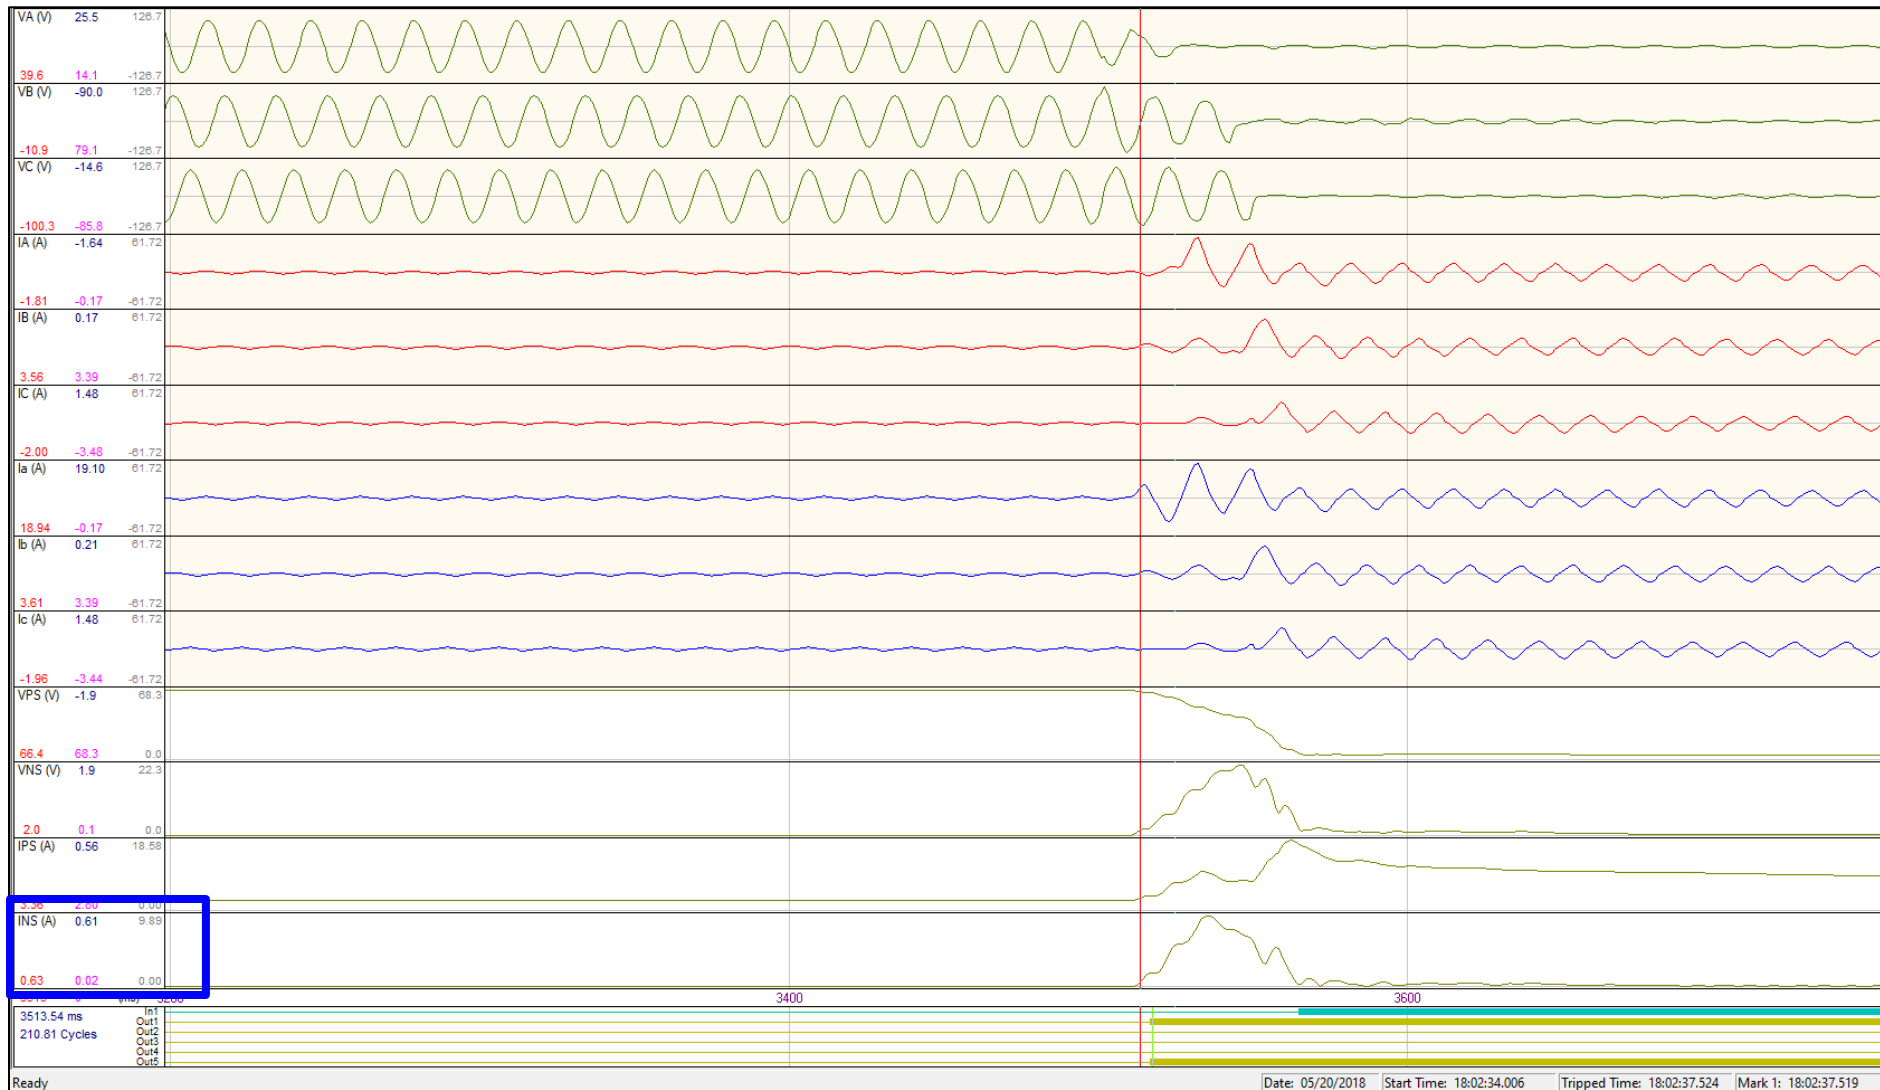
2 msec later or 17 msec after fault inception, the measured negative sequence current equaled 0.63 A, exceeding the 46IT Pickup setting of 0.314 A (8% of I_{nom}). 46IT started to time, but it did not time out as the 87 function would trip first.

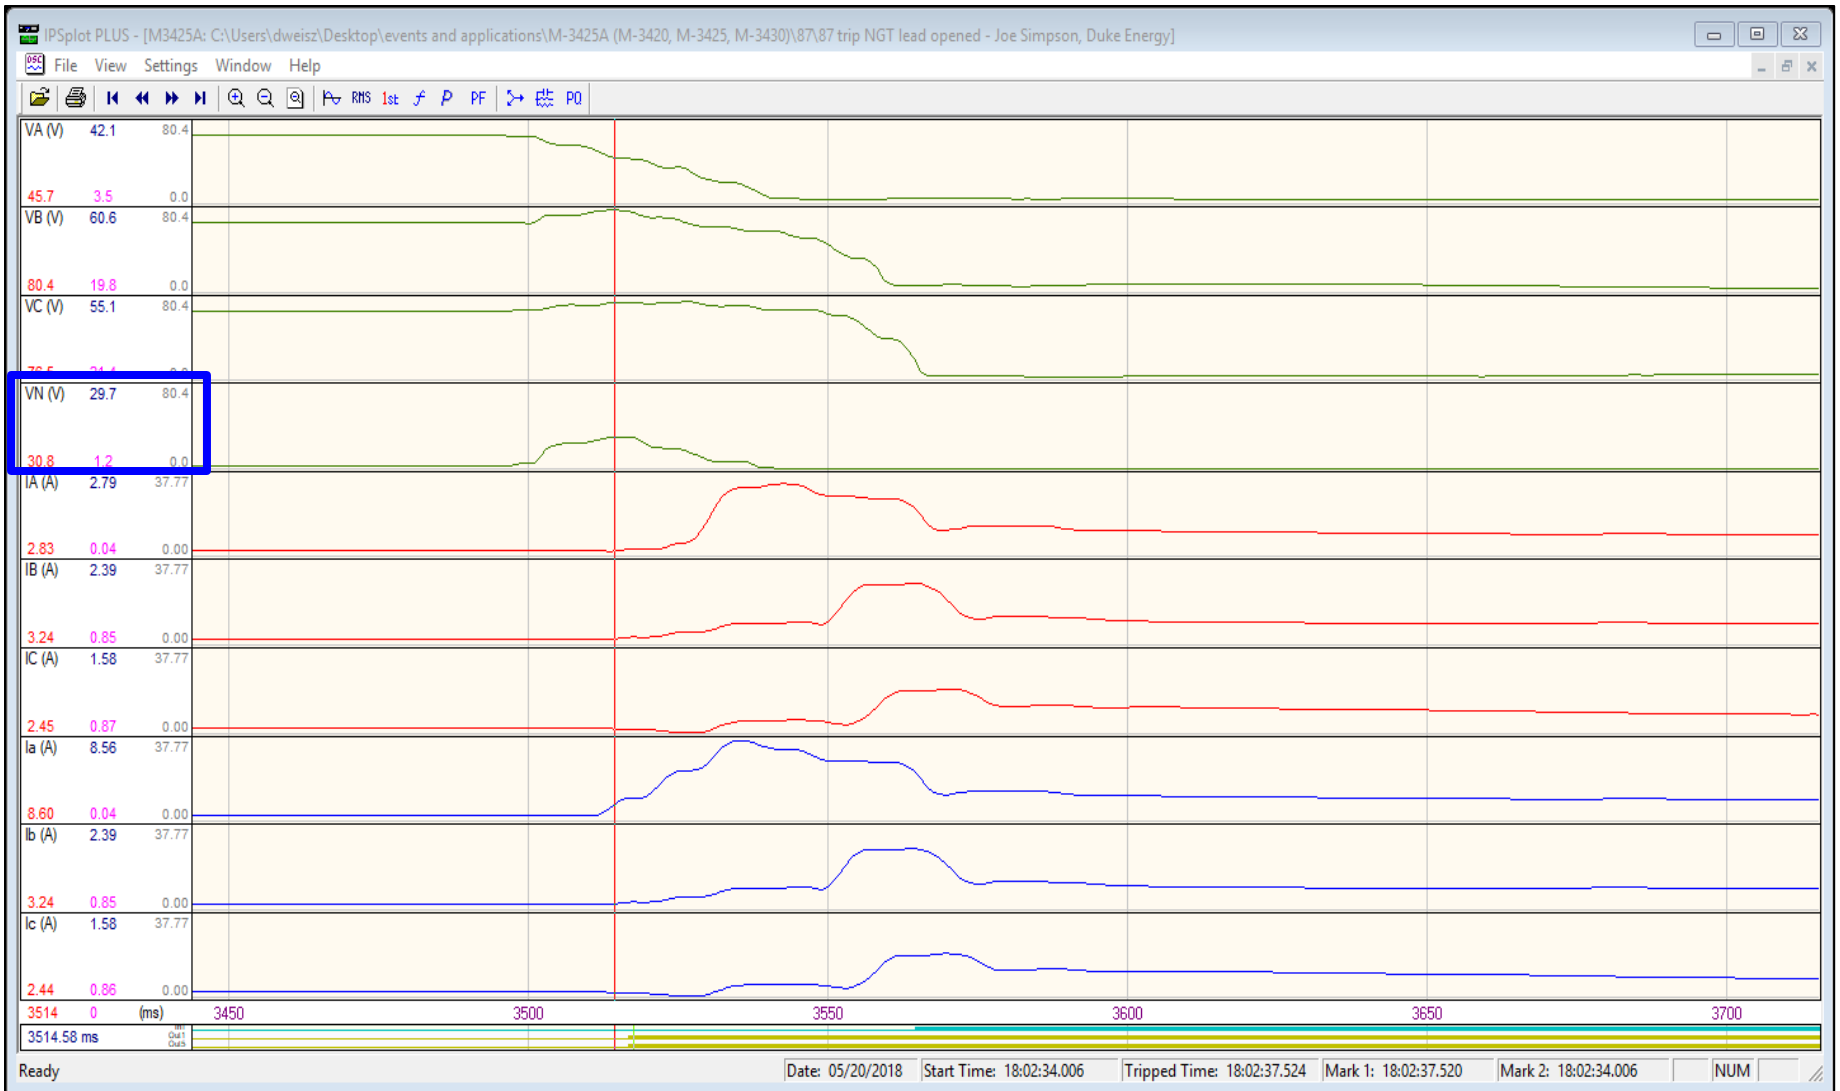
1 msec later or 18 msec after fault inception, the peak VN value is measured at 30.8 V, which is 24% of the 129.8 V. **This indicates a fault location of 24% of the stator winding from the neutral end.**

- The fault started as an AG internal fault at about 24% of the stator winding from the neutral end **(fault was found at 25%)**.
- The measured high current values (up to 90 KA) on this high-impedance grounded machine, indicates that the high impedance grounding network was compromised. This failure resulted in the NGT looking like a short circuit, thus making this high-impedance grounded machine appear as a solidly grounded machine with the accompanying very high fault current values.

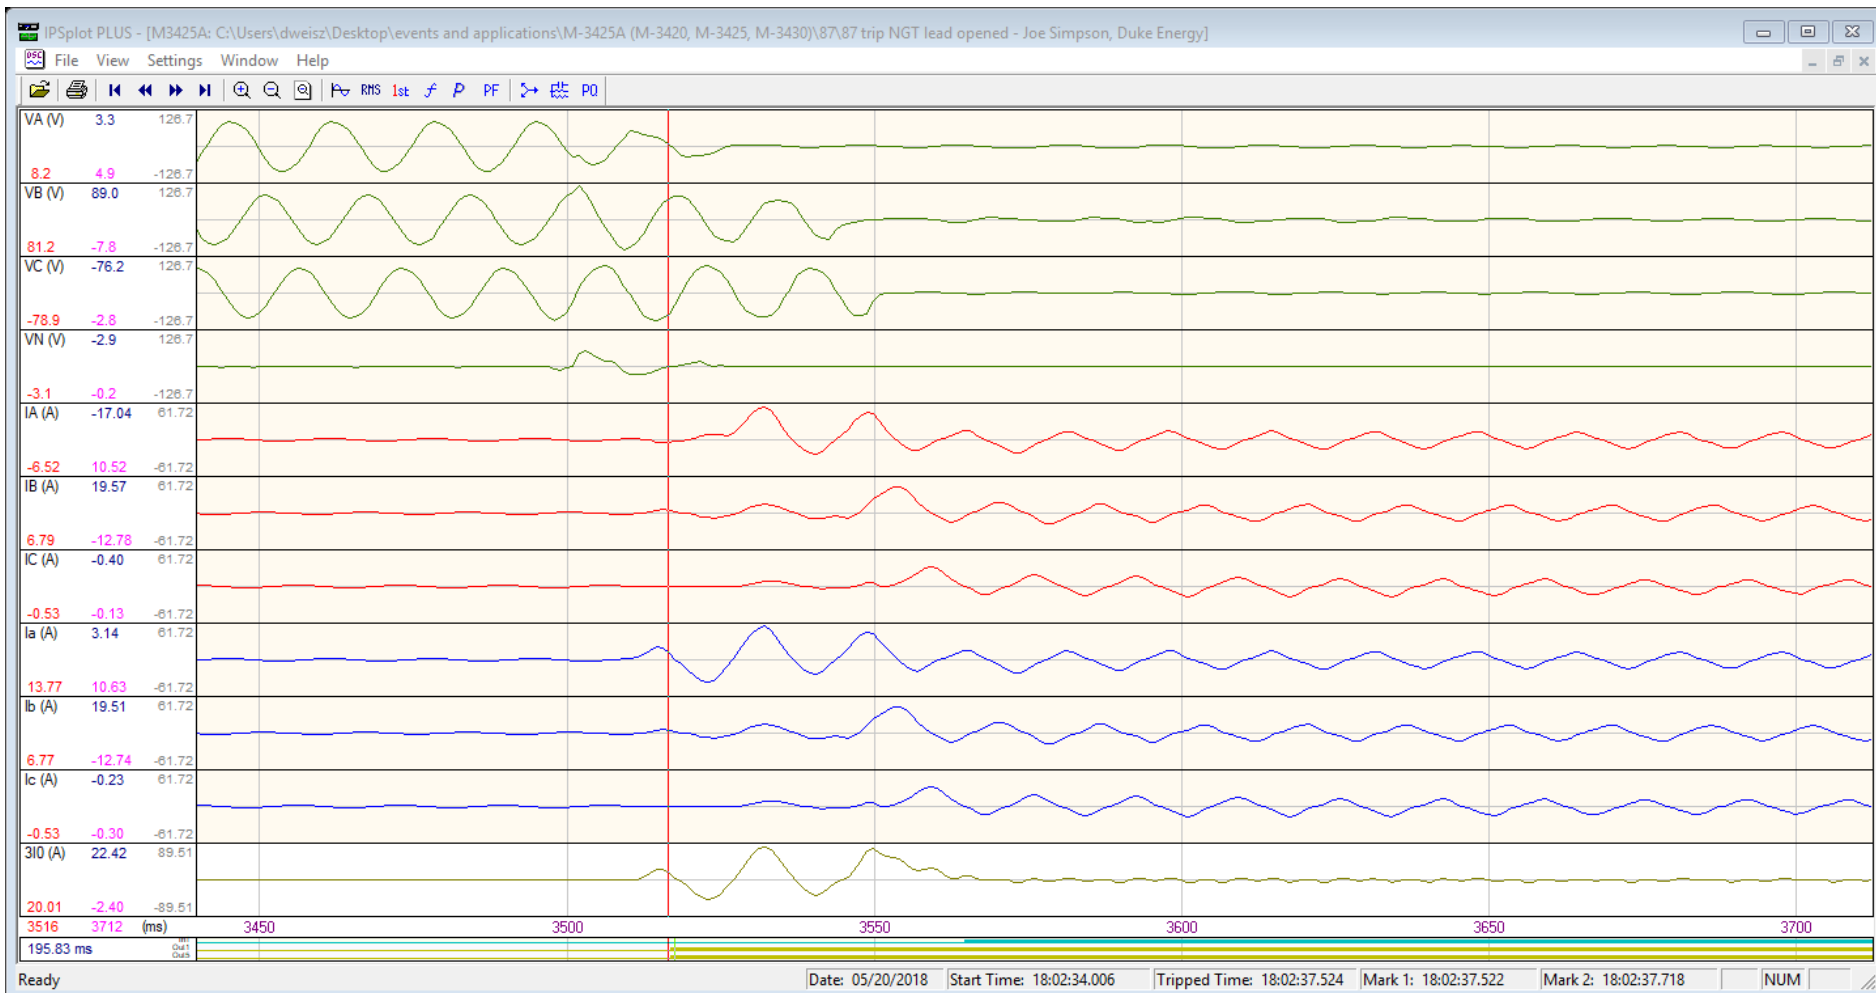
- 2 msec later or 20 msec after fault inception, Outputs 1 and 5 are activated by the 87 function.
- This is 5 msec after the current first exceeds the 87 Pickup setting.
