Event Analysis

Douglas L. Weisz, PE

Power Plant Protection Track
Thursday, August 7, 2025

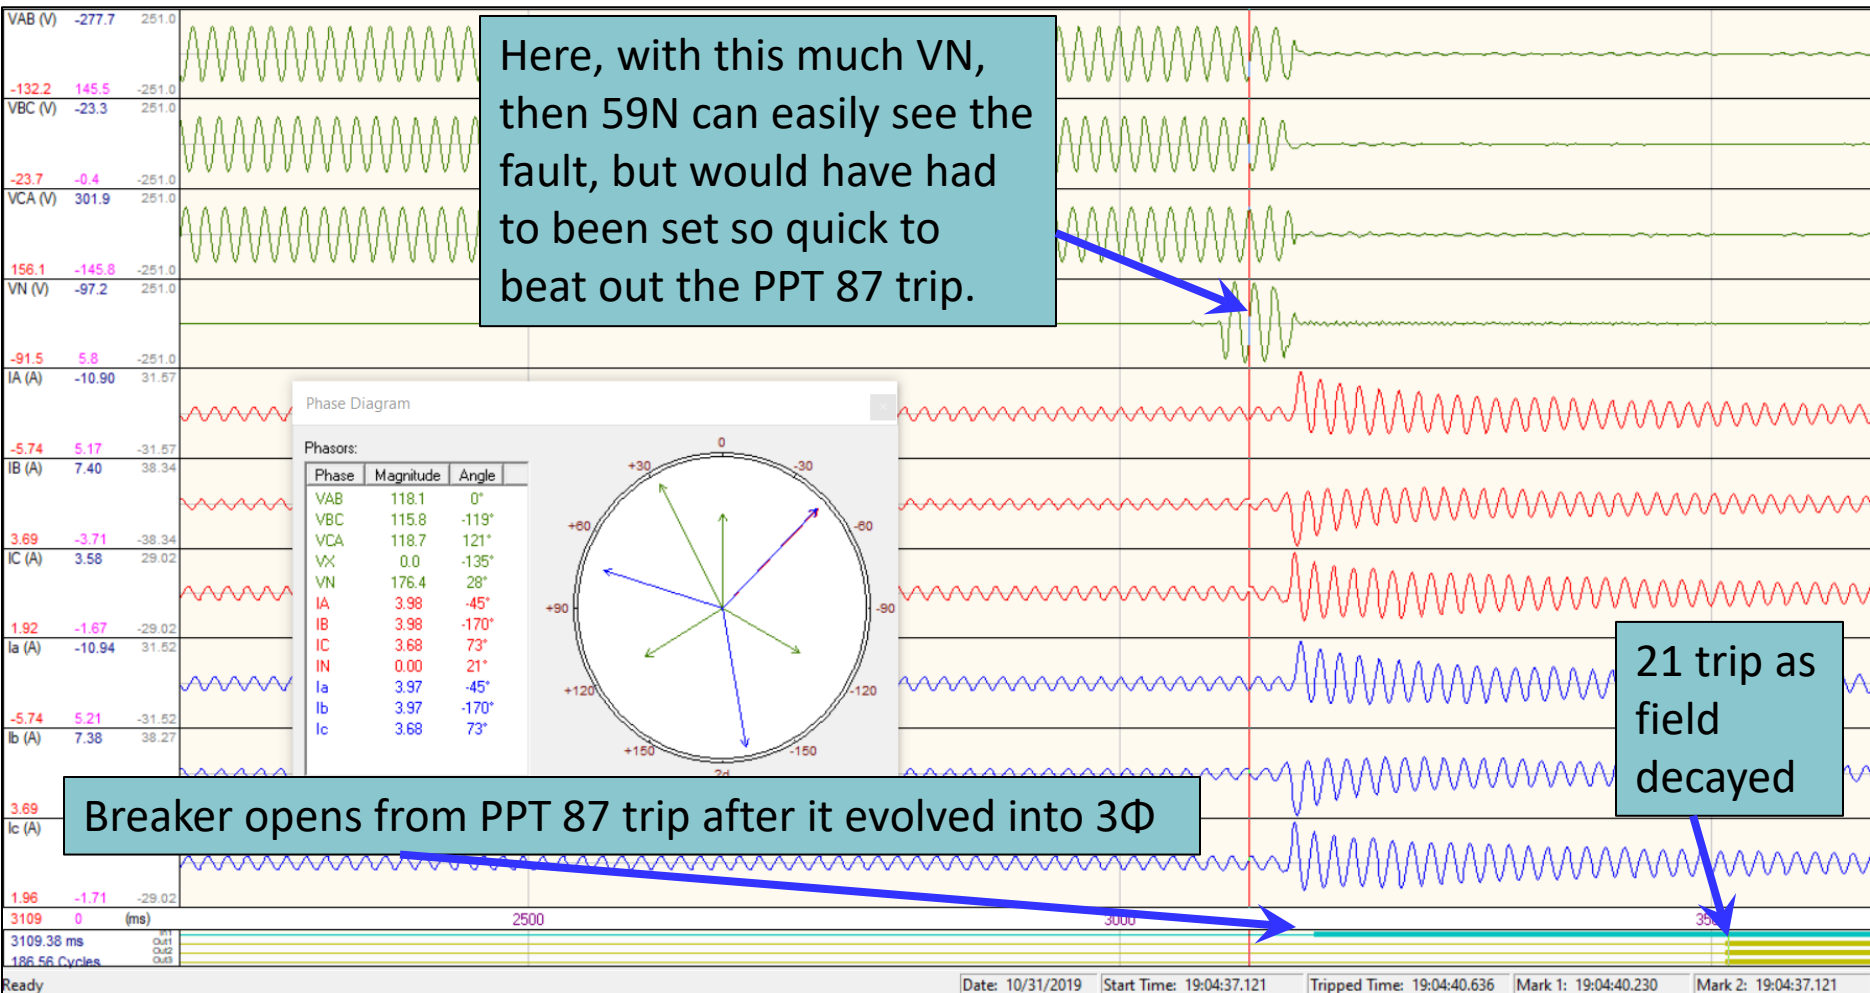
- 87 relay around the PPT issued the initial trip.
- But prior to that, there was a very low level VN measured of 4.1 V.
- The minimum setting range on most relay mfg's 59N/59G/64G elements is 5 V, so it could not see this low level, incipient ground fault initially.

- That 4.1 V at VN calculated out to a ΦG fault with 40,346 Ω resistance in it.
- Because that high of a resistance is very close to what we consider to be a healthy insulation resistance of 50 K Ω to 100 K Ω , therefore it is hard to discriminate between normal conditions and this fault condition.

- For example, modelling 40 K Ω vs 50 K Ω works out to a difference of only 0.5 mA which is usually not enough margin to set a secure 64S setting, but if they wanted to accept a slightly insecure 64S setting then maybe they could have set such a sensitive setting that could have detected this incipient fault before it evolved and ended in catastrophic failure.

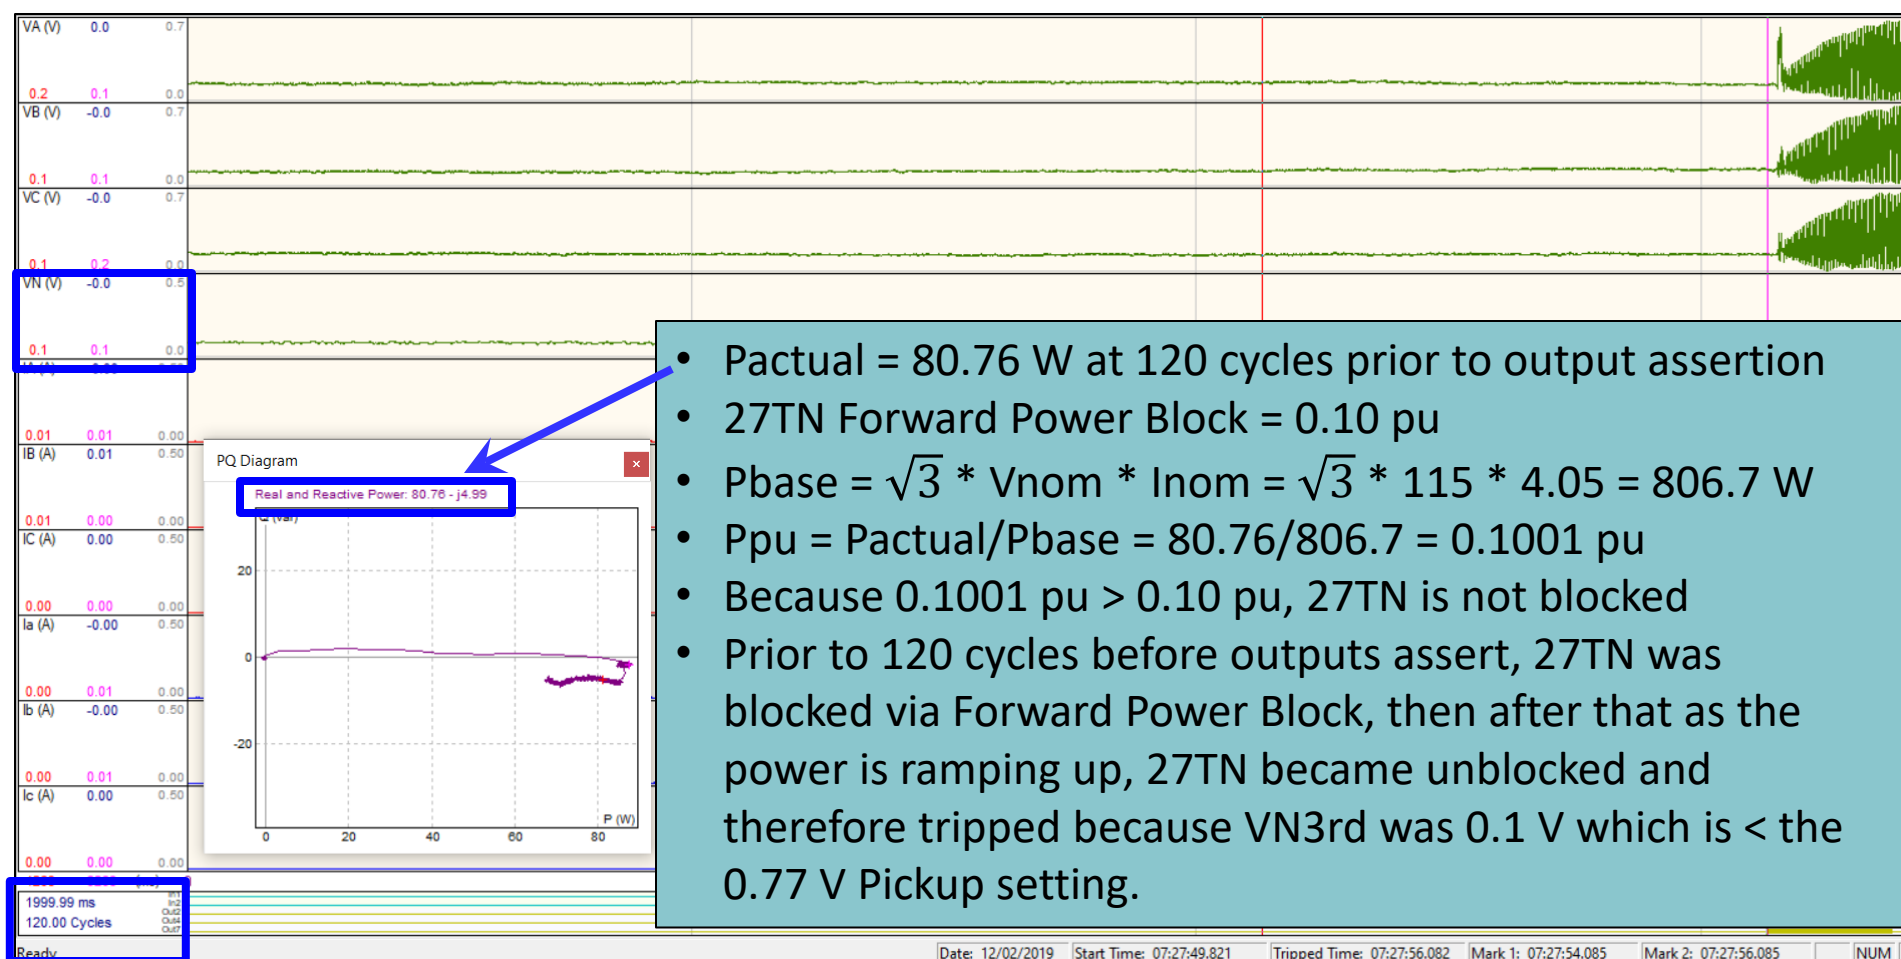
- 27TN Time Delay = 120 cycles so placed one cursor at assertion of outputs mapped from the 27TN #1 element and another cursor 120 cycles prior to that.
- Display third harmonic content from tracings: VN3rd = 0.1 V for the entire event.
- Fundamental component of VN = 0 V, so likely not a true fault.

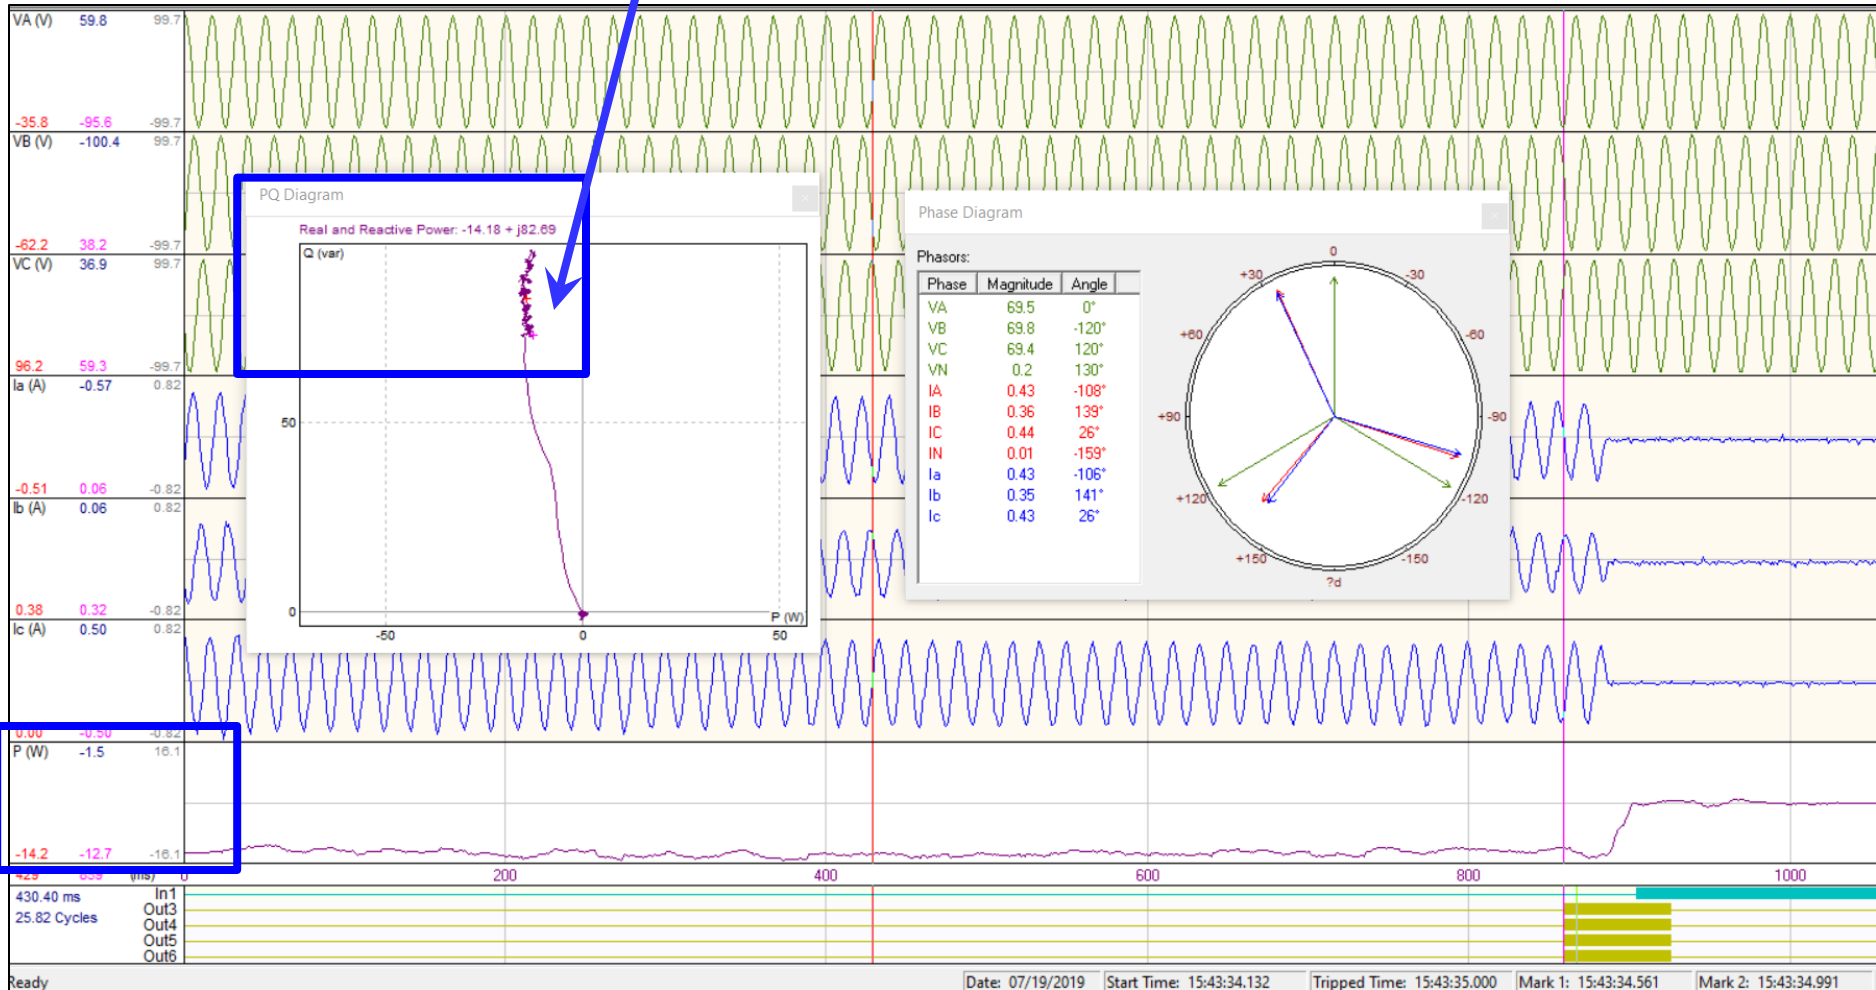
- Plotting the P (Watts) as one of the channels shows the Watts are negative.
- PQ Diagram shows the Watts are negative with operating points in the 2nd quadrant.
- Operating point in **2nd quadrant** indicates excitation still present, but turbine is lost or input to the prime mover is lost.

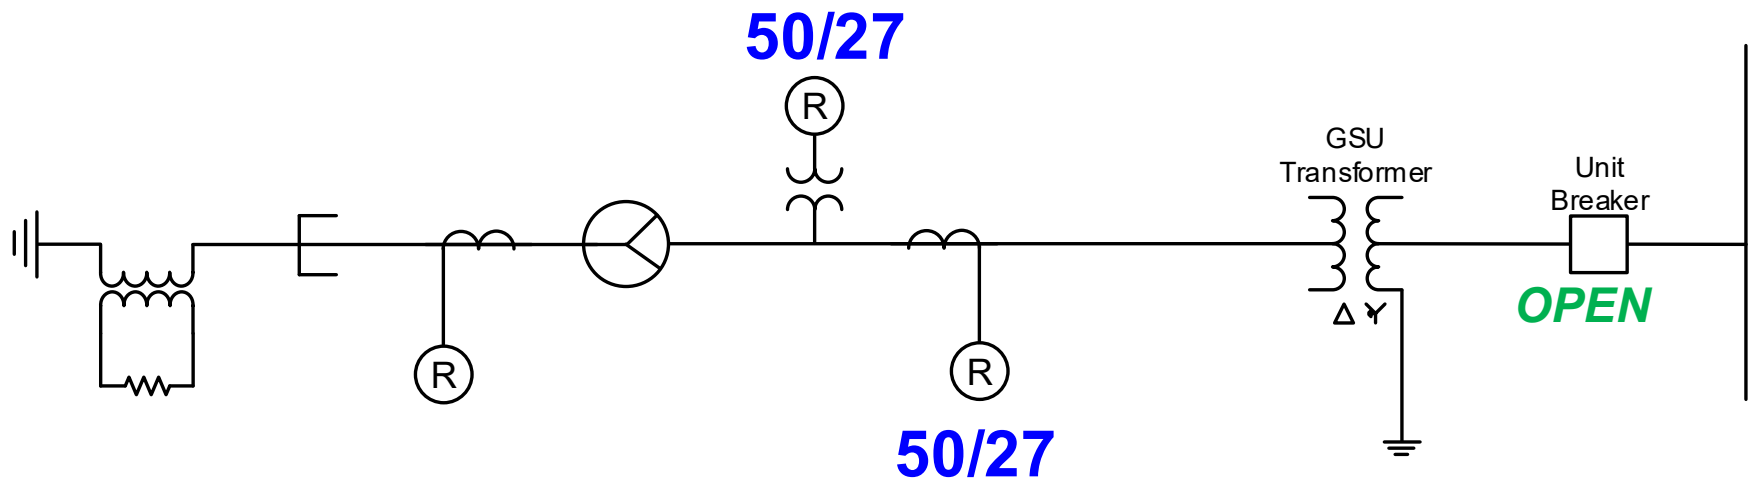
- What do all (3) events have in common?
- All 3 cases were unit connected, i.e. there was no LS generator breaker, they only had a HS unit breaker that was open at the time of the trips.
- All 3 cases occurred during startup i.e. they were coming back on-line (pre-sync period) after an outage where in one case the GSU had been replaced and in another case some GSU testing had been done.
- As the voltage was building up during startup to get ready to sync on-line, the 50/27 tripped the GSU HS unit breaker. Why?

- In all cases, the voltages were not yet built up to nominal – they were about 50-60% of nominal.
- In all cases, the currents were rich in harmonics and saturating heavily as this was pure GSU transformer magnetizing inrush current.
- At any single point in time, the current phasors add up to zero:
 - $3I_0 = I_A + I_B + I_C$
 - $0 = I_A + I_B + I_C$ (as there was no $3I_0$)
 - $-I_A = I_B + I_C$
- All 3 cases had their 50 Pickup setting portion of the 50/27 setting set at minimum or 0.50 A.
- All 3 cases had their 27 Pickup setting portion of the 50/27 setting set too high.

- It may have helped to degauss the GSU after it was tested to remove remnant flux.
- In all cases, recommended to **increase the 50 Pickup and decrease the 27 Pickup** in their 50/27 settings.

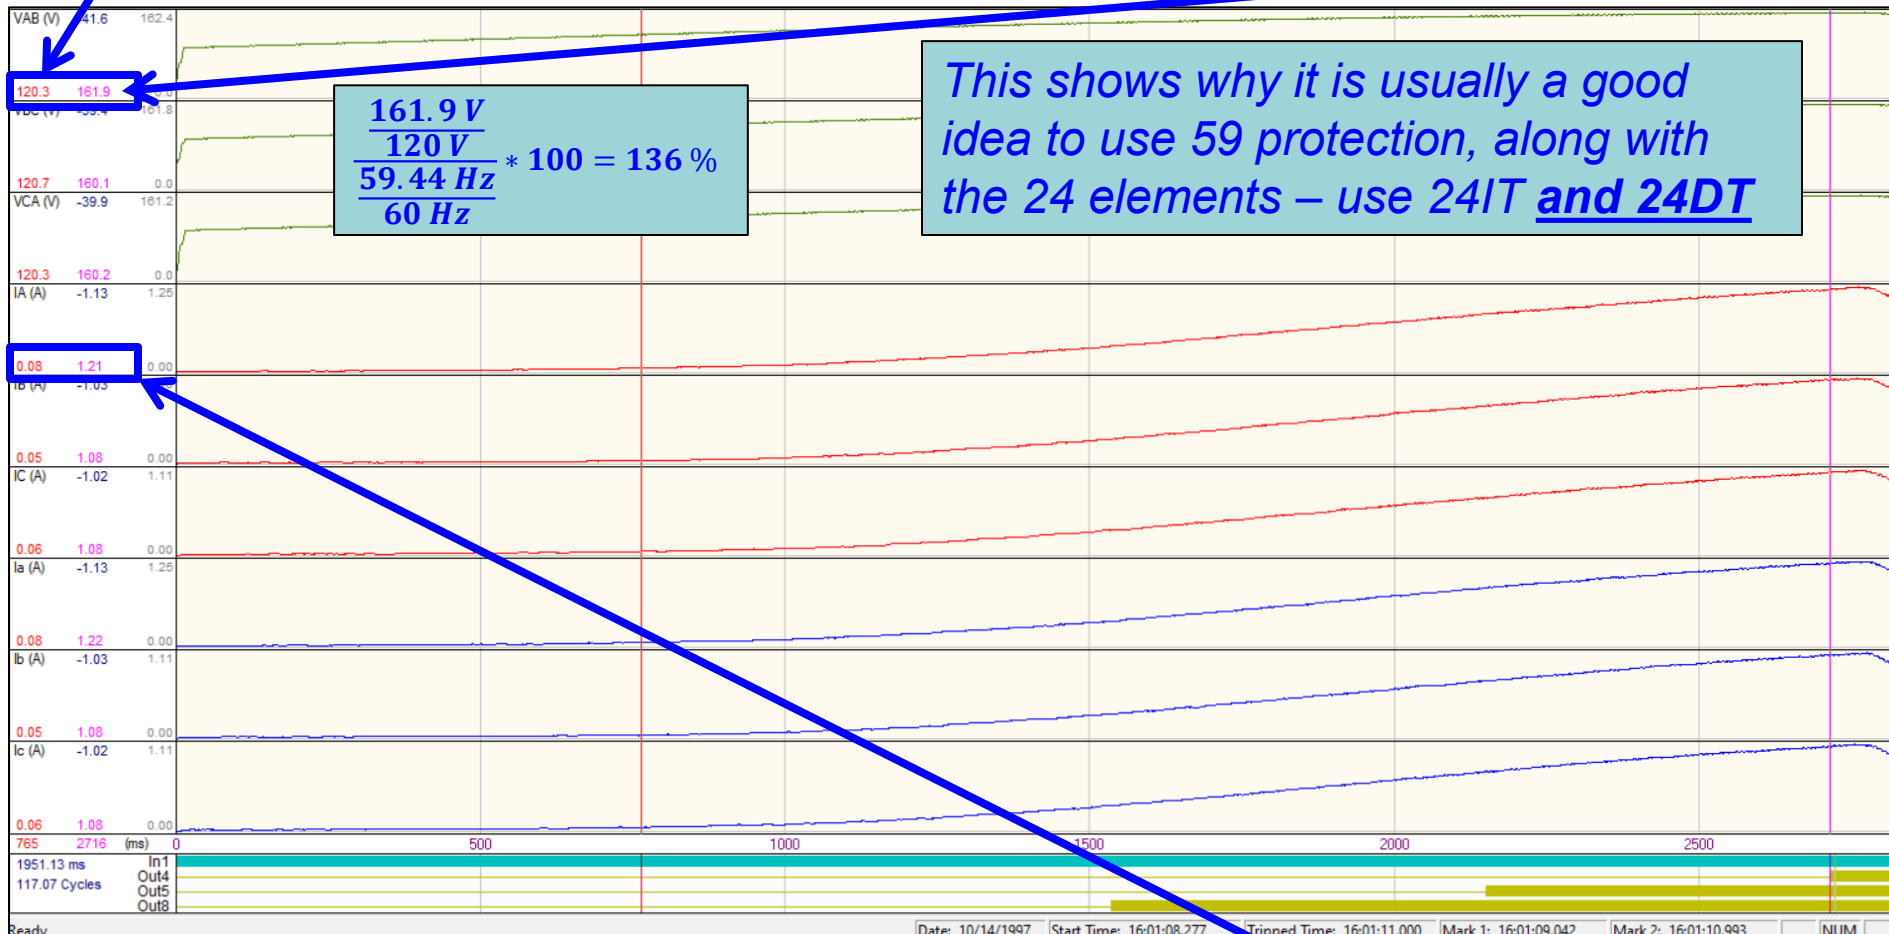
- At 120 V nominal voltage (red cursor) it should have stopped boosting, and at that time the GSU magnetizing current was very low, just 0.08 A.
- At the time the trip occurred, the voltage had boosted all the way up to **161.9 V**.

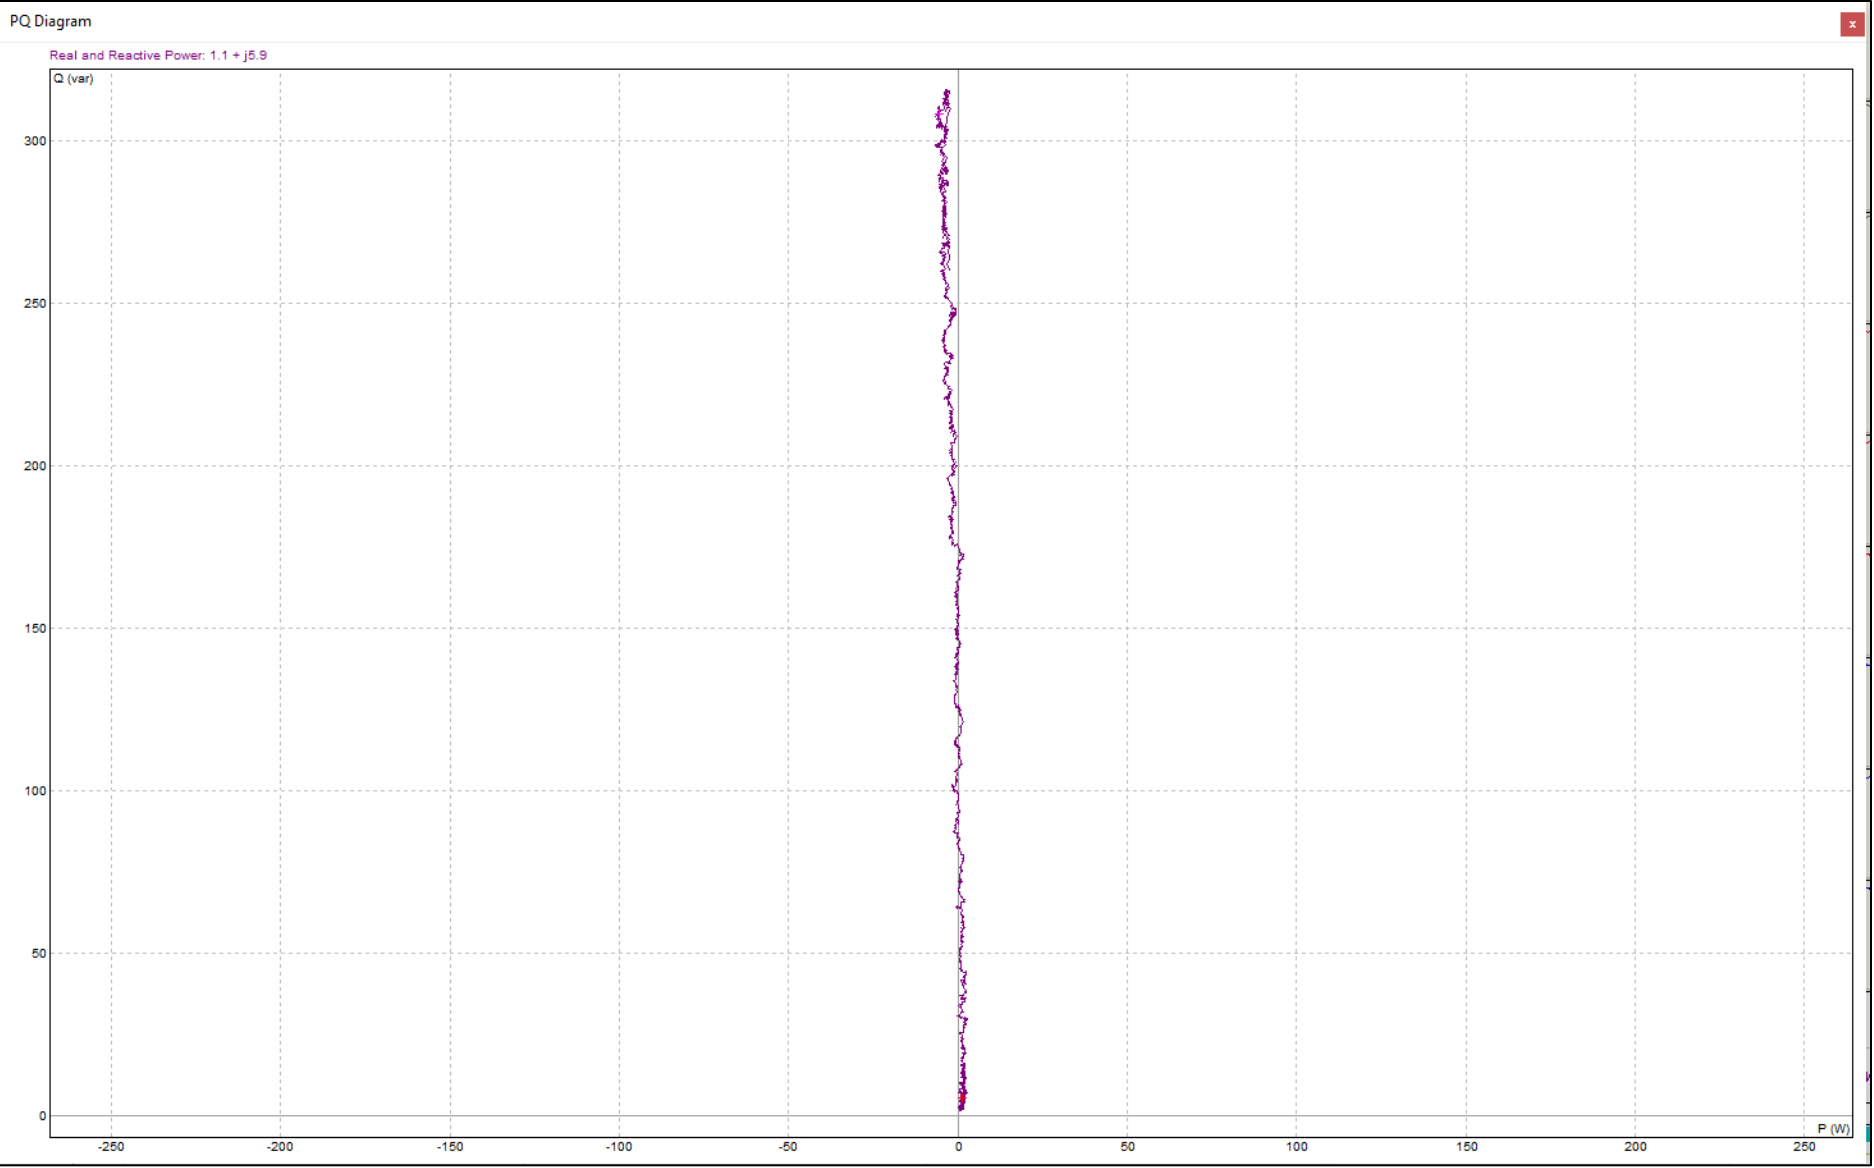
Once the voltage gets high enough to cause overexcitation, 1.21 A of current flows into the GSU and flux spills over into and heats non-laminated parts of the GSU.

- Cause was found to be a runaway excitation system due to blown fuse and the excitation control system had no such blocking for blown fuse so as it saw no volts, it kept trying to boost the voltage.
- This shows why I always preferred not to block 24 with FL because if excitation and relay are driven from the same VTs, then the relay's 24 protection would not have tripped if FL blocking were implemented.
- Where did the current go if the GSU HS breaker is open?
- Into the GSU and then out as heat.
- Conservation of energy.....electricity in, heat out.

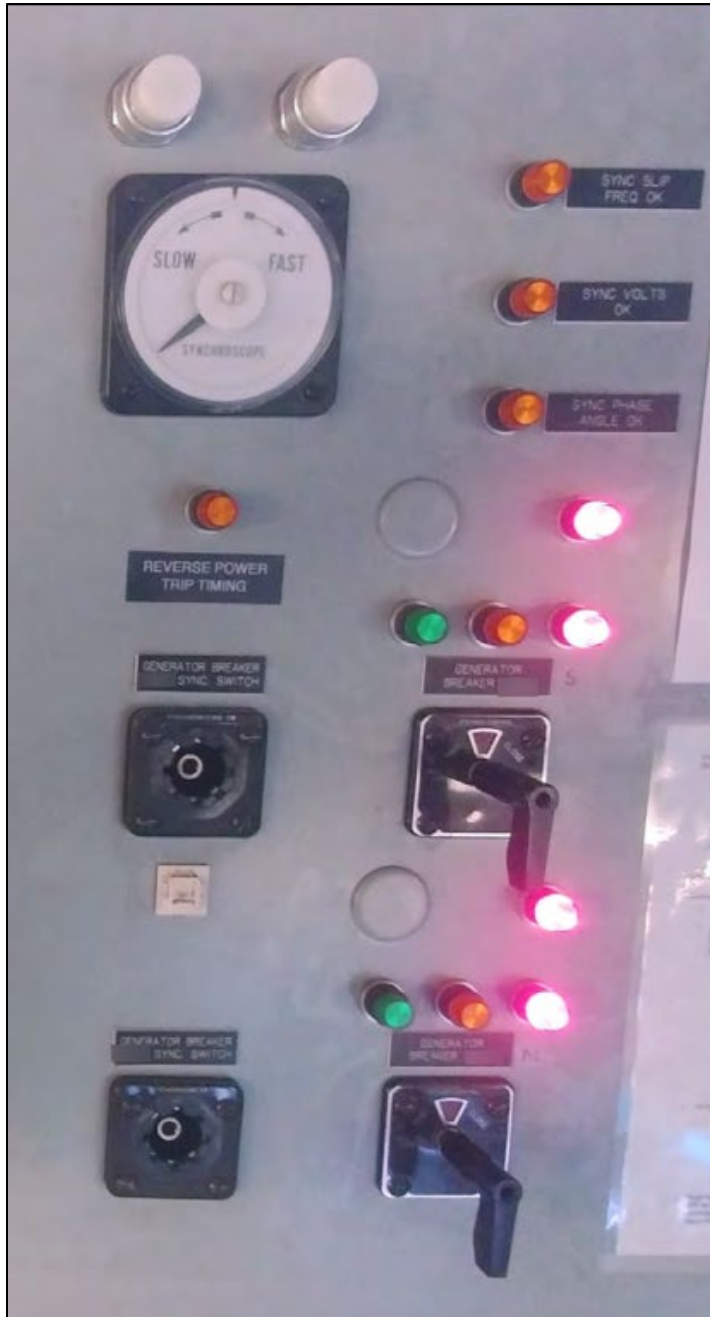
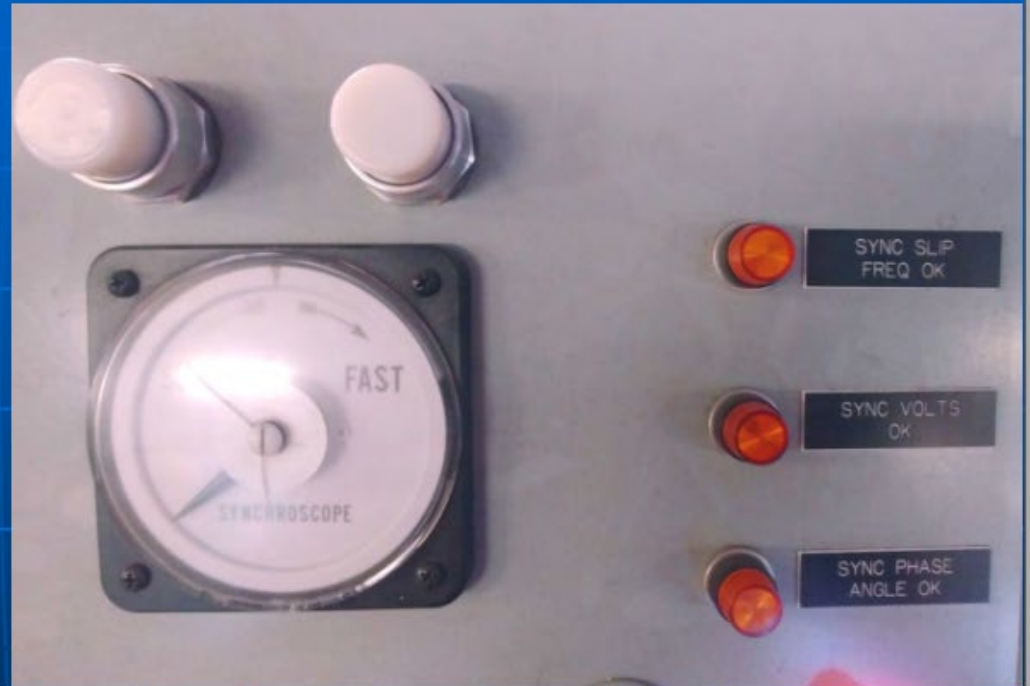
Sync Panel

- **The manual sync check relay (solid state) failed in the closed position due to circuit board level component failure.**
- **Also, the pistol grip switch to manually sync close the breaker was forcibly held in the closed position.**

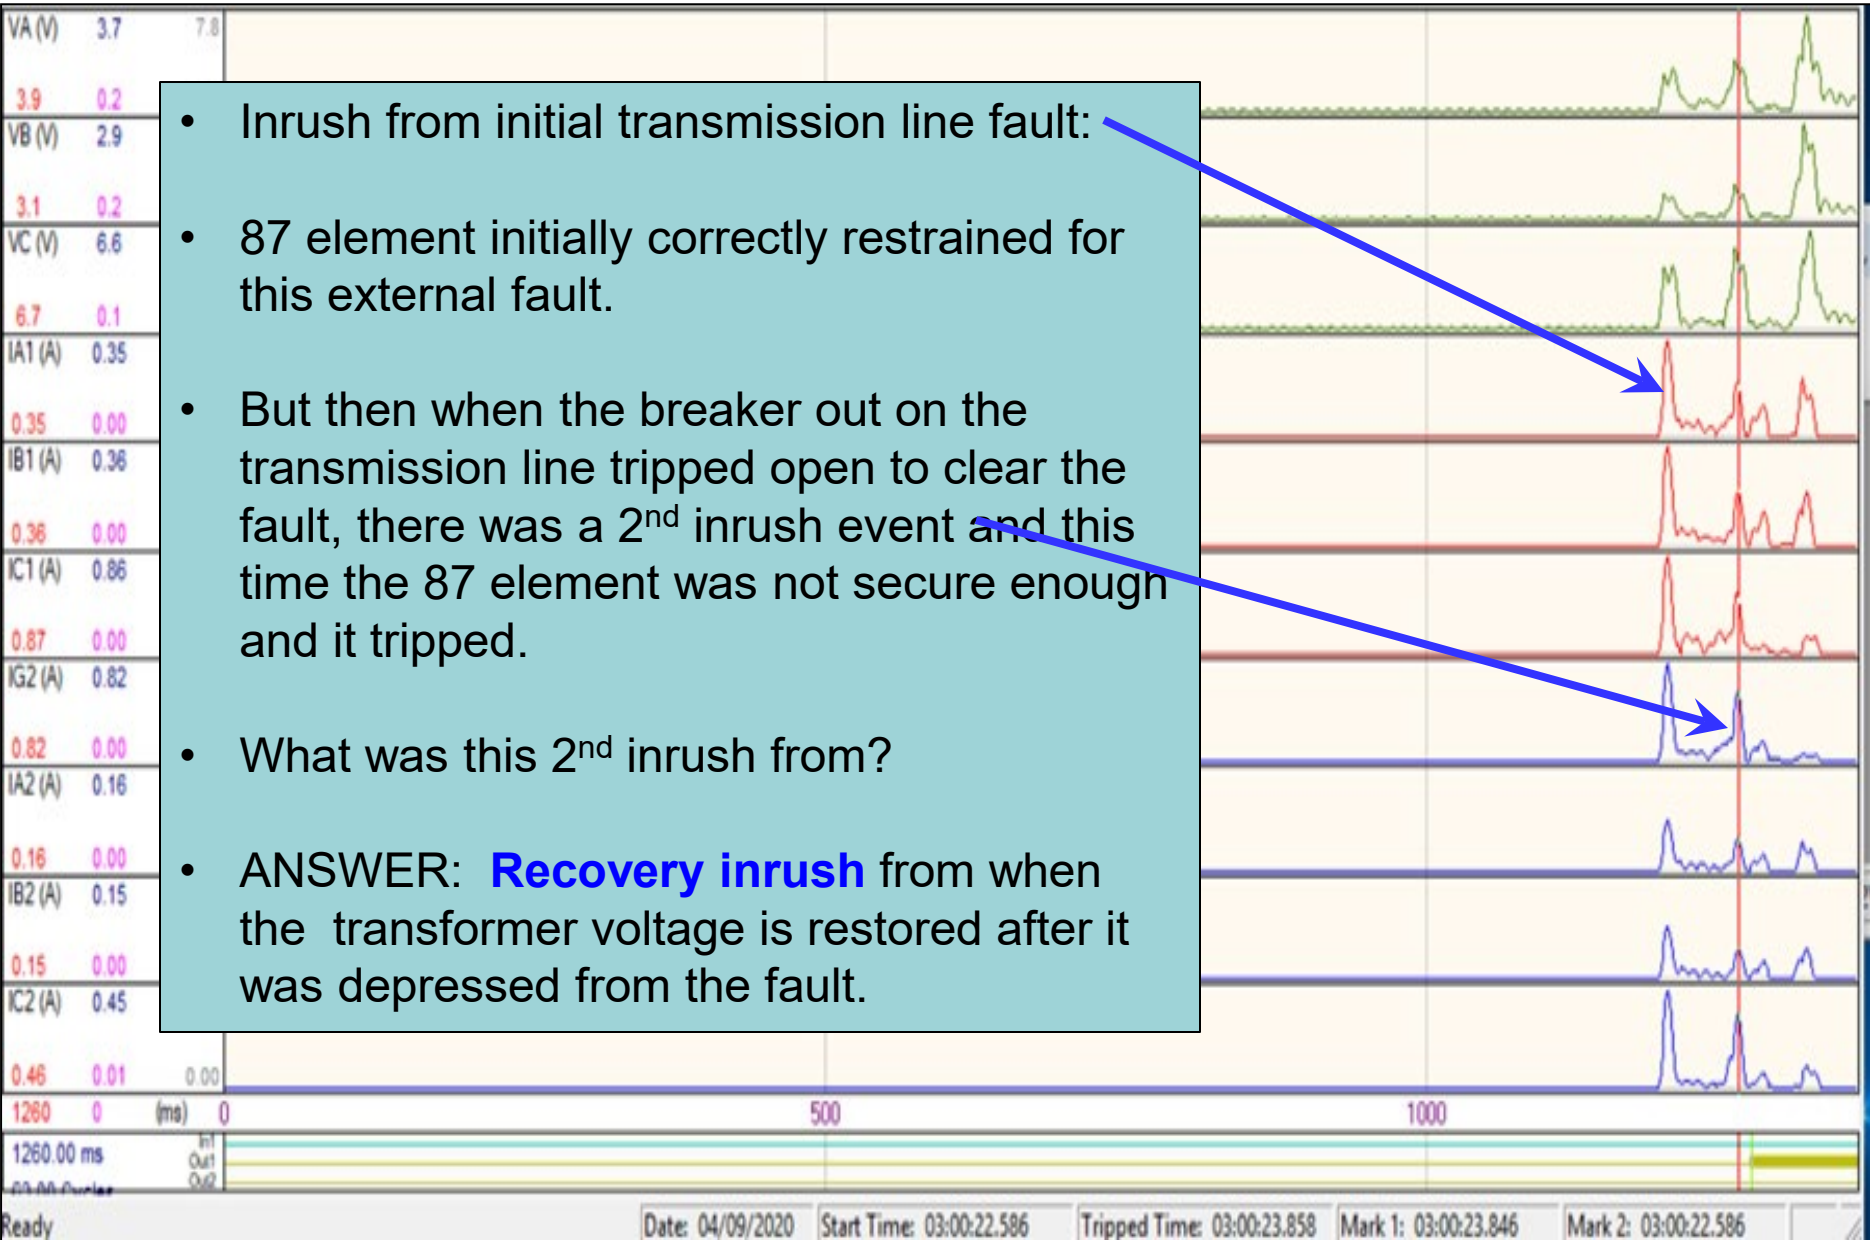
- Inrush from initial transmission line fault:
- 87 element initially correctly restrained for this external fault.
- But then when the breaker out on the transmission line tripped open to clear the fault, there was a 2nd inrush event and this time the 87 element was not secure enough and it tripped.
- What was this 2nd inrush from?
- ANSWER: **Recovery inrush** from when the transformer voltage is restored after it was depressed from the fault.

- Recommended they consider desensitizing the 87T settings: Pickup and/or Slope and/or Even Harmonic Restraint.
- The settings had already been desensitized per my recommendations from an 87T trip a couple years earlier where it had tripped for a transmission line fault.
- The CT Saturation performance matching is likely not that great.
