Event Analysis

Douglas L. Weisz, PE

Power Plant Protection Track
Thursday, August 7, 2025

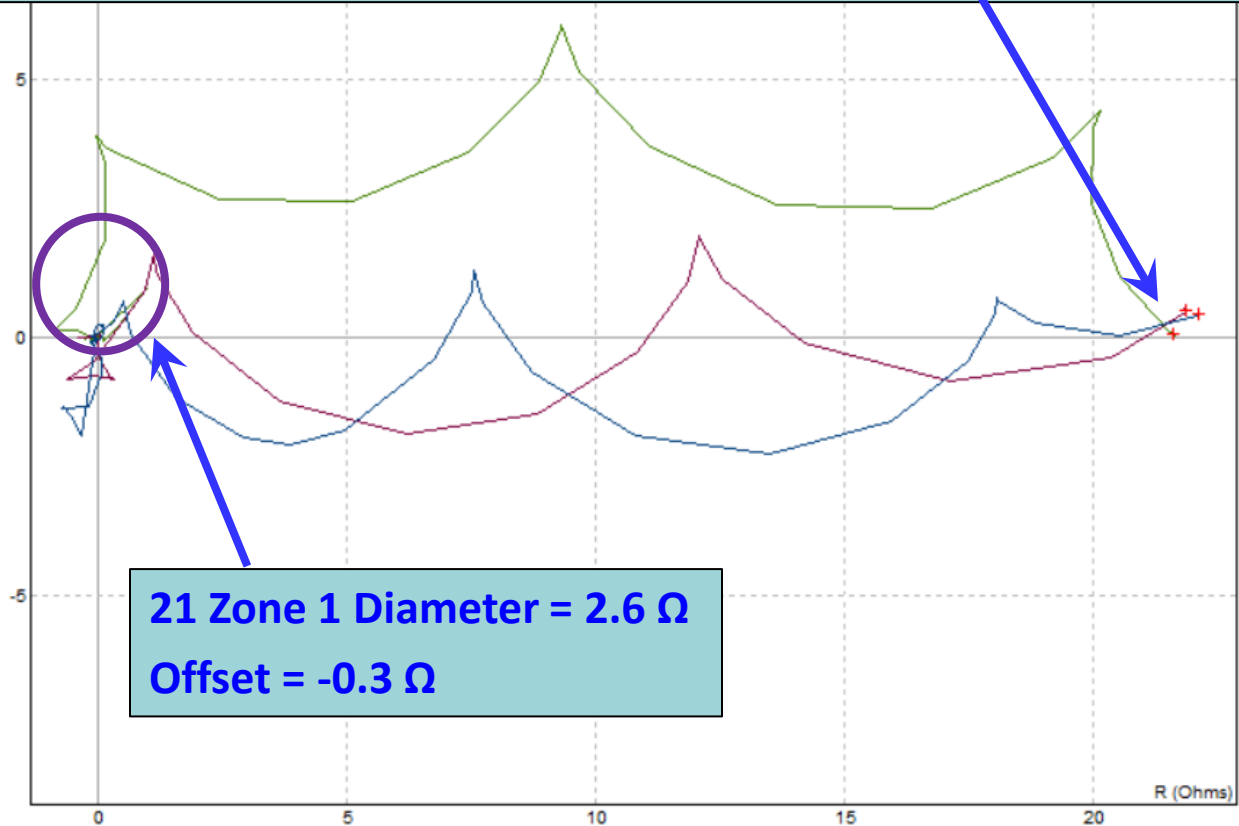
- Check if the pre-fault Zlocus points plot outside of the 21 relay settings, which they clearly do as the 21 Zone 1 Diameter was set to 2.6 Ω with an offset of -0.3 Ω and the cursors positions are way out here during pre-fault:

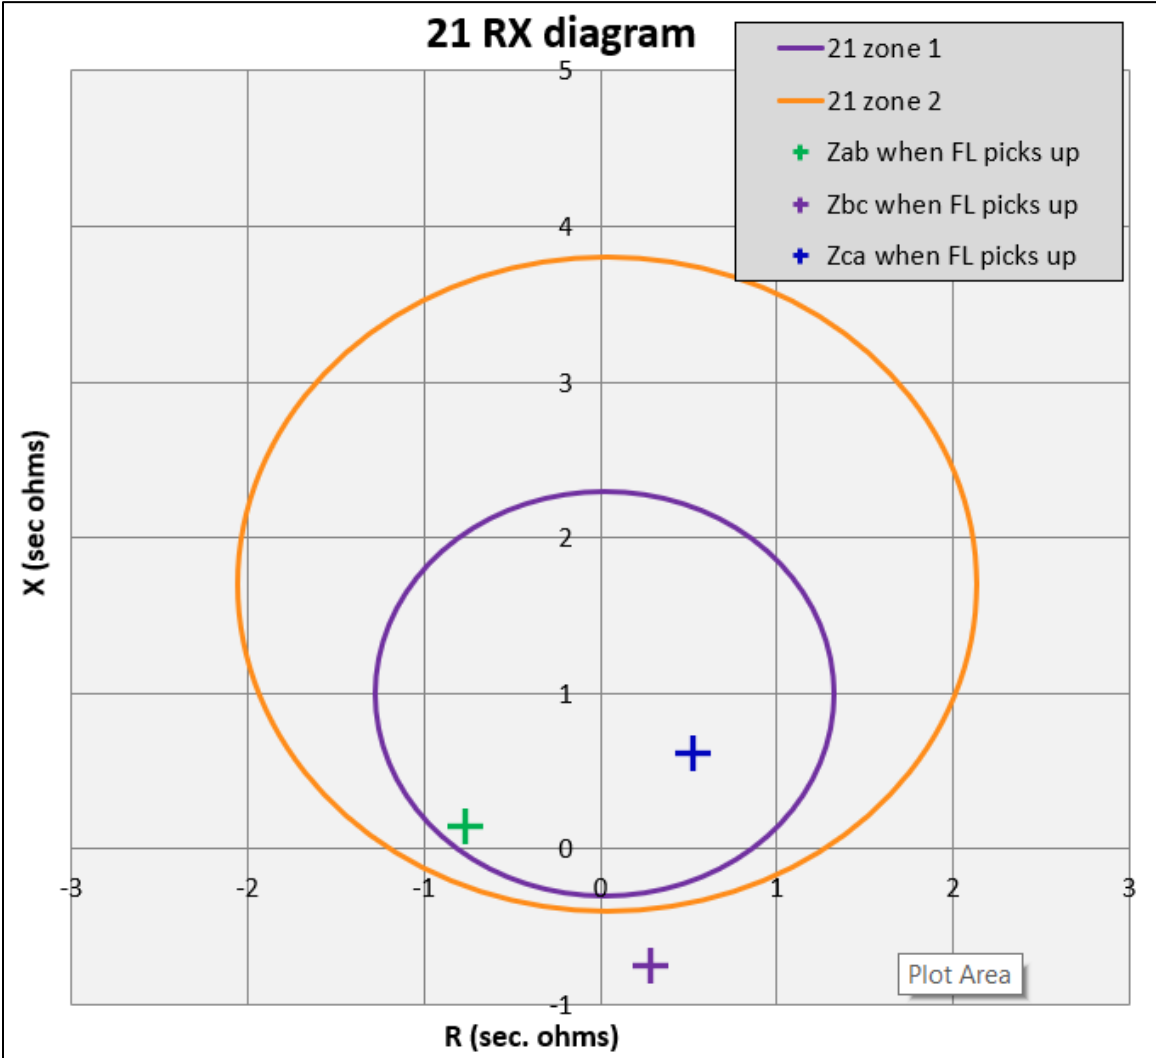
- Cursors at timestamp of SOE 499 when FL picked up where Zab and Zca have entered the zone 1 mho circle, but Zbc is still outside the mho circle; however, because these are OR'd together in the 21 algorithm therefore if Zab or Zbc or Zca enters mho circle, 21 zone 1 would have picked up but it didn't because FL was blocking it at this timestamp:

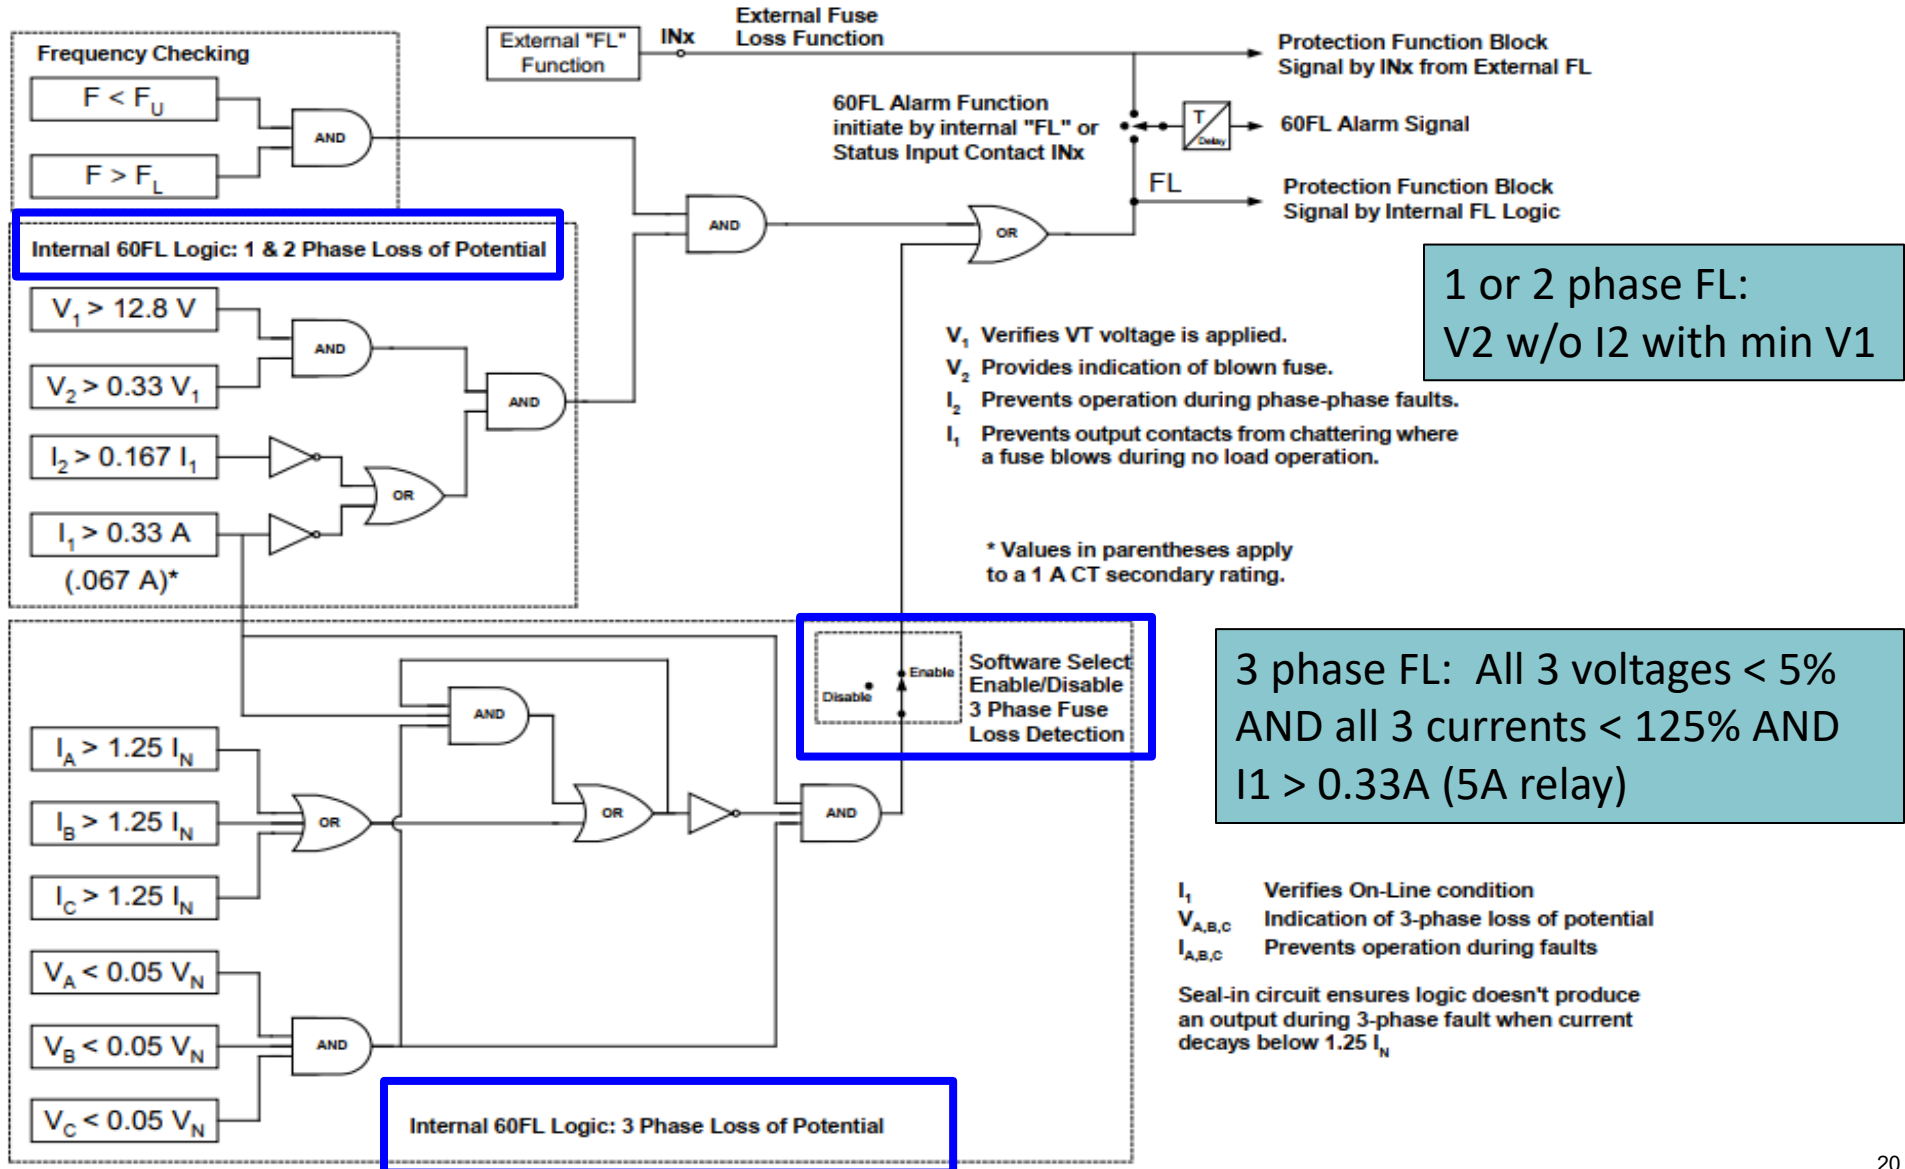
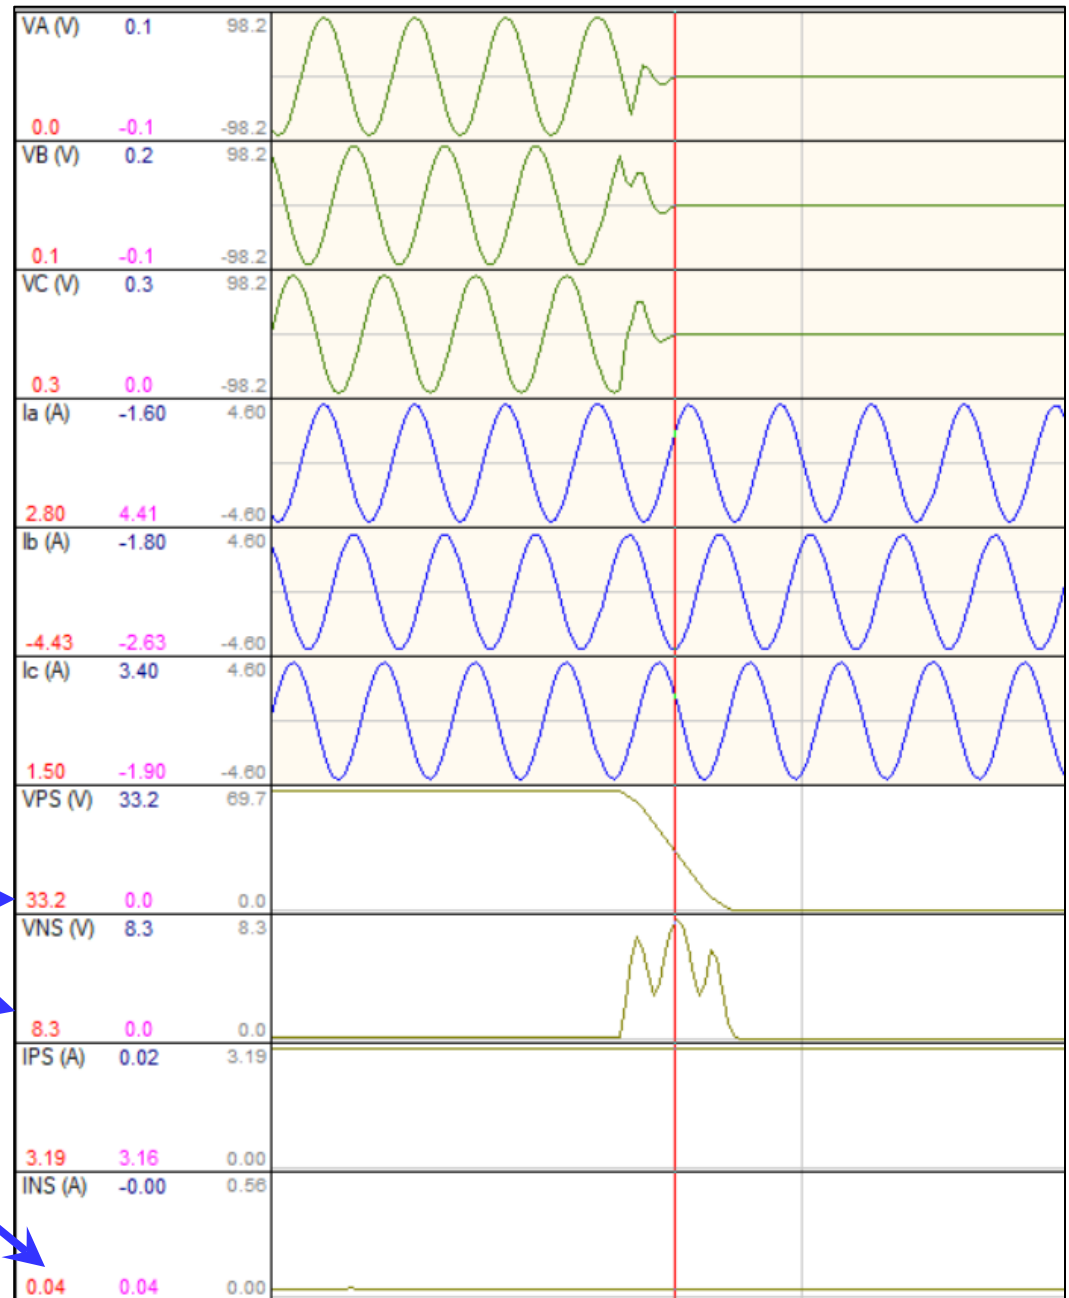
It can be seen at this cursor position that initially when the 3 phases of voltages are lost that:

- $V1 (VPS) > 12.8 V$
- and there is some $V2 (VNS)$
- but there is no $I2 (INS)$

therefore, FL may have initially picked up on its 1 or 2 phase fuse loss logic portion of the algorithm.

- But then a few cycles later, SOE shows that FL drops out and then 21 zone 1 and 2 pick up and 12 cycles later (equaling the 21 zone 1 time delay setting), 21 zone 1 times out and trips, asserting Output 3 as programmed:

- It is suspected that the 60FL setting “Three Phase Fuse Loss Detection” is Disabled in the settings that are installed on the relay.
- The native, “as-left” relay setting file in the mfg specific software format (e.g. .ips extension file) was not provided.
- The relay setting file should always be downloaded from the relay after the event (not a copy of the native, supposed “as-left” file from some storage location) along with all the other files: OSC, SOE, Target List, etc.
- The other possibility is that the relay operated incorrectly; however, this would be an odd failure mode i.e. failure of the relay code that represents the 60FL algorithm to execute in the manner as displayed in the 60FL logic diagram

- Check the applied relay settings to ensure that the 60FL “Three Phase Fuse Loss Detection” is really Enabled.
- However, if it is Enabled, then recommend secondary injection test the relay.
- Did not hear back from customer on what was found, although I assume my guess may have been correct; otherwise, I am sure I would have heard something.

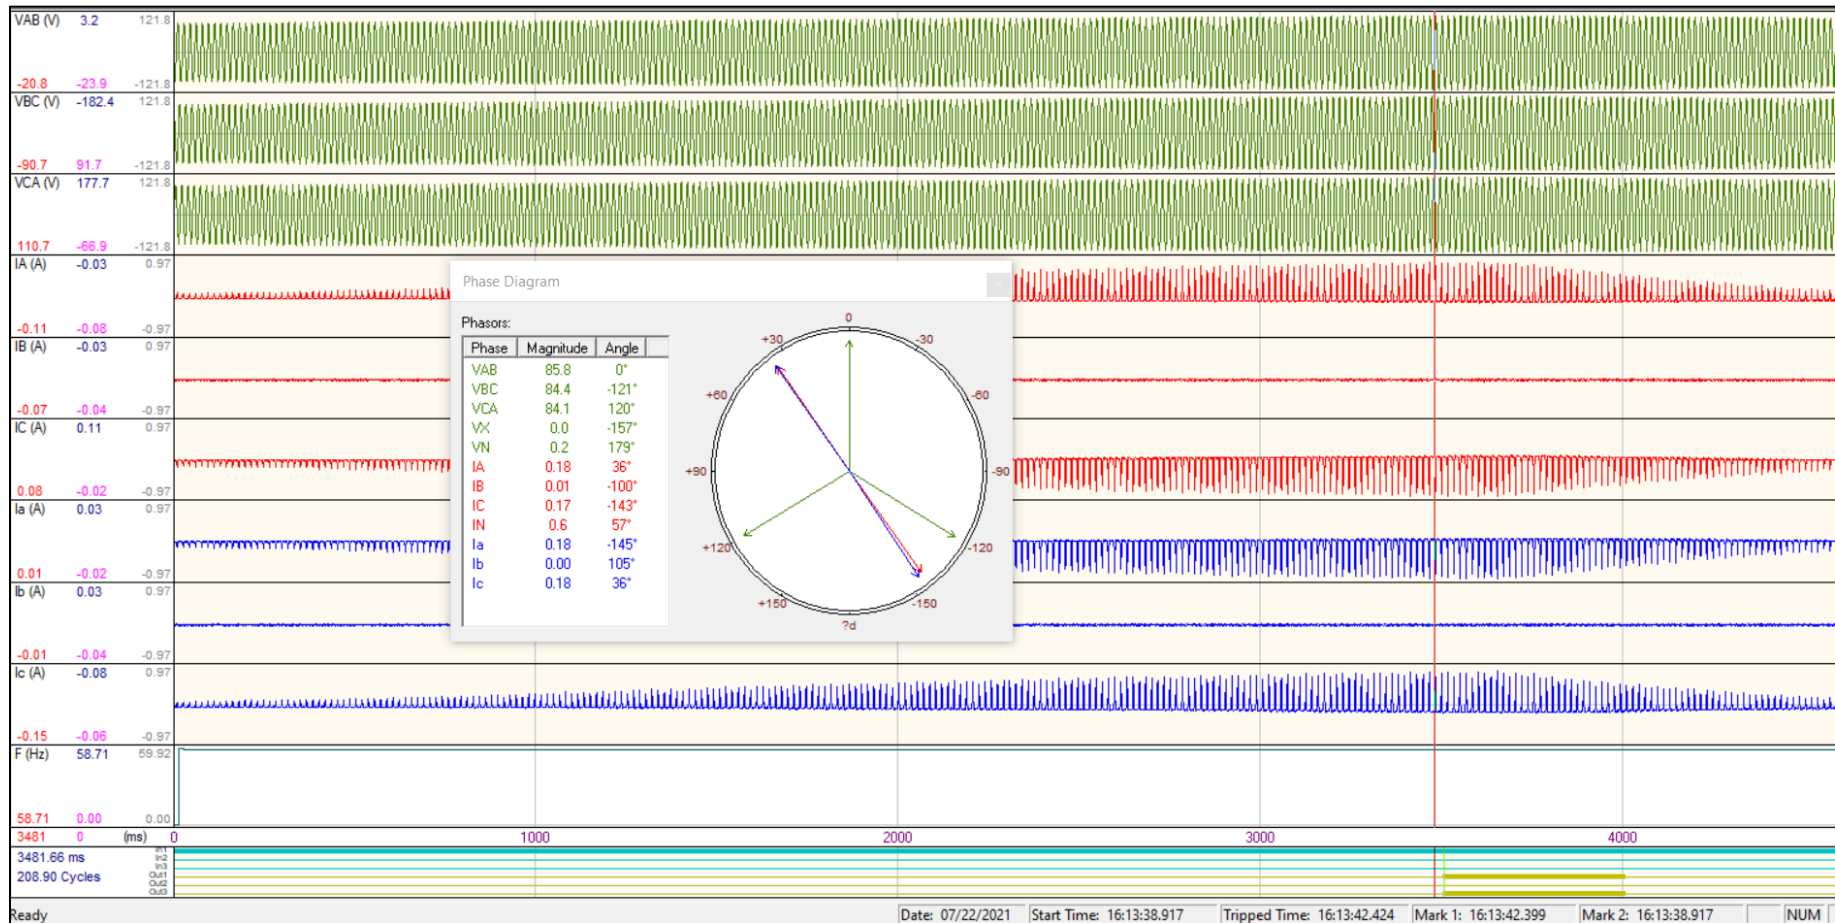
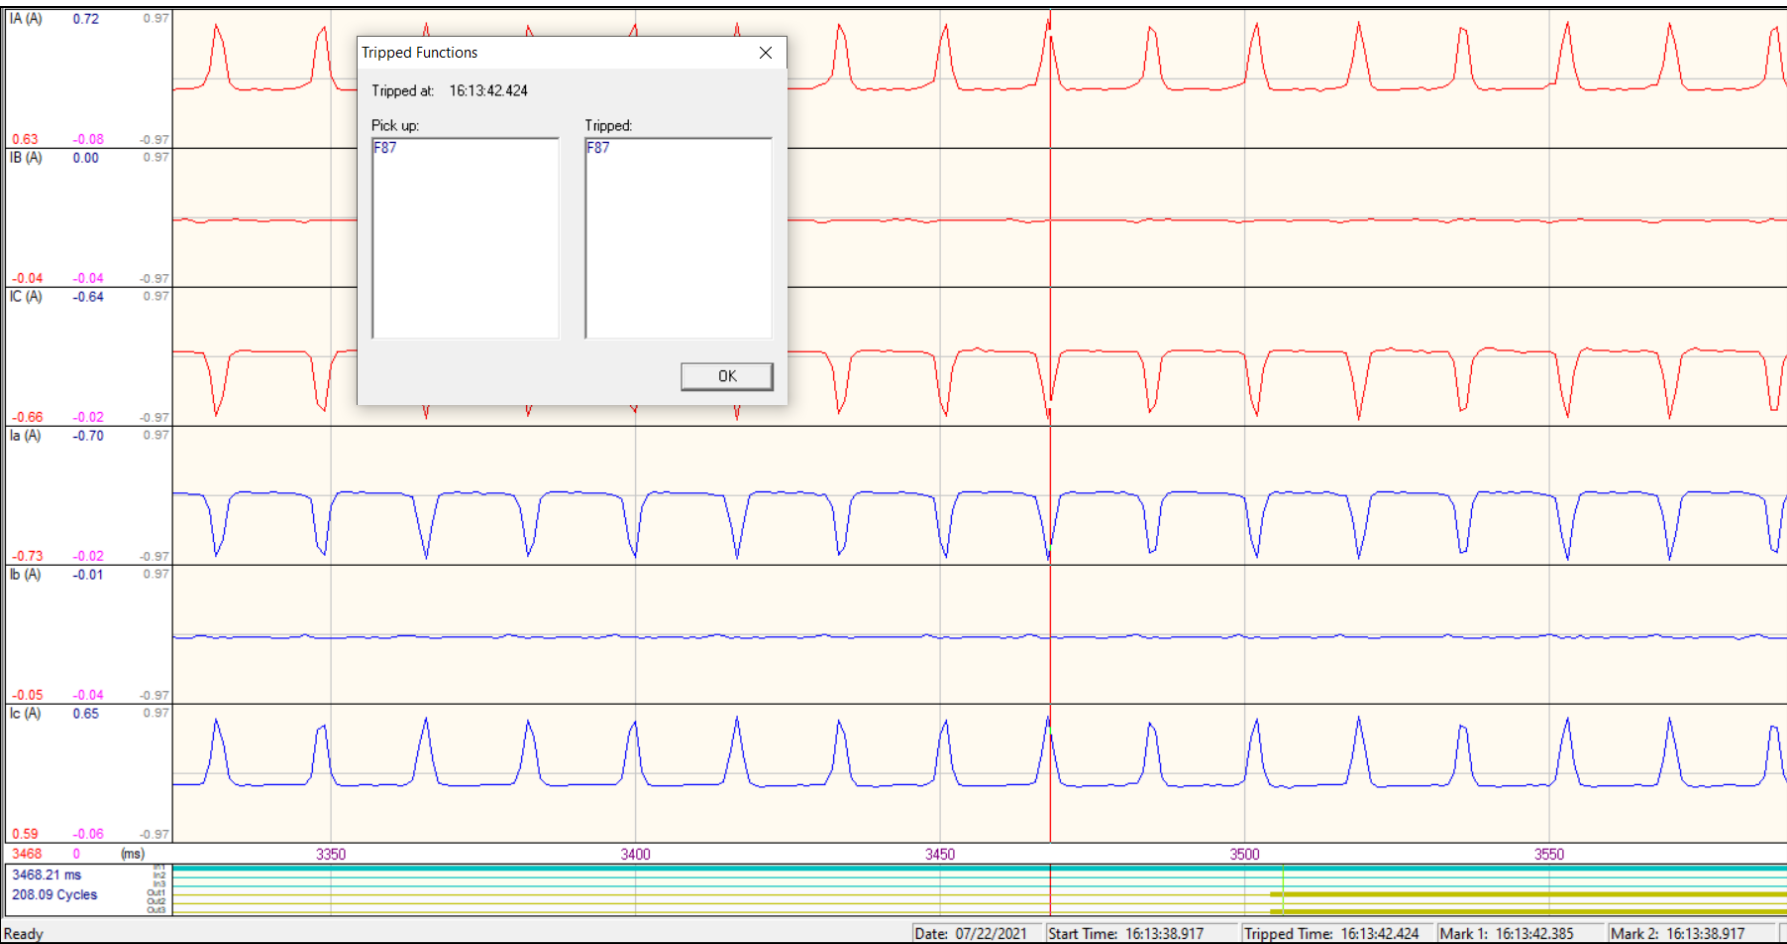
- Current waveforms with half the wave chopped off is indicative of inrush current.
- During startup as the field is building up, this type of GSU magnetizing inrush current is normal for applications with no GSU LS gen breaker and only a GSU HS unit breaker to synch across.

- Notice there are no “IB” or “Ib” currents, does this mean there are open circuits somewhere from the CTs to the relay current inputs?
- In this case probably not, because inrush can present as no inrush current being seen on one phase if the other 2 phases cancel out.
- “IA” and “IC” (also “Ia” and “Ic”) oppose and match each other. “IA” positive peak coincides with “IC” negative peak, therefore $IA + IB + IC = +0.63 + 0 + -0.66 \approx 0$.

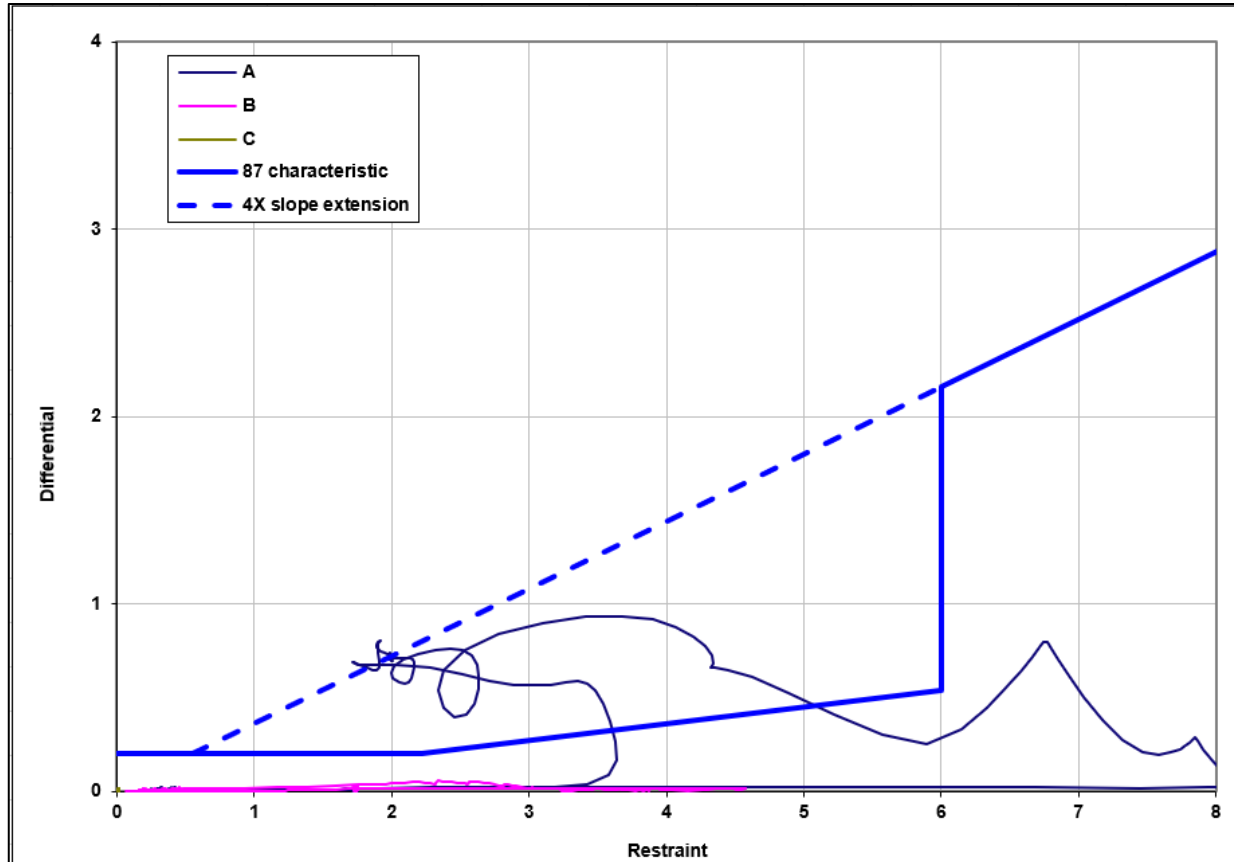
- When the event is played back, the event locus vs 87 curve plot as such (they had **87 slope set at 10%**):

- The A-phase event locus plots slightly above the 4X slope extension portion of the 87 characteristic with the settings that it presently has installed.
- The 4X slope extension is invoked for high DC offset and/or harmonic content so it should have been invoked for this event.

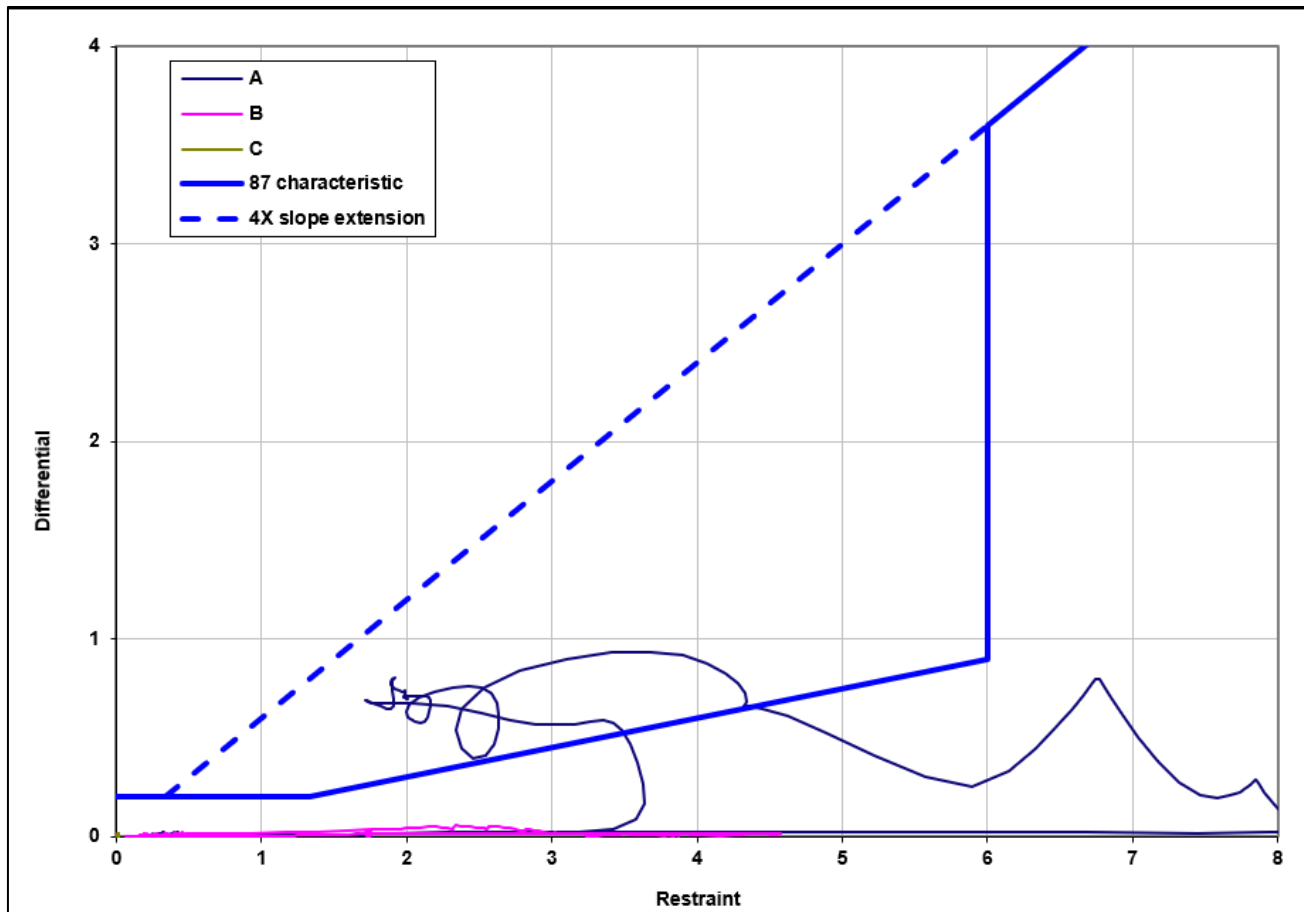
- If the 87 Slope setting would have been set to **15%** (so 4X slope = 60%), then here is how that event when played back would appear i.e. it would have been secure with this slightly higher slope setting:

- Cause: CT saturation performance mismatch.
- Remedy 1: Address CT saturation performance mismatch – perform CT saturation calculations, look at burdens on each side, CT class on each side, CT knee point voltage on each side, CT secondary winding resistance on each side, CT cable length and wire gauge used on each side, etc.

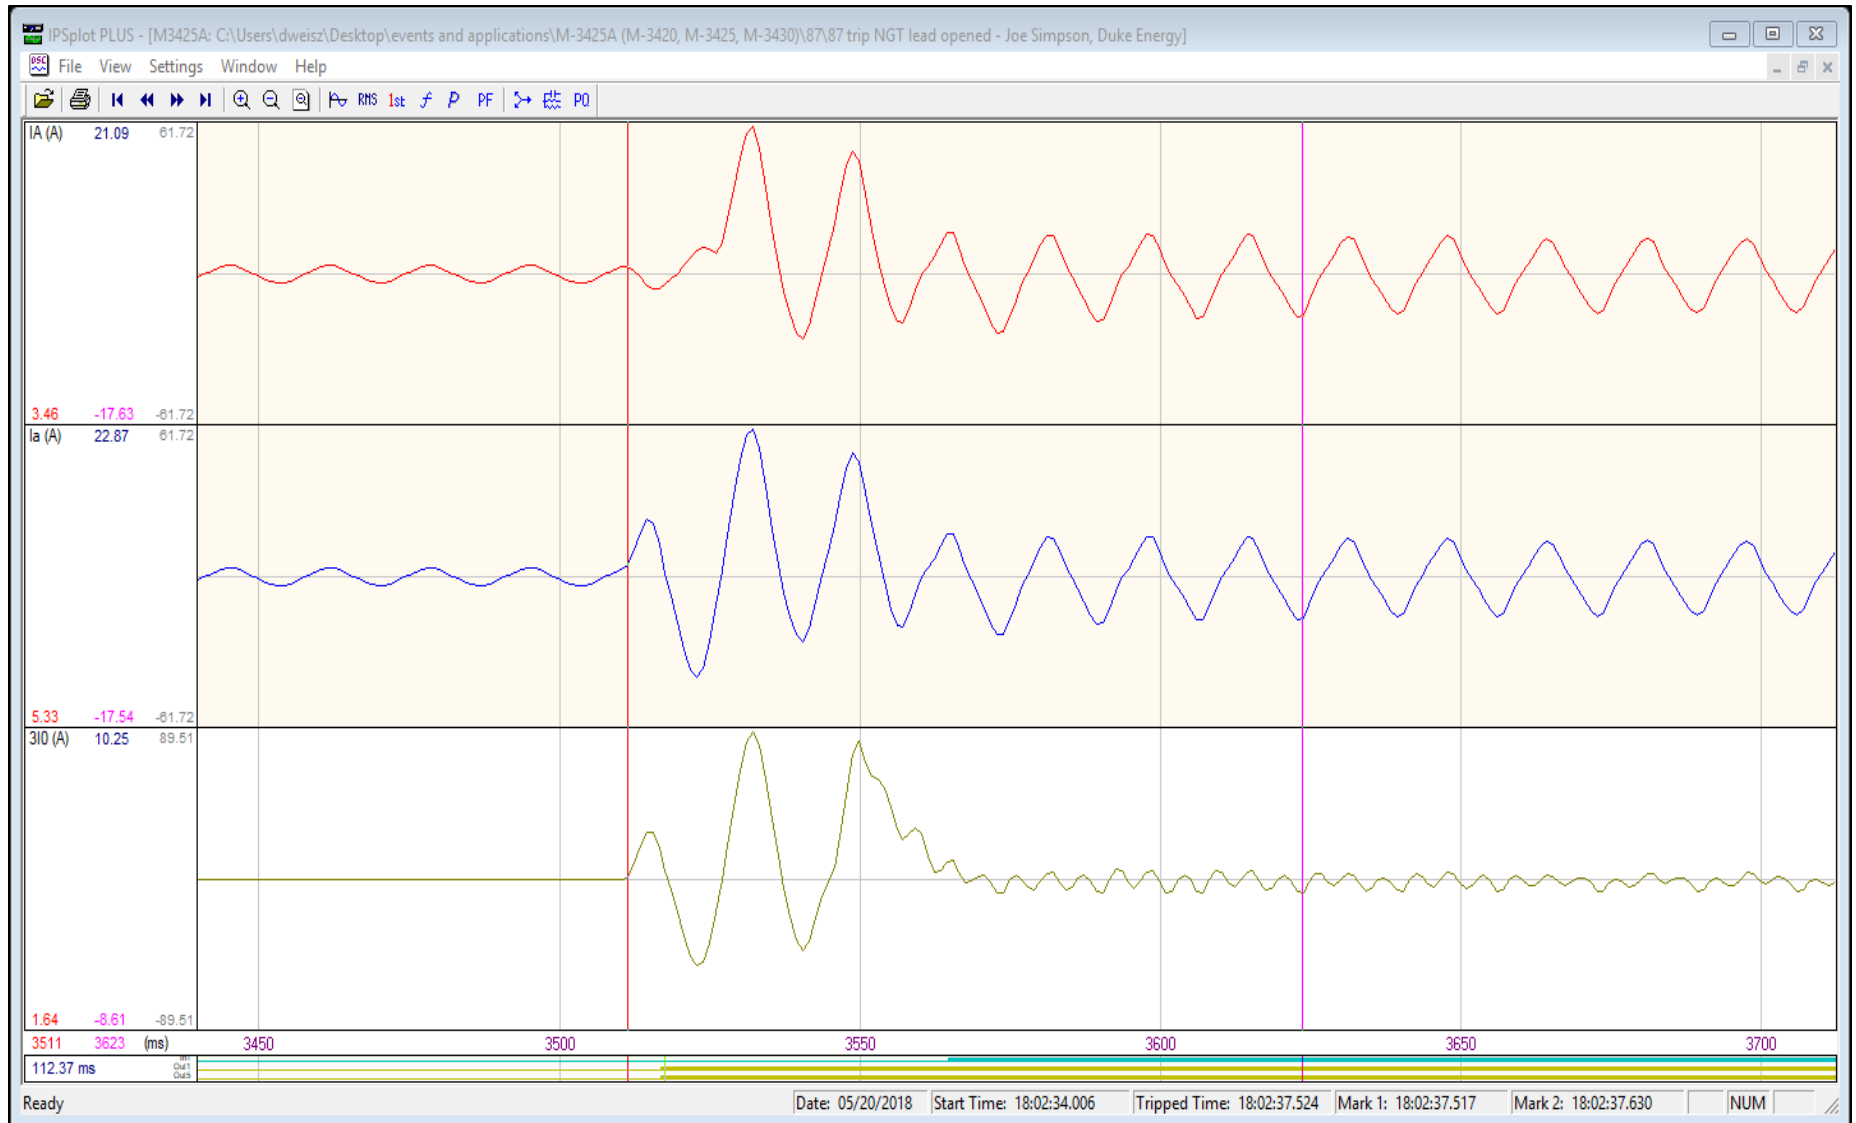
3Io is also seen at this sample point for the first time (the displayed 3Io tracing is calculated from $I_a+I_b+I_c$) and 3Io is in phase with I_a :

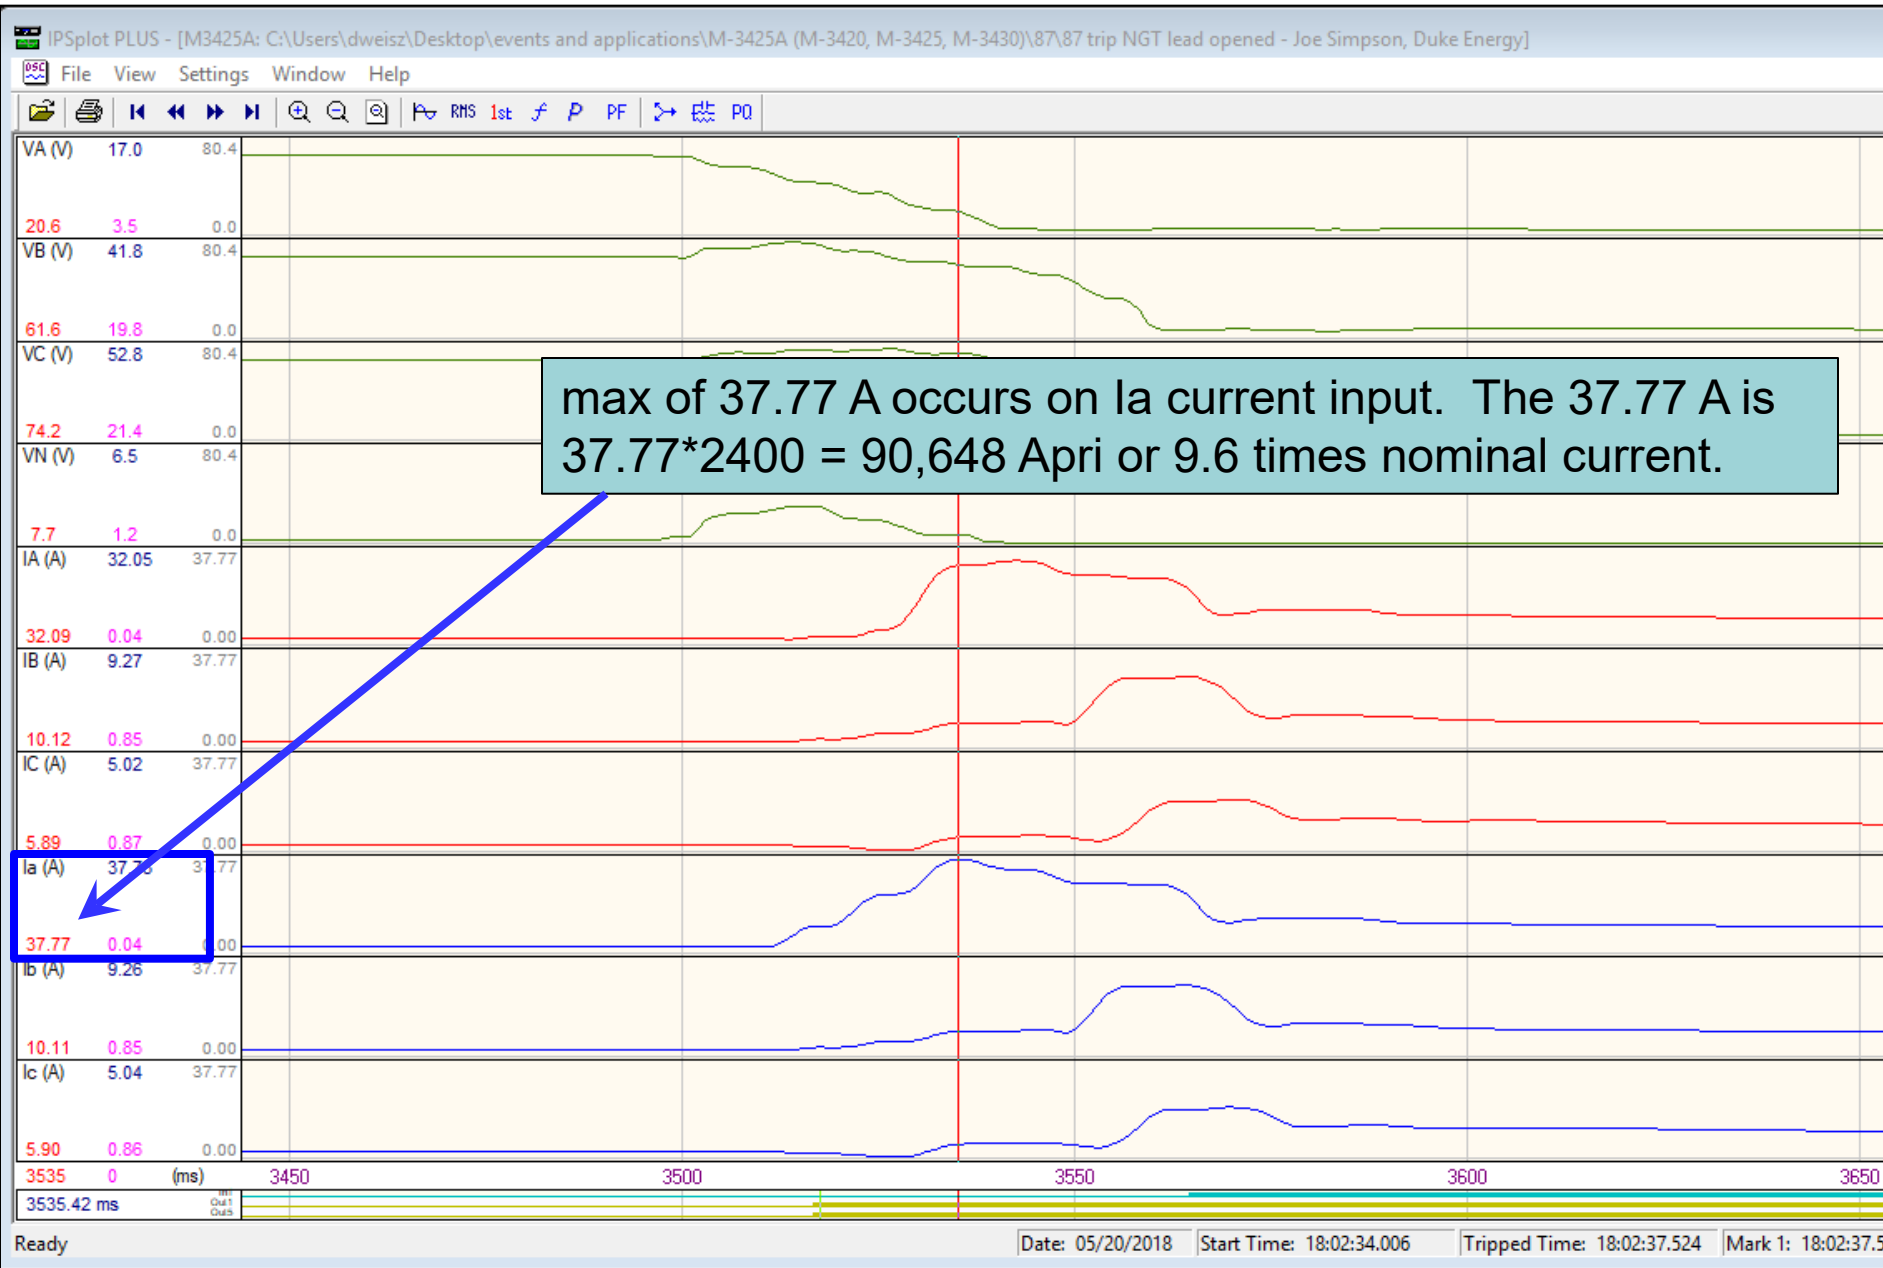
- The fault started as an AG internal fault at about 24% of the stator winding from the neutral end **(fault was found at 25%)**.
- The measured high current values (up to 90 KA) on this high-impedance grounded machine, indicates that the high impedance grounding network was compromised. This failure resulted in the NGT looking like a short circuit, thus making this high-impedance grounded machine appear as a solidly grounded machine with the accompanying very high fault current values.

- As an open lead was detected to the NGT in the post fault investigation, this likely indicates that the lead burned open only after having been shorted.

- The 87 function detected the fault and tripped very quickly, but with the machine's field decay time constants and with all the stored inertia from the rotational energy, the fault current did not extinguish immediately.

- After the NGT was shorted, the fault briefly still looked like an internal AG fault before evolving into an external AG fault at the terminal end. It eventually involved B-phase and then C-phase making it into a three phase-to-ground fault.

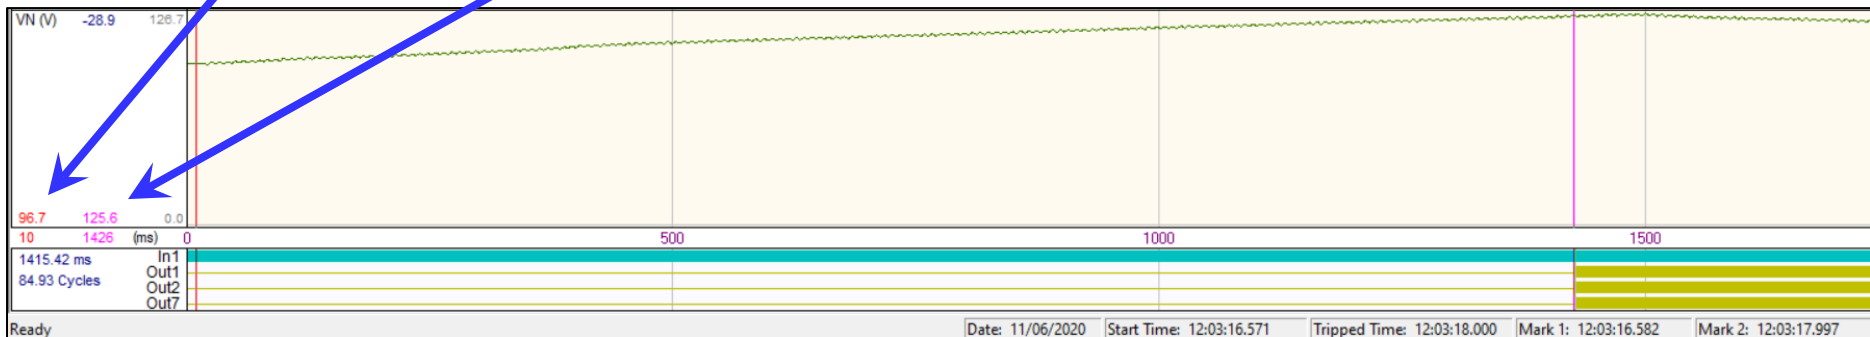
- What did the fundamental component of the VN waveform measure before the outputs asserted?
- From 96.7 V up to 125.6 V:

$$\frac{96.7}{159} * 100 = 61\%$$

$$\frac{125.6}{159} * 100 = 79\%$$

- Could put some discrimination between 59N #1 and #2 elements.
- A much shorter 59N time delay may be OK if the GSU high side relaying time to clear for ground faults on the high side of the GSU is known.
- If a newer relay is installed, then some of the 59N accelerated tripping schemes could be employed.
- Also, 64S could be added which would have detected this fault while still off-line i.e., even before the field was applied.

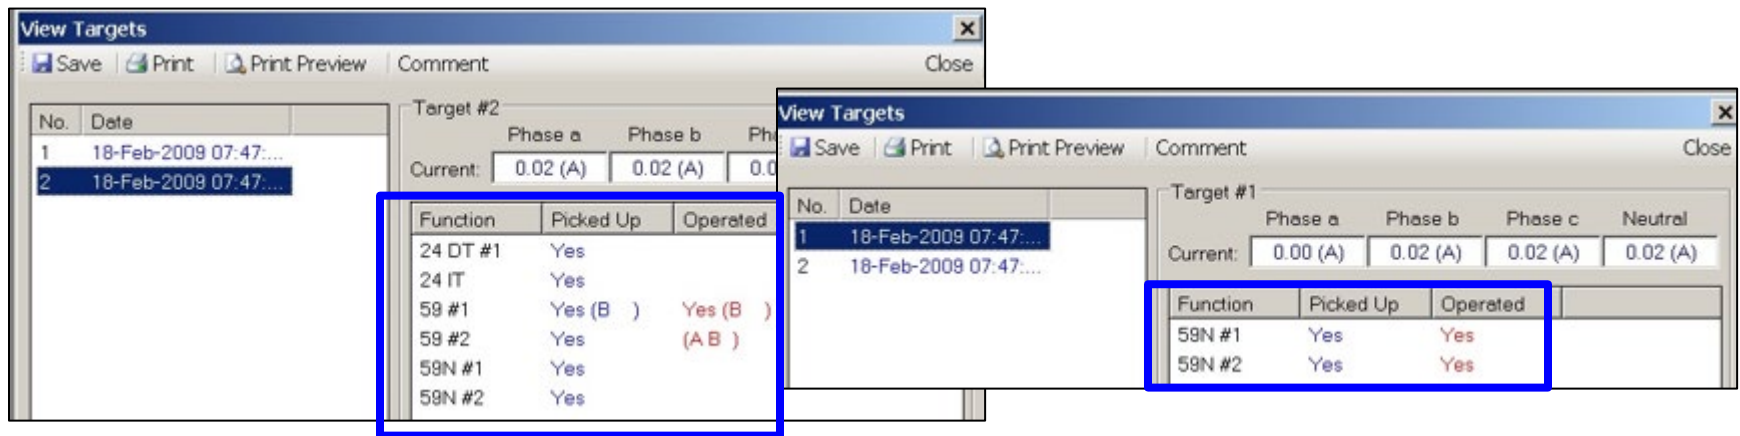
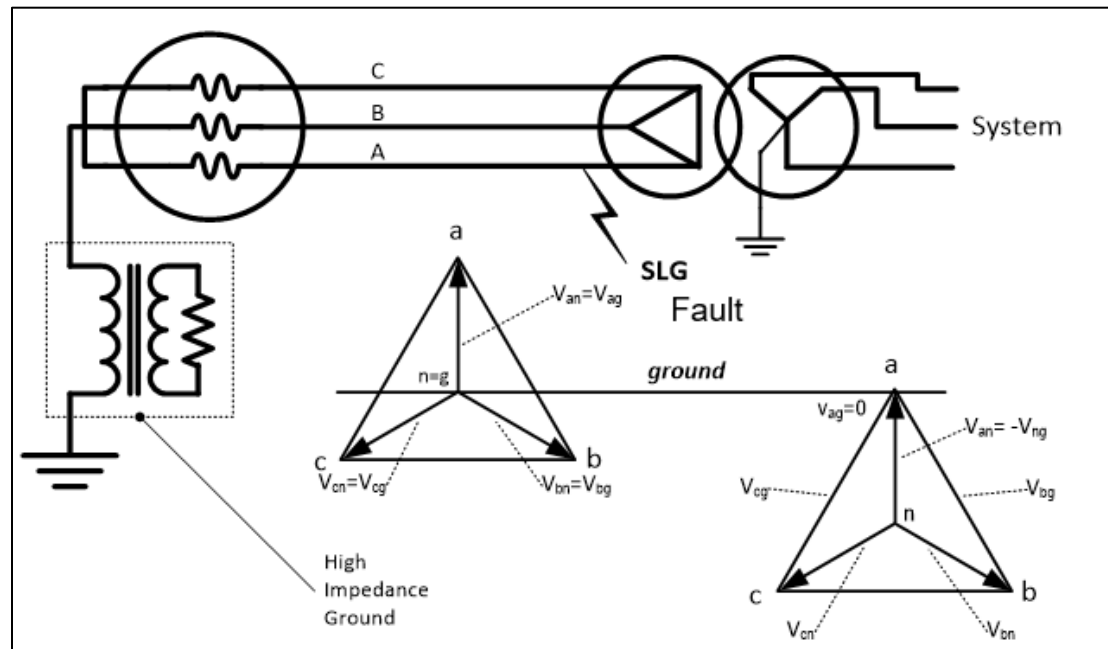
- Why were some 24 and 59 elements asserting just prior to the 59N trip?

- This is because of the neutral shift from ΦG fault on a high-impedance grounded gen.
- This can confuse and prolong the post-event investigation.
- It can be avoided by setting VT Config = LG-LL (and then all voltage-based settings must be set based on LL values).

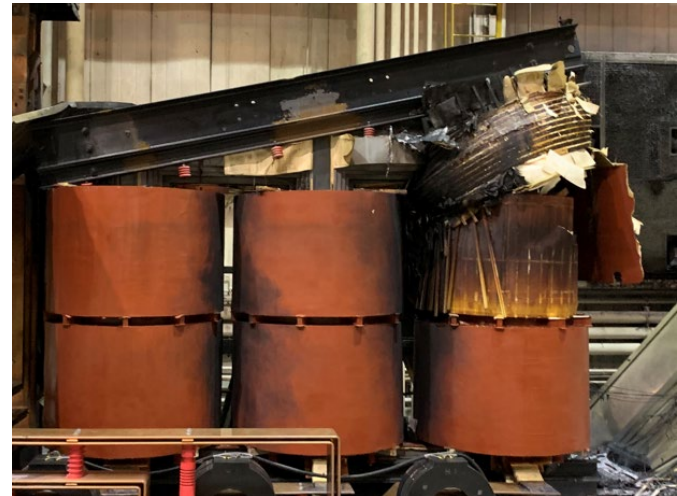
- Customer reported PPT failure:
- Asked why the 59N function sourced from the VN voltage input did not detect it.
- Also, asked what phase it started on?

- 87 relay around the PPT issued the initial trip.
- But prior to that, there was a very low level VN measured of 4.1 V.
- The minimum setting range on most relay mfg's 59N/59G/64G elements is 5 V, so it could not see this low level, incipient ground fault initially.

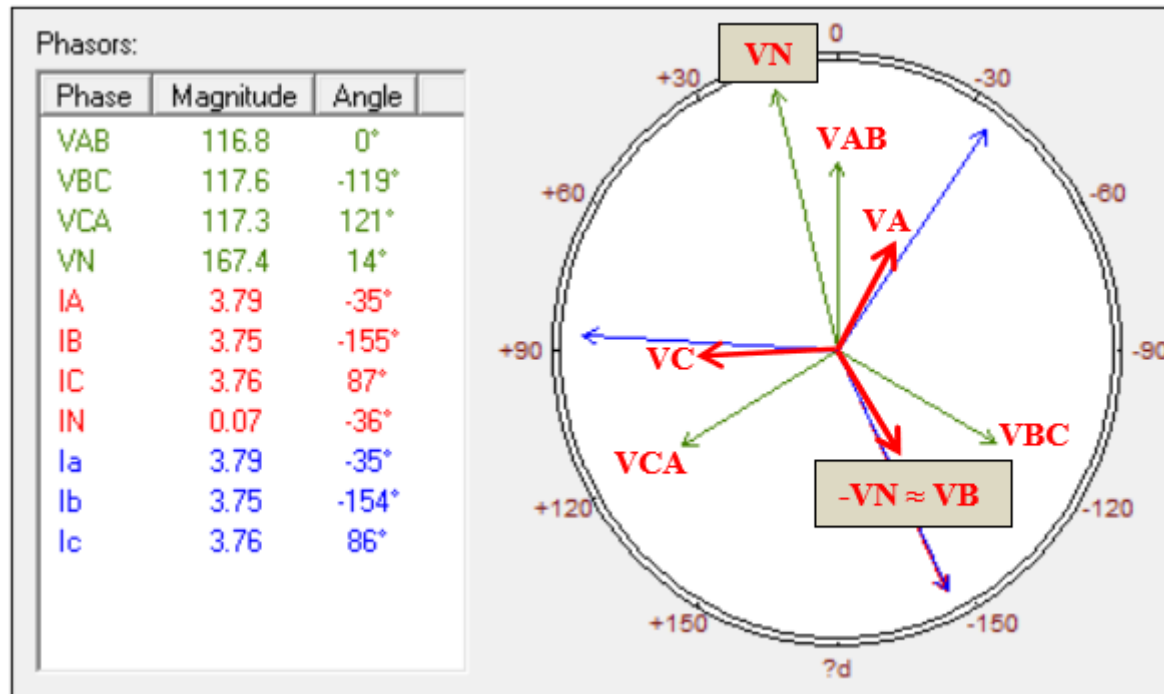
- *To address the question of what phase it started on:*
- *When VT Configuration = LL the oscillography will show LL voltages, therefore identifying the faulted phase from a LG fault may not be readily apparent.*
- *However, as VN will be 180° from the faulted phase of a LG fault, the VN vector can be rotated by 180° using the phasor diagram and that position should approximately match the phase angle of the faulted phase.*

- When V_N did jump from that low level value of 4.1 V up to its max it saw of 176.7 V, what does that say about the fault location?

$$V_N = \frac{V_{LG}}{N} = \frac{20000}{\sqrt{3} * 60} = 192 \text{ sec volts} \qquad \frac{176.7}{192} * 100 = 92\%$$
