Event Analysis

Douglas L. Weisz, PE

Power Plant Protection Track
Thursday, August 7, 2025

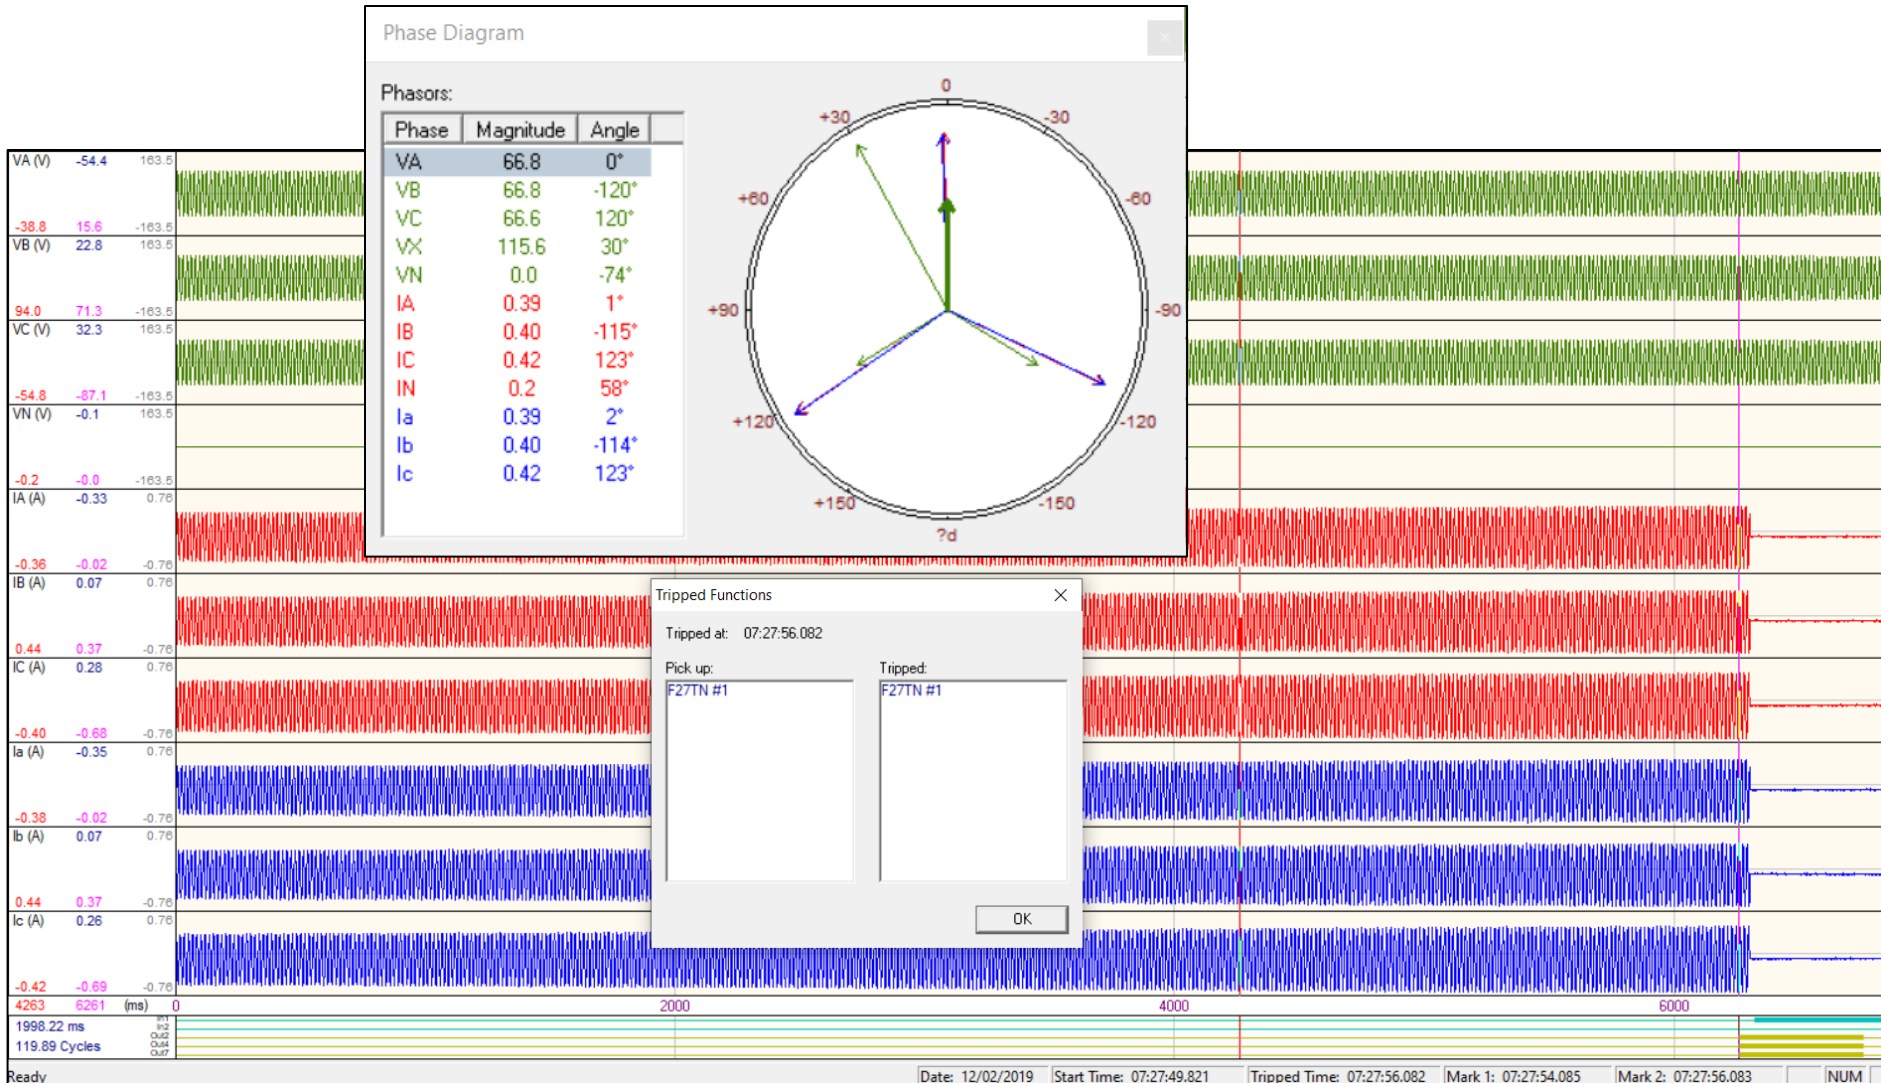
- Customer reported 27TN trip after unit synced on-line and as it was ramping up:

- 27TN Time Delay = 120 cycles so placed one cursor at assertion of outputs mapped from the 27TN #1 element and another cursor 120 cycles prior to that.
- Display third harmonic content from tracings: VN3rd = 0.1 V for the entire event.
- Fundamental component of VN = 0 V, so likely not a true fault.

- Pactual = 80.76 W at 120 cycles prior to output assertion
- 27TN Forward Power Block = 0.10 pu
- $P_{base} = \sqrt{3} * V_{nom} * I_{nom} = \sqrt{3} * 115 * 4.05 = 806.7 \text{ W}$
- $P_{pu} = P_{actual} / P_{base} = 80.76 / 806.7 = 0.1001 \text{ pu}$
- Because $0.1001 \text{ pu} > 0.10 \text{ pu}$, 27TN is not blocked
- Prior to 120 cycles before outputs assert, 27TN was blocked via Forward Power Block, then after that as the power is ramping up, 27TN became unblocked and therefore tripped because VN3rd was 0.1 V which is < the 0.77 V Pickup setting.

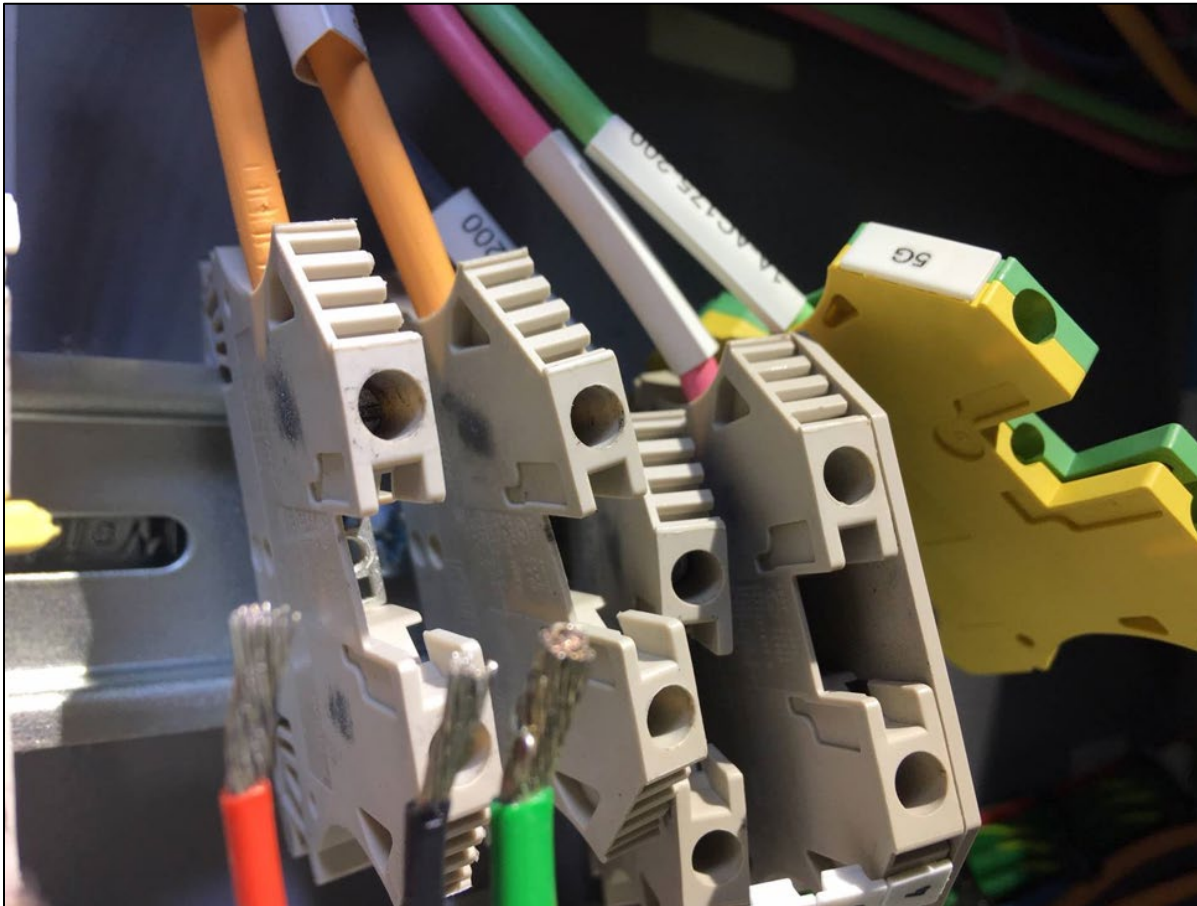
- Customer reported:

“the terminal block had built up enough metal shavings that after it rained, it tracked and shorted to ground the VN signal and therefore also the 3rd harmonic voltage signal at the VN terminal.”

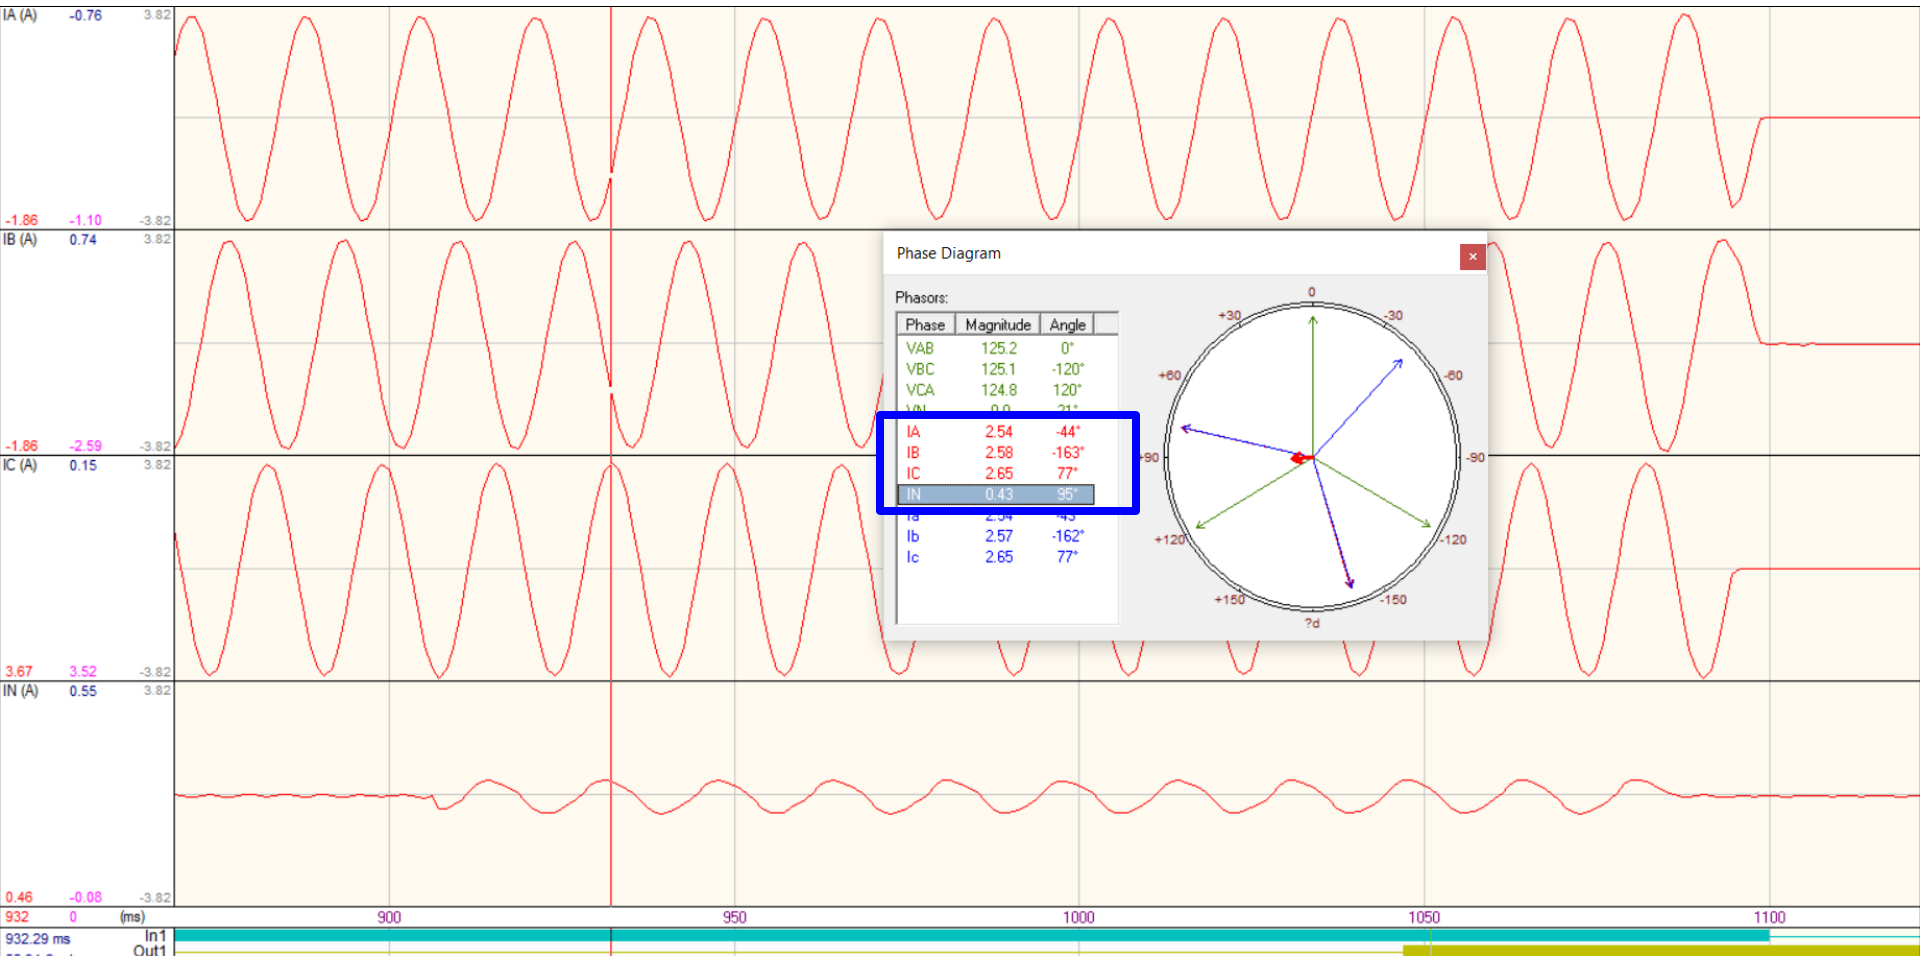
Mis-operation due to wrong CT Ratio Correction setting:

- First, calculate $3I_o$ from terminal side CTs:
 - ✓ $3I_o = I_A + I_B + I_C = 0.077 \text{ A}$
- Because $0.077 \text{ A} < 0.20 \text{ A}$, directional supervision is disabled.

- $I_N = 0.43 \text{ A}$
- $R_c = \text{CT Ratio Correction}$ was mistakenly set at 0.1
- $R_{c3I_0} = 0.1 * 0.077 = 0.0077 \text{ A}$
- $|R_{c3I_0} - I_N| = |0.0077 - 0.43| = 0.42 \text{ A}$, since $0.42 > 0.20$ (pickup), it correctly tripped.

- Ideally $R_c = (1500/5)/(25/5) = 300/5 = 60$, but max possible is 7.99, so for this particular fault if $R_c = 7.99$, then $R_{c3I_0} = 7.99 * 0.077 = 0.615 \text{ A}$
- $|R_{c3I_0} - I_N| = |0.615 - 0.43| = 0.185 \text{ A}$, and since $0.185 < 0.2$ (pickup), it would not have tripped for this fault had R_c been set to 7.99.
- This is a misapplication of 87GD function with the available CTRs, but the best it can be set is max R_c of 7.99 and probably increase Pickup and Time Delay.

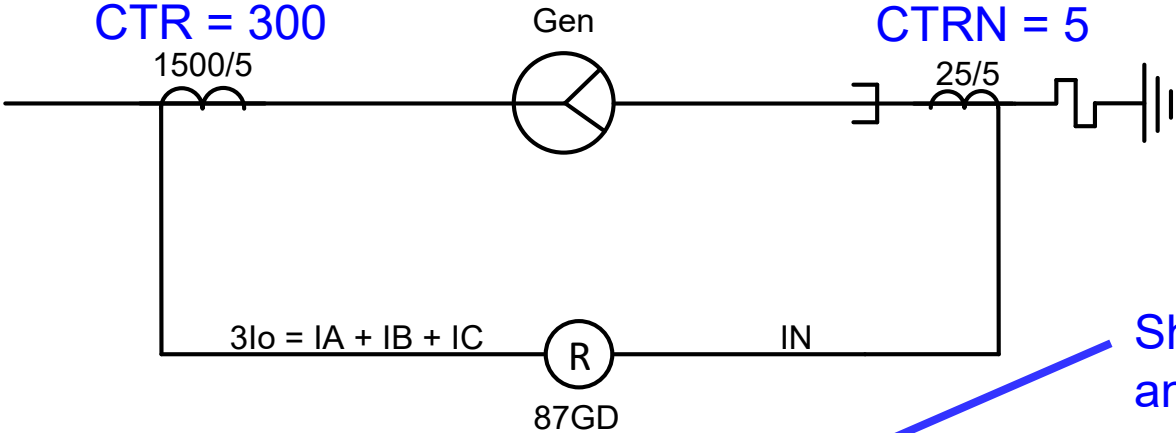
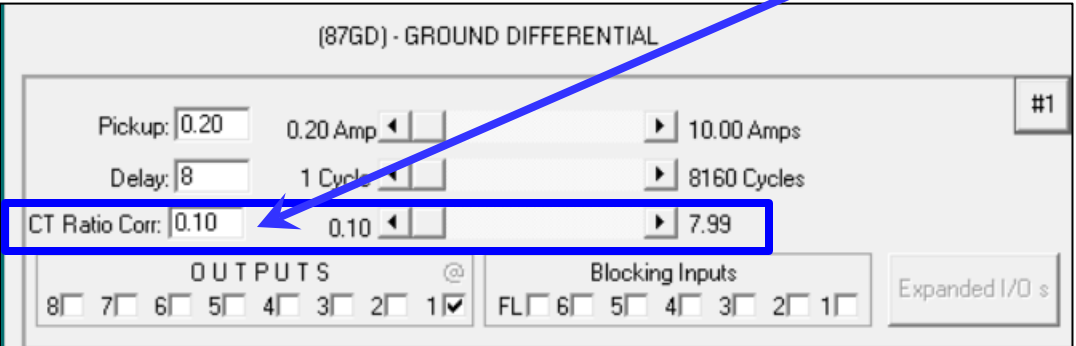
Should be set to $300/5 = 60$, and instead it is set = 0.10 – max setting is 7.99 so at least that would have been better, but really it is a misapplication.

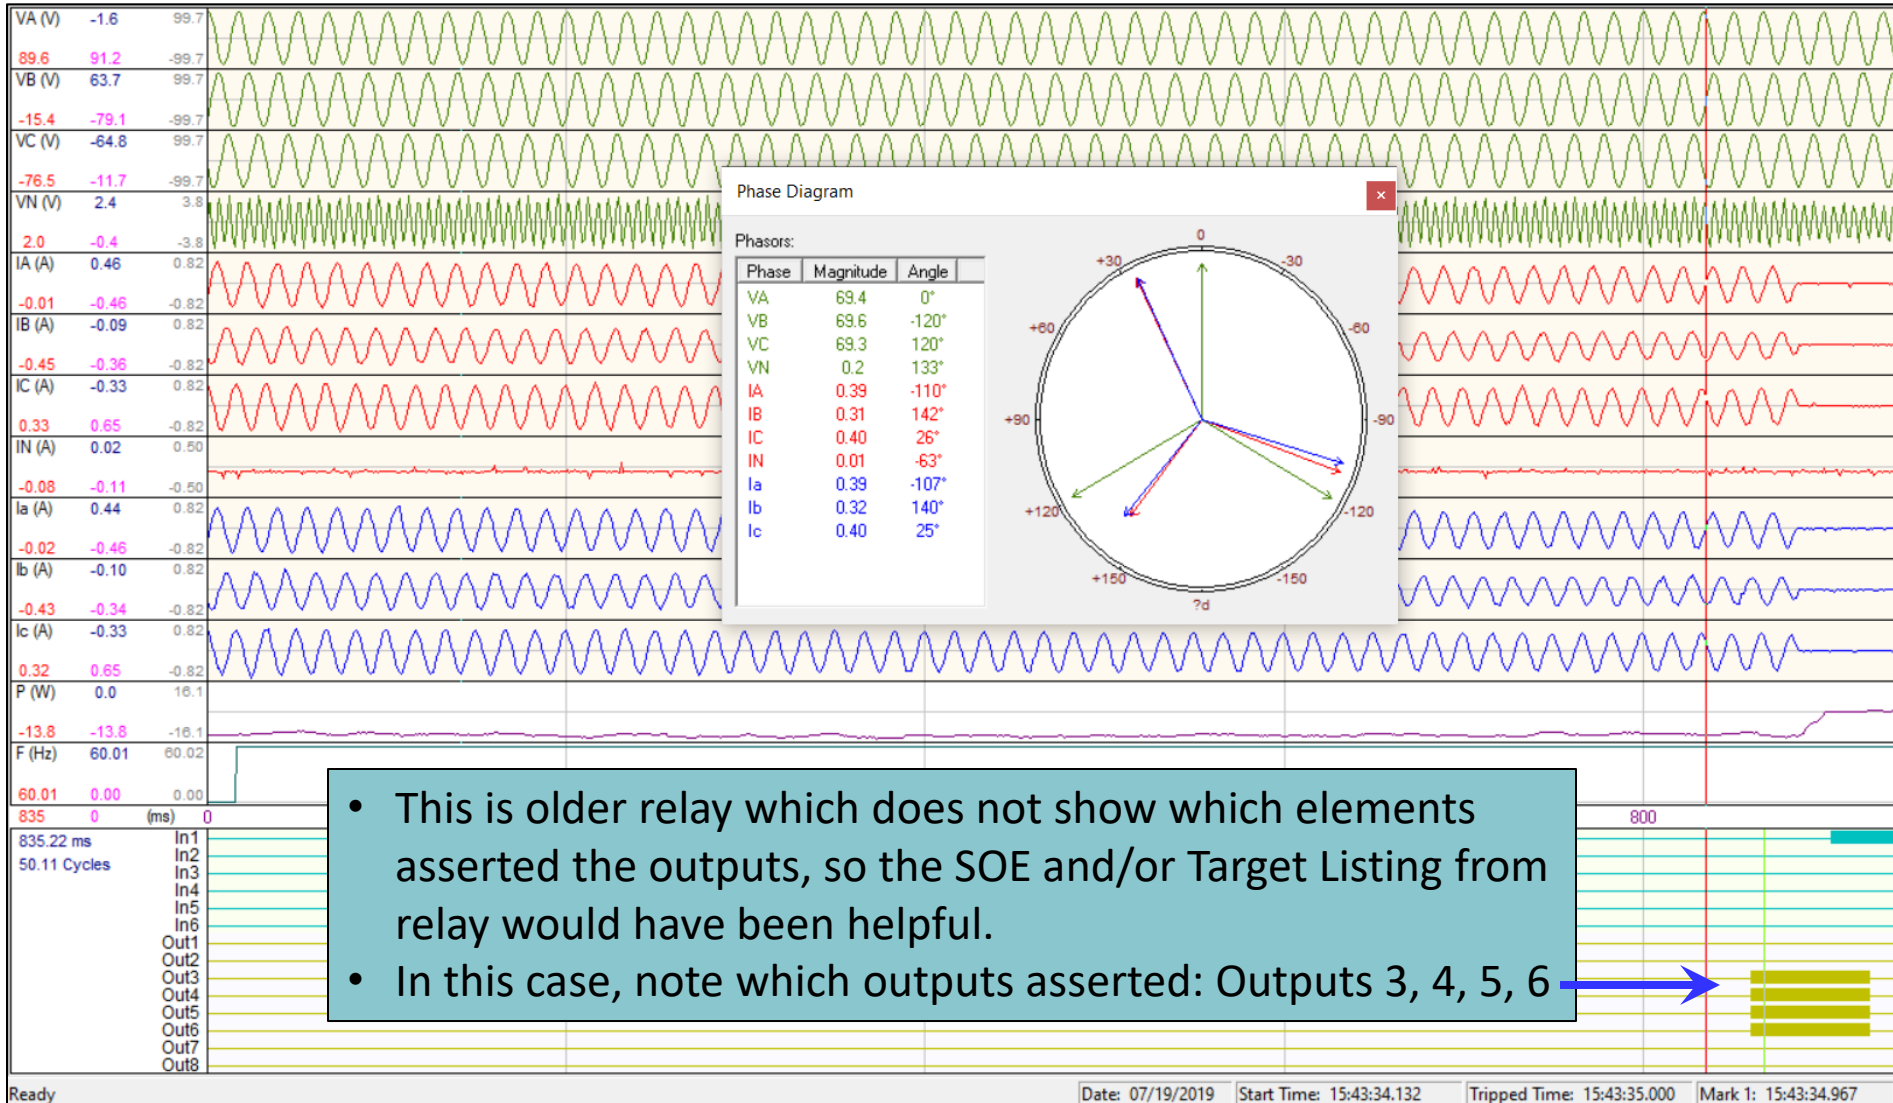
- First, take a big picture look at event displaying all Analog and Digital channels.
- Scroll cursor thru event with Phase Diagram which shows tracings were consistent for length of record.

• This is older relay which does not show which elements asserted the outputs, so the SOE and/or Target Listing from relay would have been helpful.

• In this case, note which outputs asserted: Outputs 3, 4, 5, 6

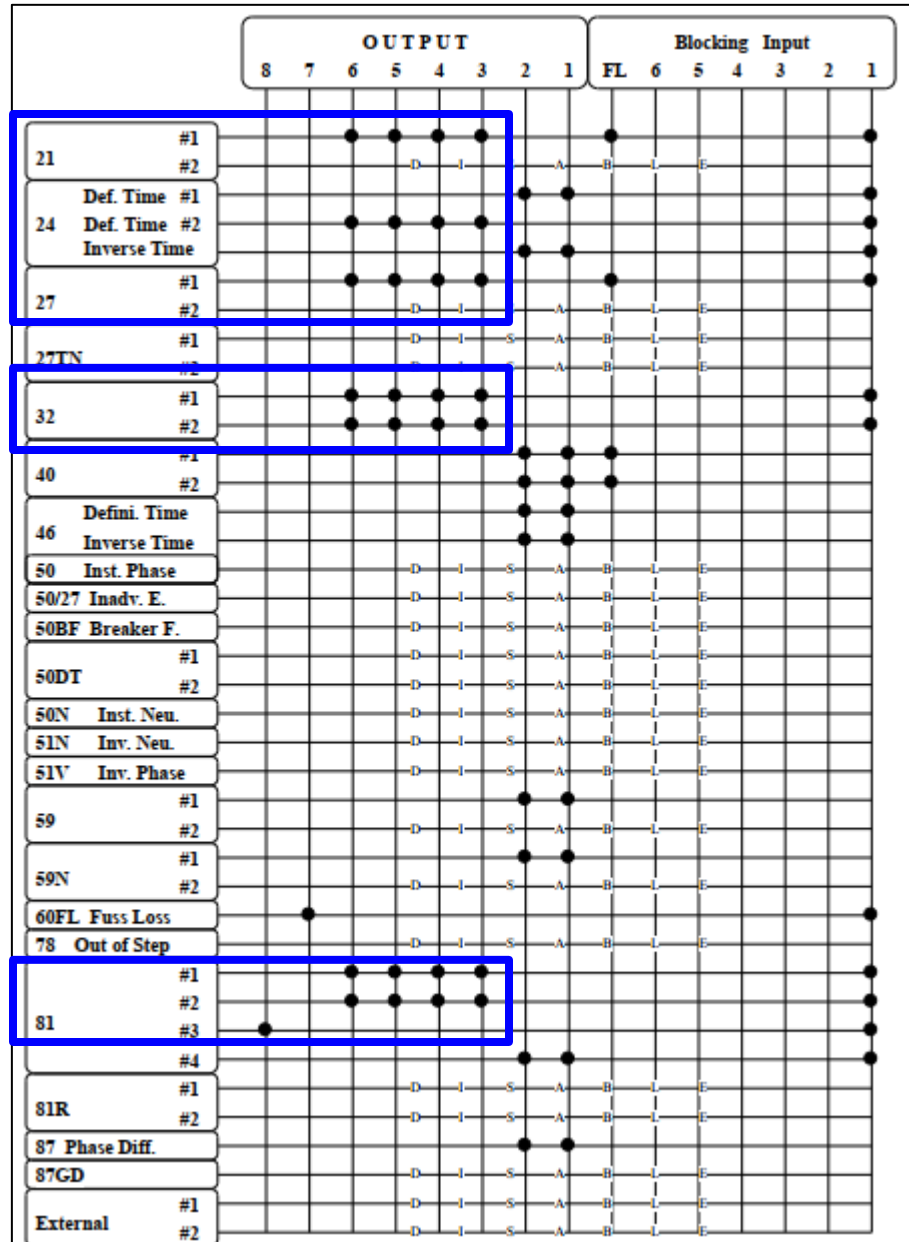
- Voltage and Frequency were running at nominal throughout the event, so it is easy to eliminate the 24, 27, and 81 elements as having triggered this record.
- Next, looking at the RX Diagram, it can be seen loci are way outside of the 1.7 Ω setting of 21 zone #1 and 21 zone #2 is disabled.
- So that leaves us with the 32 element.

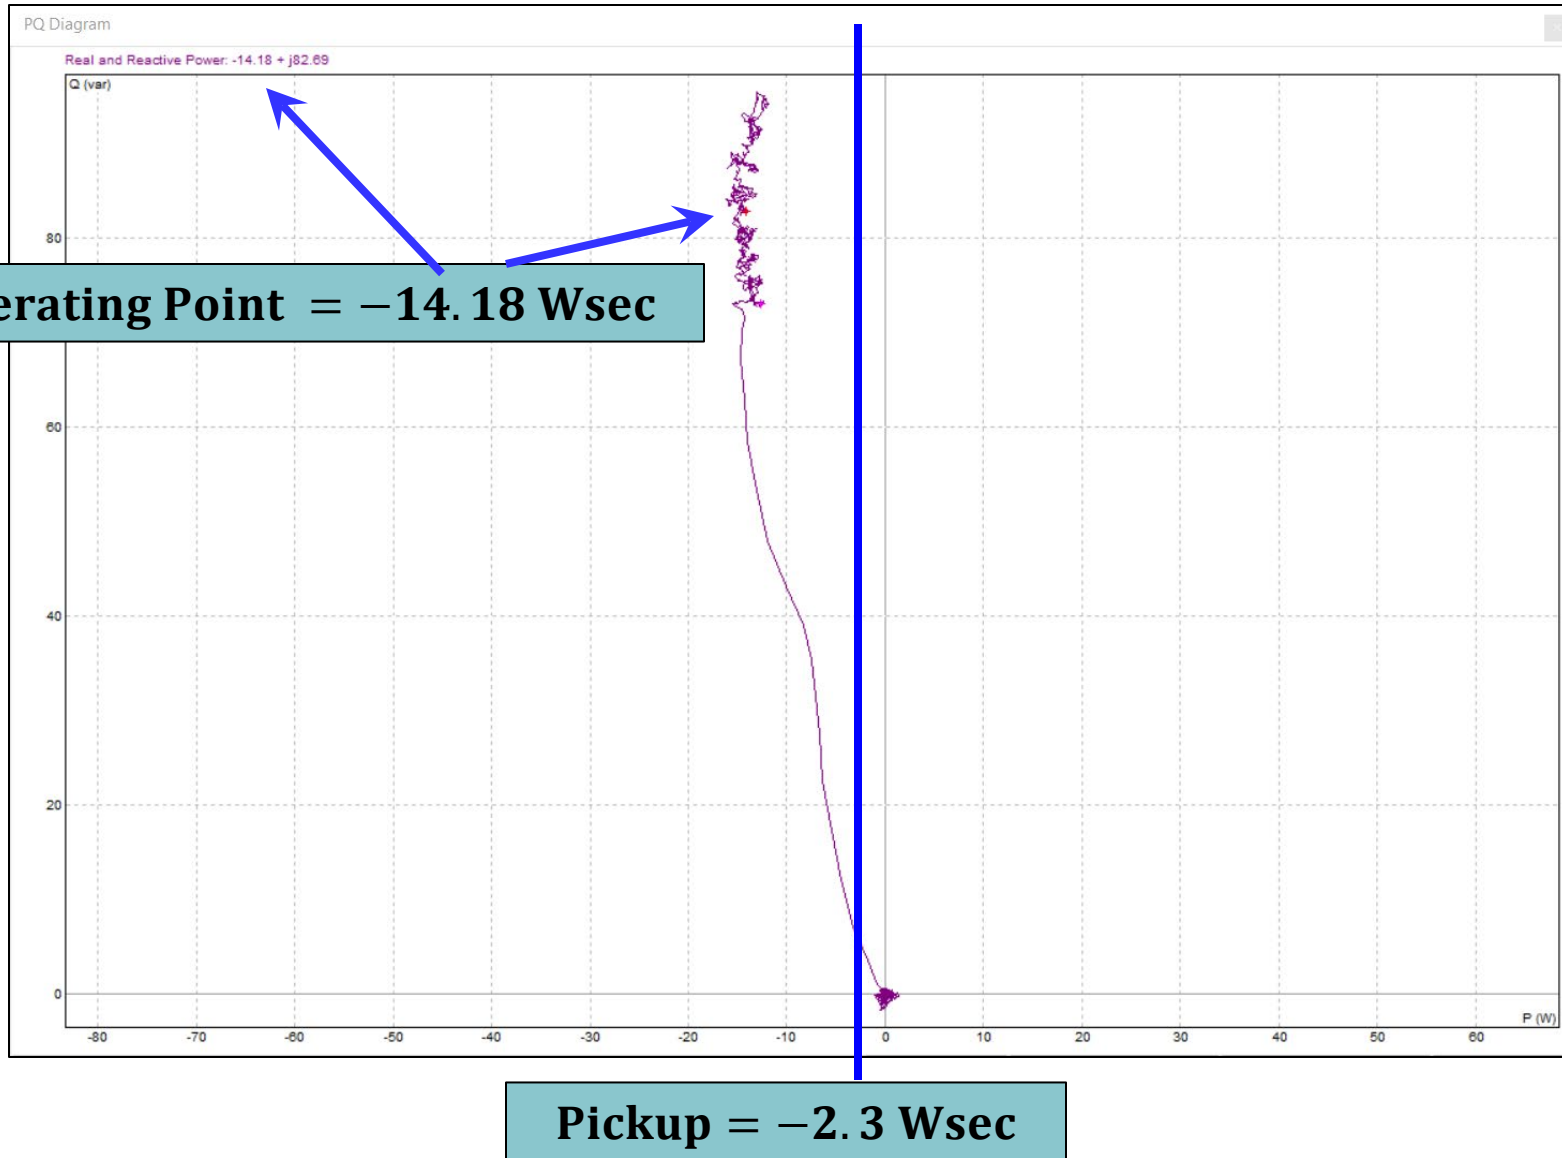
- View trip on PQ Diagram in Primary or Secondary values – here shown secondary:

- Reported to customer that the relay tripped correctly based on settings.
- May have been a normal shutdown, sequential trip.
- Or there could have been an issue with the turbine, turbine control, etc.

- Recommended, if this was a normal shutdown sequential trip, that they may want some discrimination between 32 #1 and 32 #2 as both have the same outputs mapped and the same blocking input for open breaker – they could consider blocking for FL if 60FL is brought to DCS.

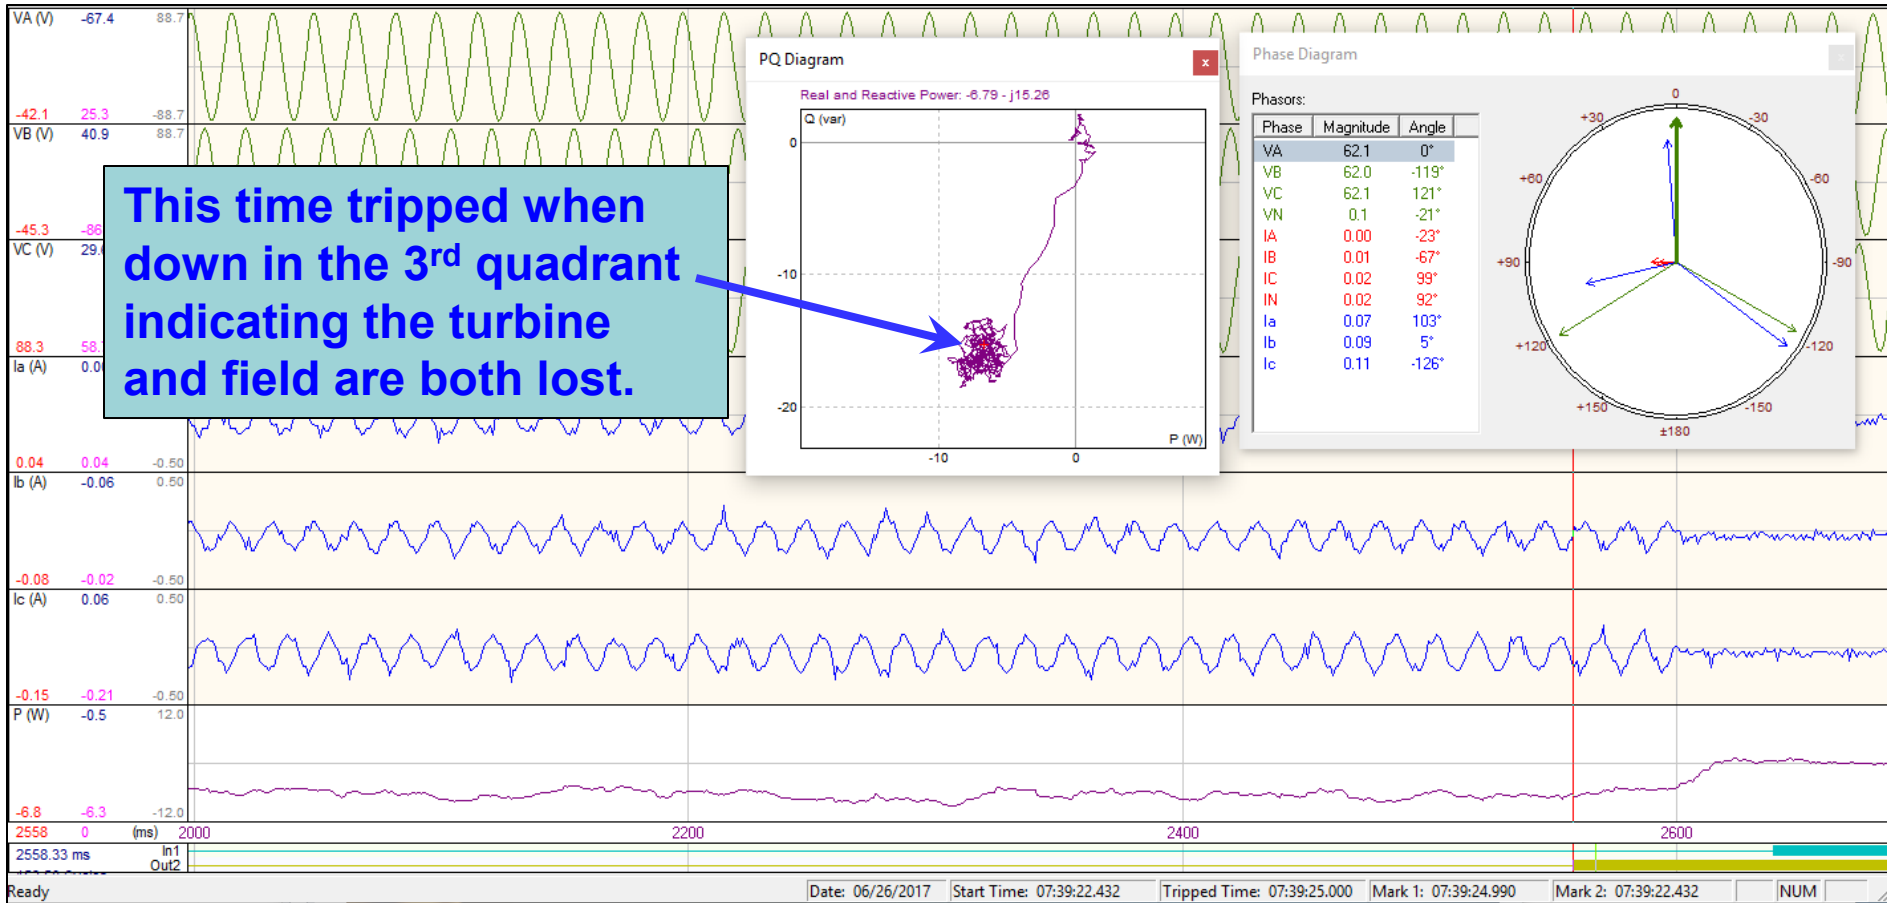
- Customer reported 32 trip and asked if it operated correctly:

- Reported that the relay operated per the settings and showed how it did so.
- I mentioned that if they would provide me with the setting file or tell me what their 40 settings are, then we will be able to see why the 40 elements did not trip prior to this 32 trip (as may typically be desired for operating points down in the 3rd quadrant) and based on that analysis and what they are trying to accomplish possibly suggest some setting adjustments to the 40 and/or 32 elements or maybe prove that it did operate as they wanted it too.
- No further information was provided from the customer.

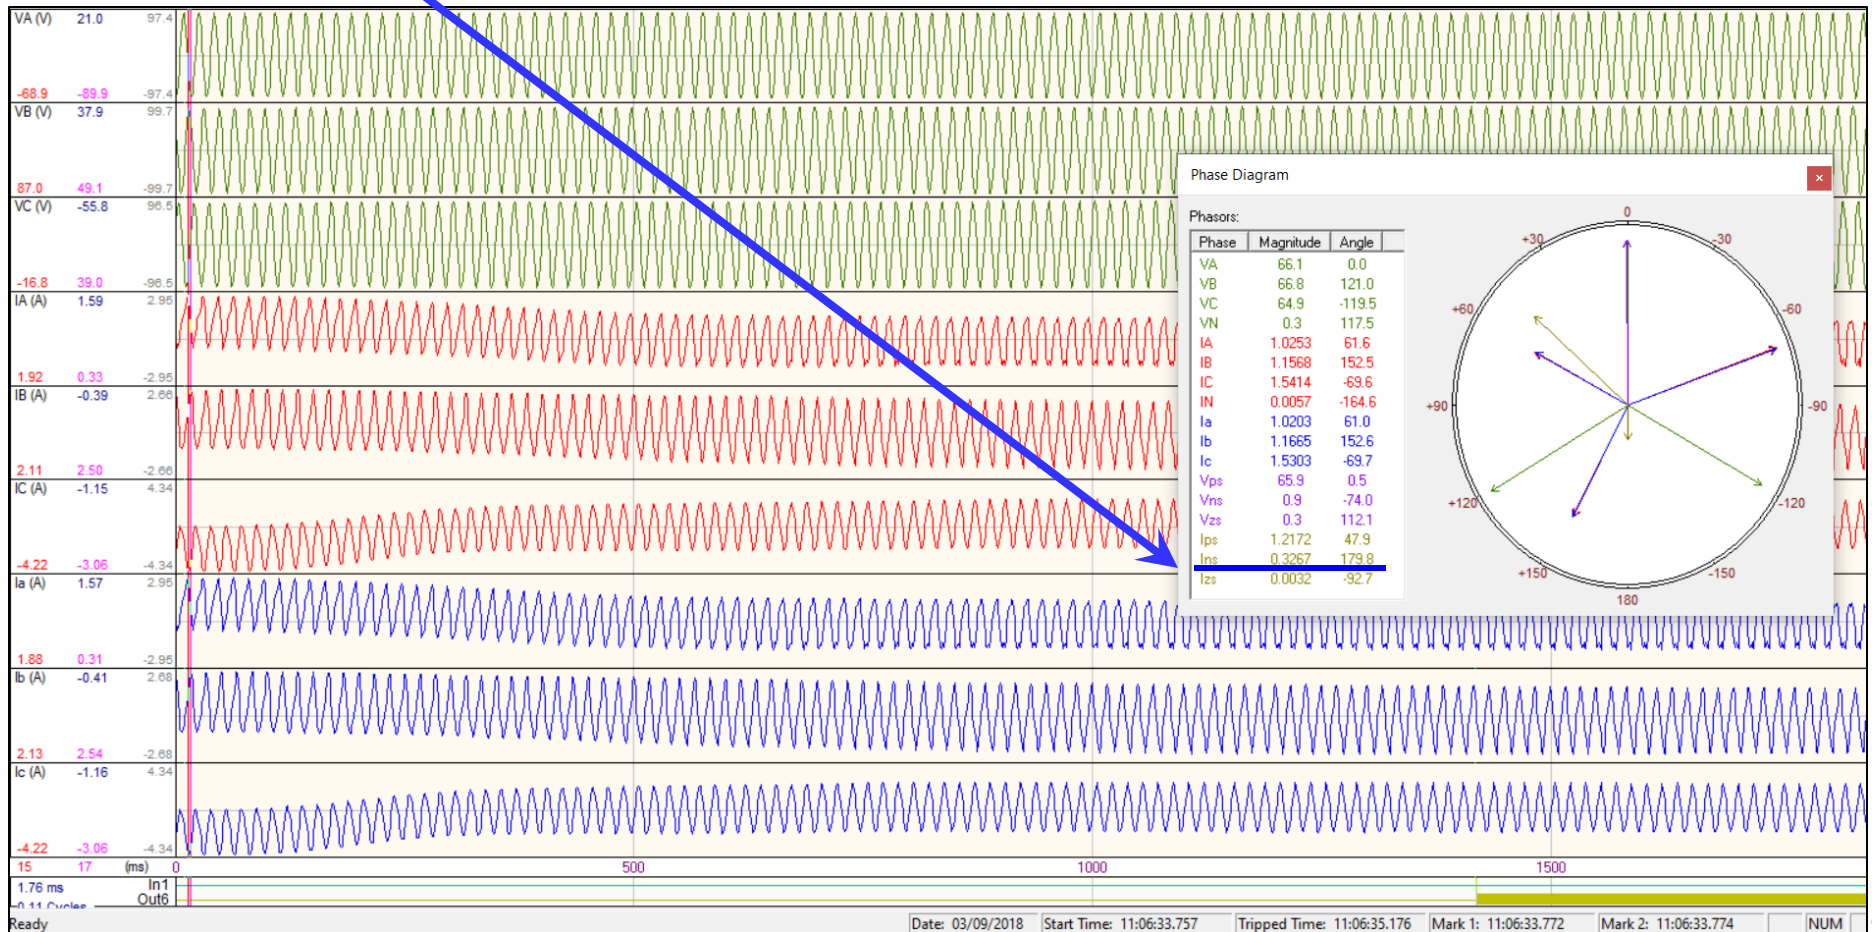
- From beginning of event to the time the output asserts, the negative sequence current varies from 0.3267 A to 0.2510 A, which is

- $$\left(\frac{0.3267}{4.24}\right) * 100 = 7.7\% \quad \text{to} \quad \left(\frac{0.2510}{4.24}\right) * 100 = 5.9\%$$

- Recommended to review the phasing transposition diagrams for the transmission lines on high side of GSU to ensure the phases are being transposed optimally.
- Recommended they could consider adjusting 46 settings:
 - ✓ The 46IT Trip Pickup could be changed from 5% to 7%.
 - ✓ The 46DT Alarm Pickup could be bumped up a bit too or it could be left at 3% so the operators have a chance to react before it trips, but it depends on what the normal, quiescent I_2 is for this application.

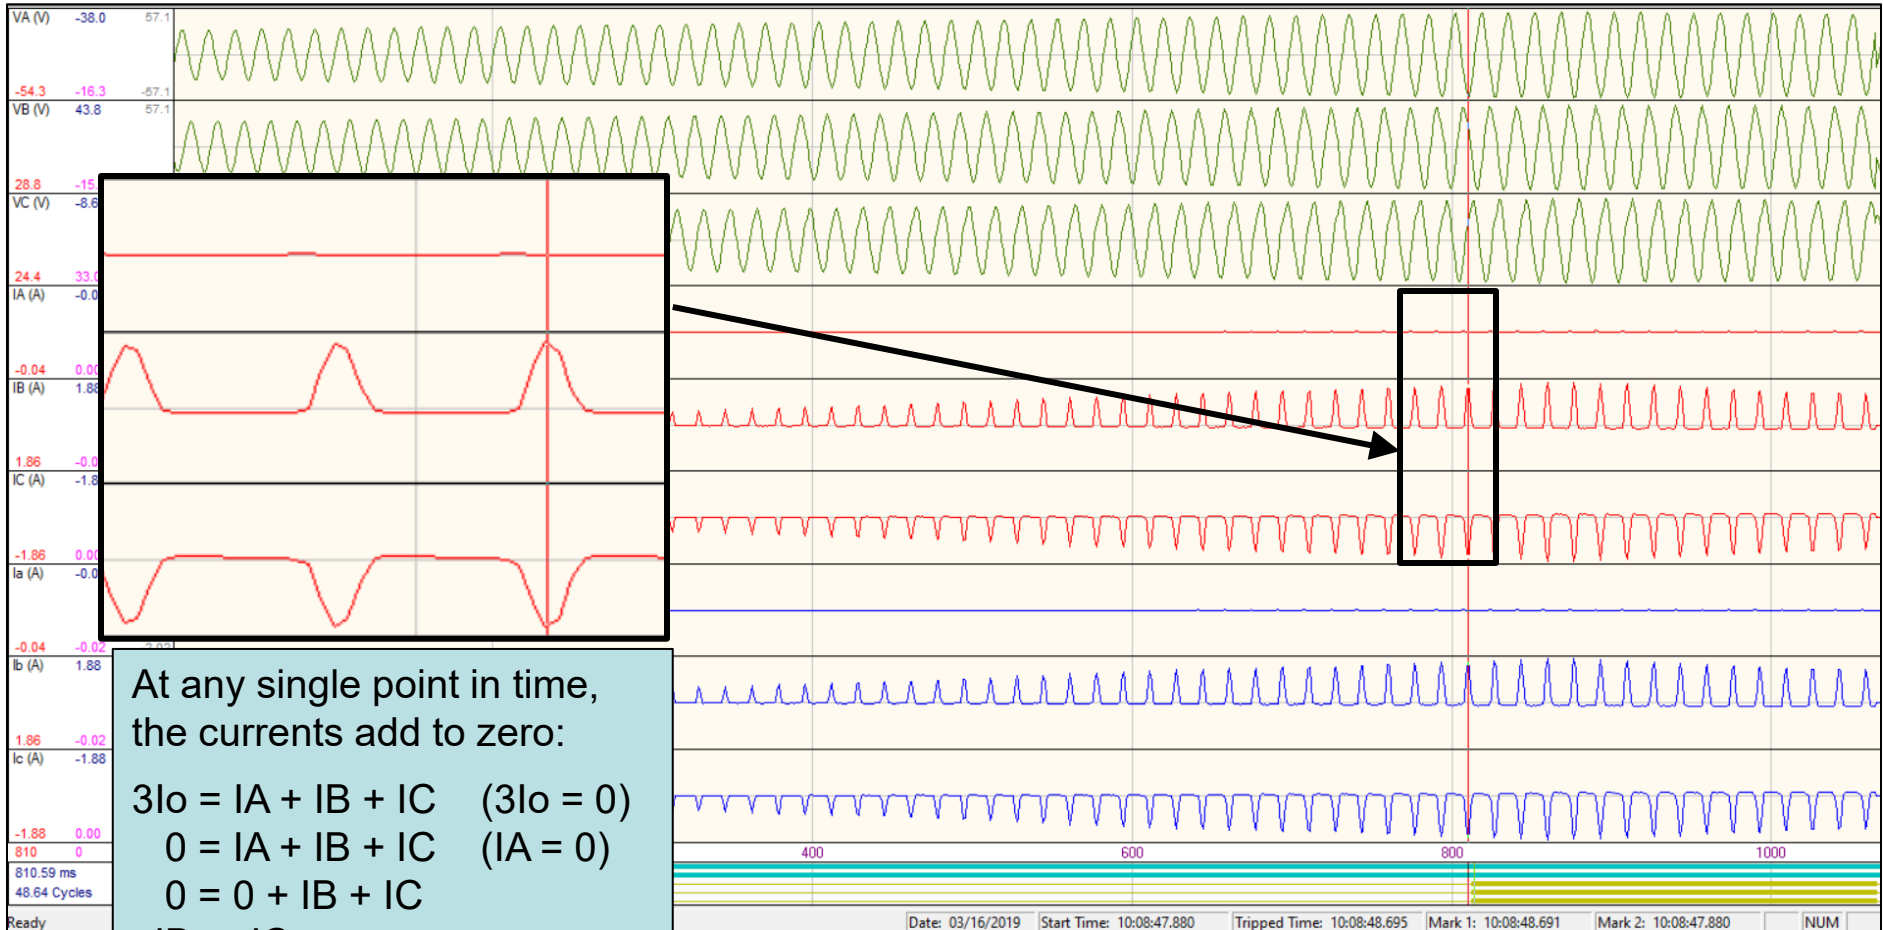
• 1st 50/27 trip event:

At any single point in time,
the currents add to zero:

$$3I_0 = I_A + I_B + I_C \quad (3I_0 = 0)$$
$$0 = I_A + I_B + I_C \quad (I_A = 0)$$
$$0 = 0 + I_B + I_C$$
$$I_B = -I_C$$

- It may have helped to degauss the GSU after it was tested to remove remnant flux.
- In all cases, recommended to **increase the 50 Pickup and decrease the 27 Pickup** in their 50/27 settings.

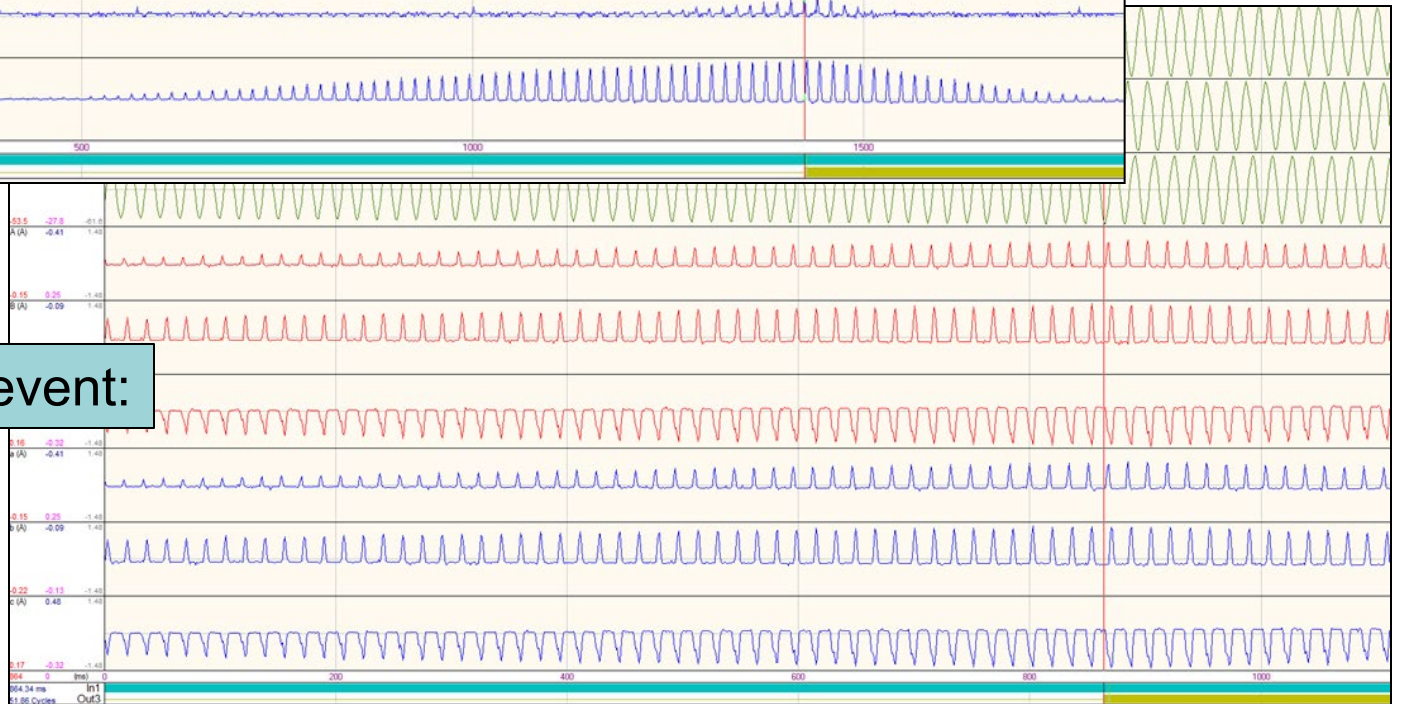
• 3rd 50/27 trip event:

- What do all (3) events have in common?
- All 3 cases were unit connected, i.e. there was no LS generator breaker, they only had a HS unit breaker that was open at the time of the trips.
- All 3 cases occurred during startup i.e. they were coming back on-line (pre-sync period) after an outage where in one case the GSU had been replaced and in another case some GSU testing had been done.
- As the voltage was building up during startup to get ready to sync on-line, the 50/27 tripped the GSU HS unit breaker. Why?

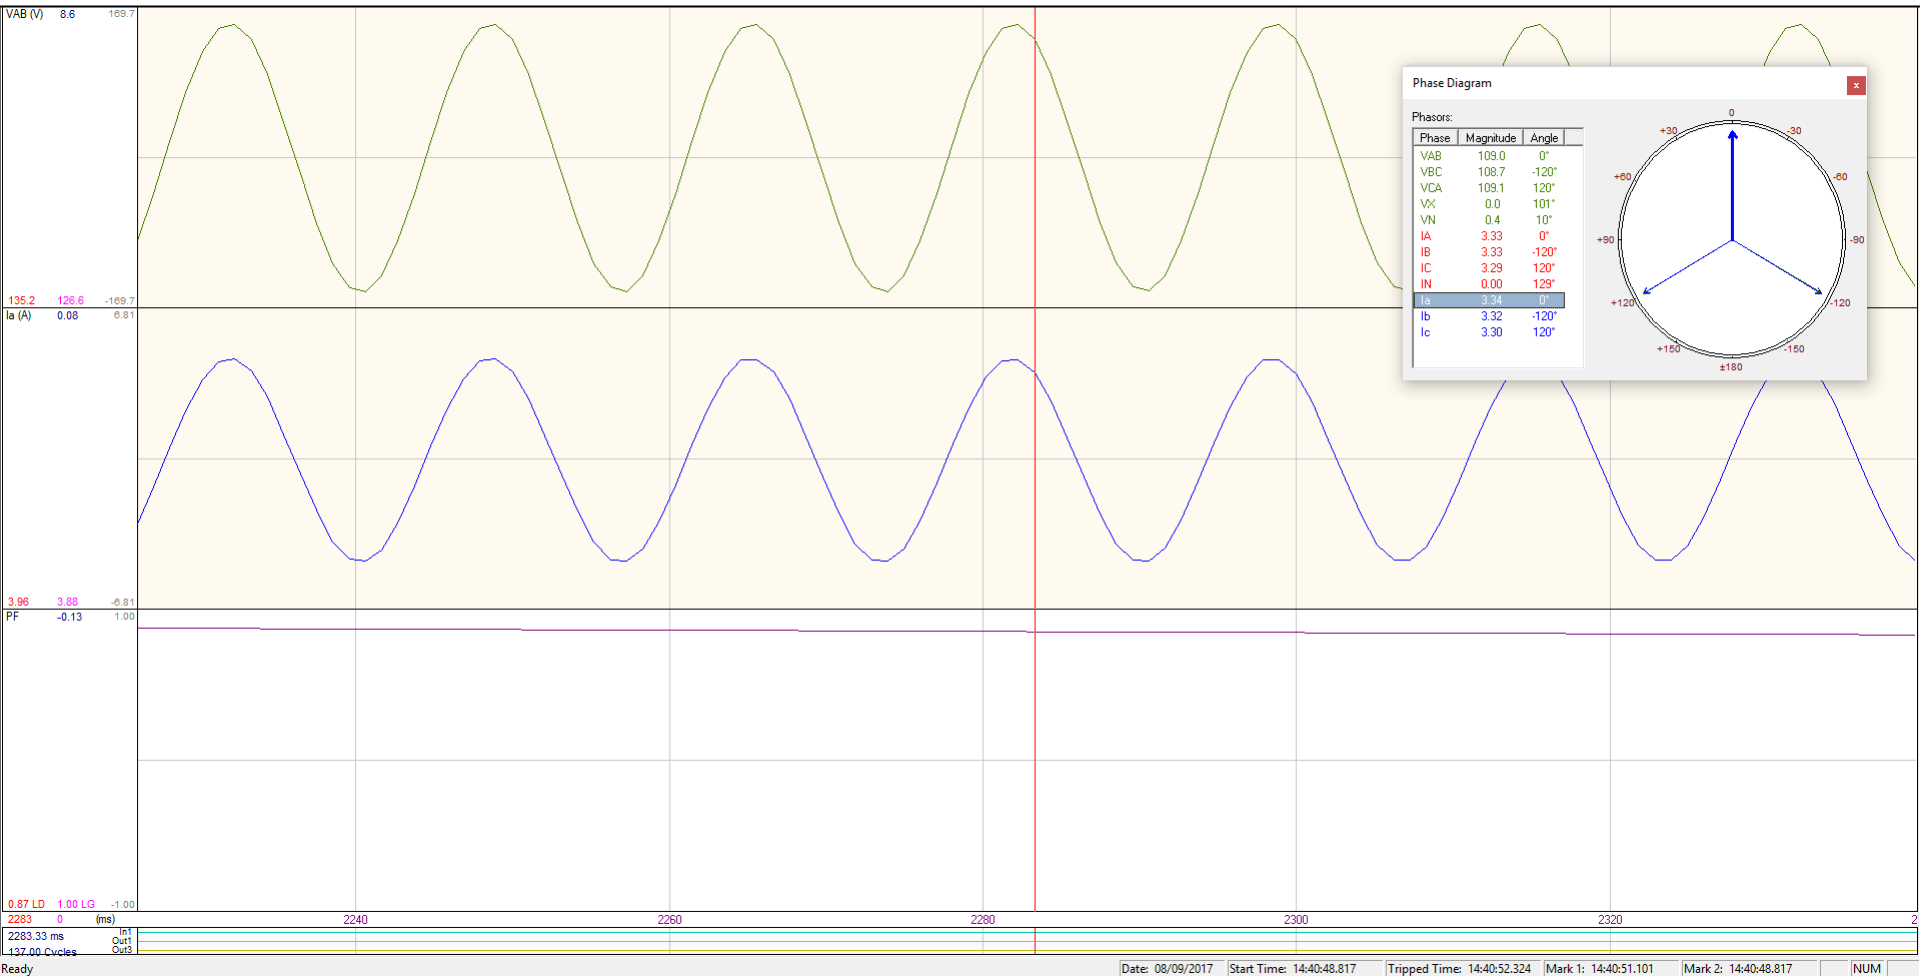
- Point at which the impedance enters zone 1 mho circle (5 cycles prior to trip)

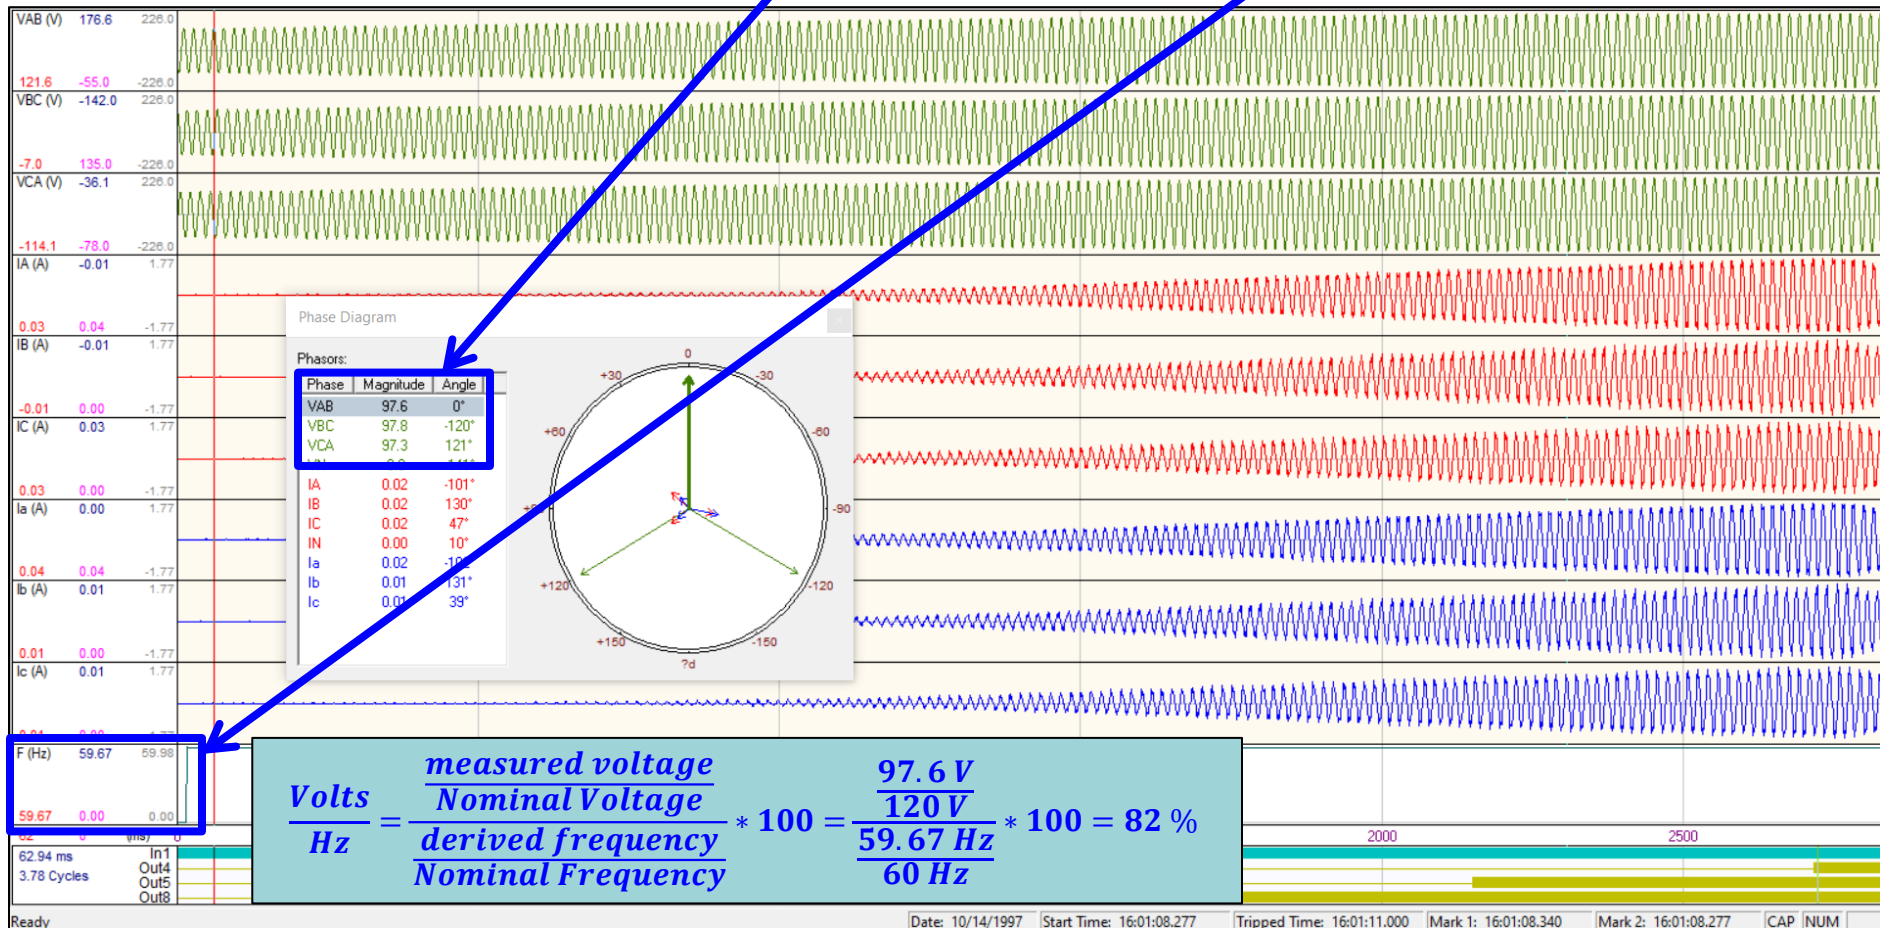
- At start of event, LL phase voltage was 97.6 V and frequency was at 59.67 Hz.
- And the current was zero at that point as one would expect with the GSU HS breaker open.
- But the current will increase a bit just strictly as magnetizing current into the GSU.

- At 120 V nominal voltage (red cursor) it should have stopped boosting, and at that time the GSU magnetizing current was very low, just 0.08 A.
- At the time the trip occurred, the voltage had boosted all the way up to **161.9 V**.

- Cause was found to be a runaway excitation system due to blown fuse and the excitation control system had no such blocking for blown fuse so as it saw no volts, it kept trying to boost the voltage.
- This shows why I always preferred not to block 24 with FL because if excitation and relay are driven from the same VTs, then the relay's 24 protection would not have tripped if FL blocking were implemented.
- Where did the current go if the GSU HS breaker is open?
- Into the GSU and then out as heat.
- Conservation of energy.....electricity in, heat out.
