Event Analysis

Douglas L. Weisz, PE

Power Plant Protection Track
Thursday, August 7, 2025

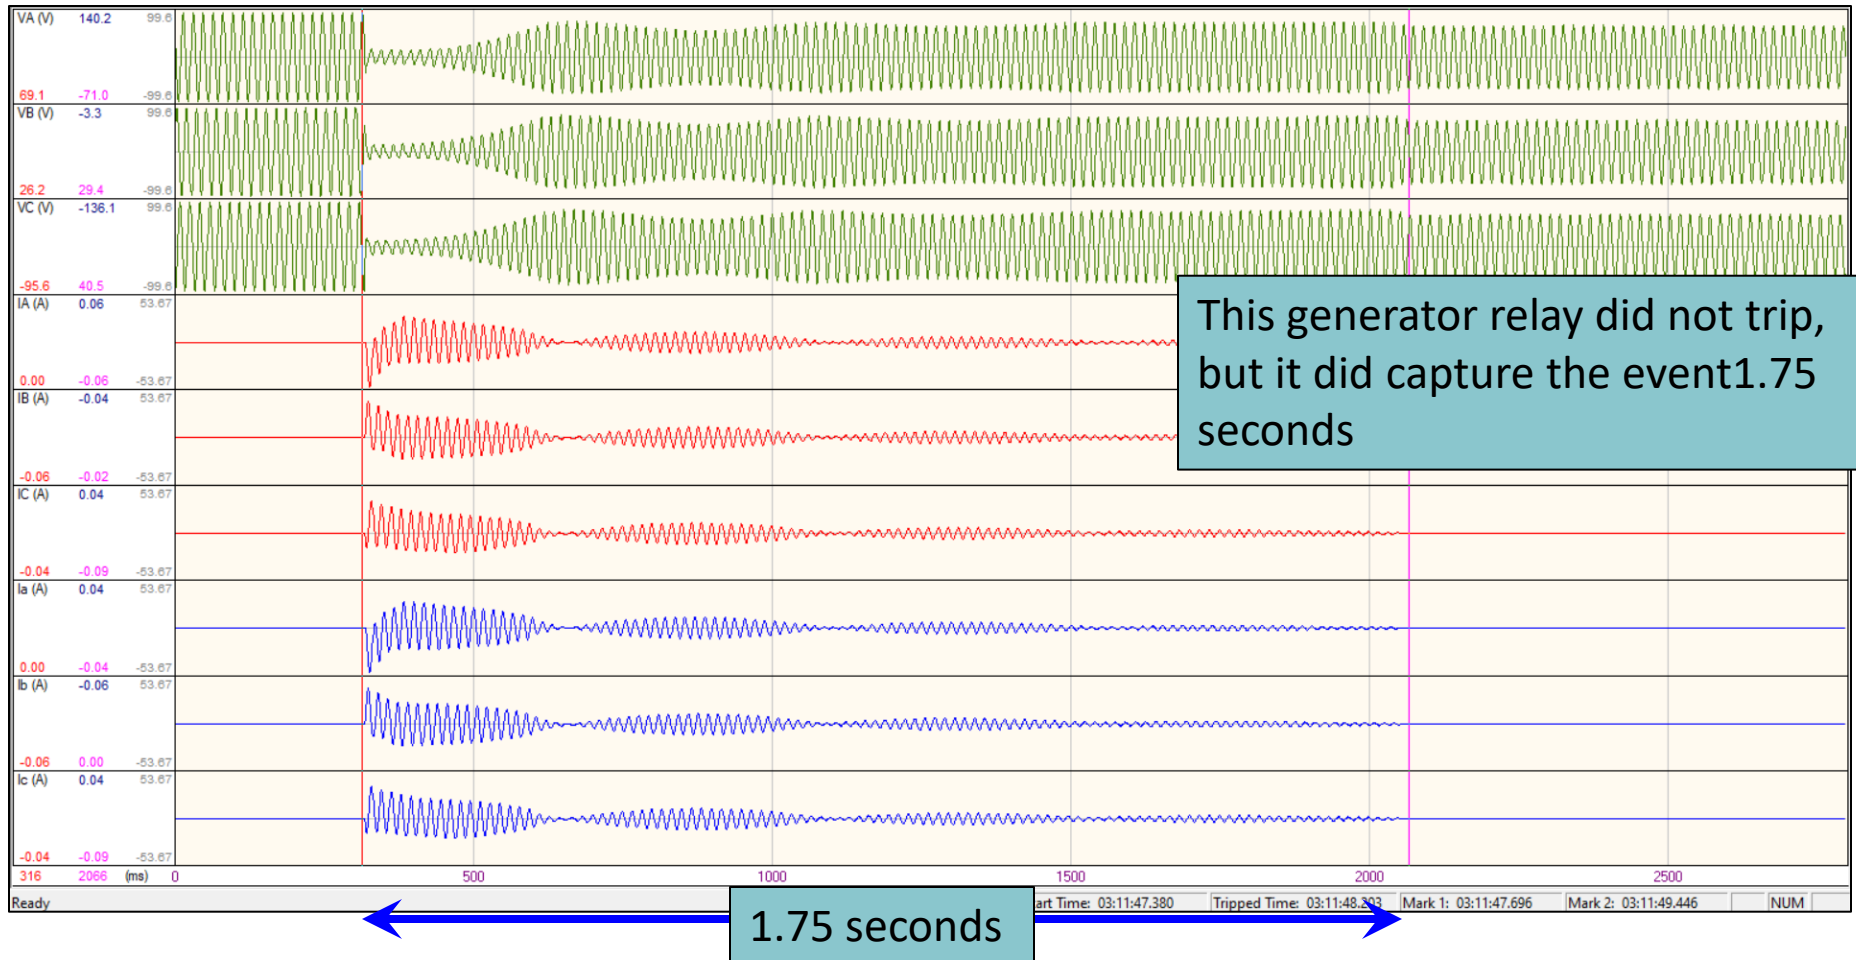
- Customer reported this occurred during a **manual sync** when they closed in the GSU high side breaker out-of-phase causing the “building to shake” and resulting in extensive rotor damage and a long outage.

2 causes of the event:

- **The manual sync check relay (solid state) failed in the closed position due to circuit board level component failure.**
- **Also, the pistol grip switch to manually sync close the breaker was forcibly held in the closed position.**

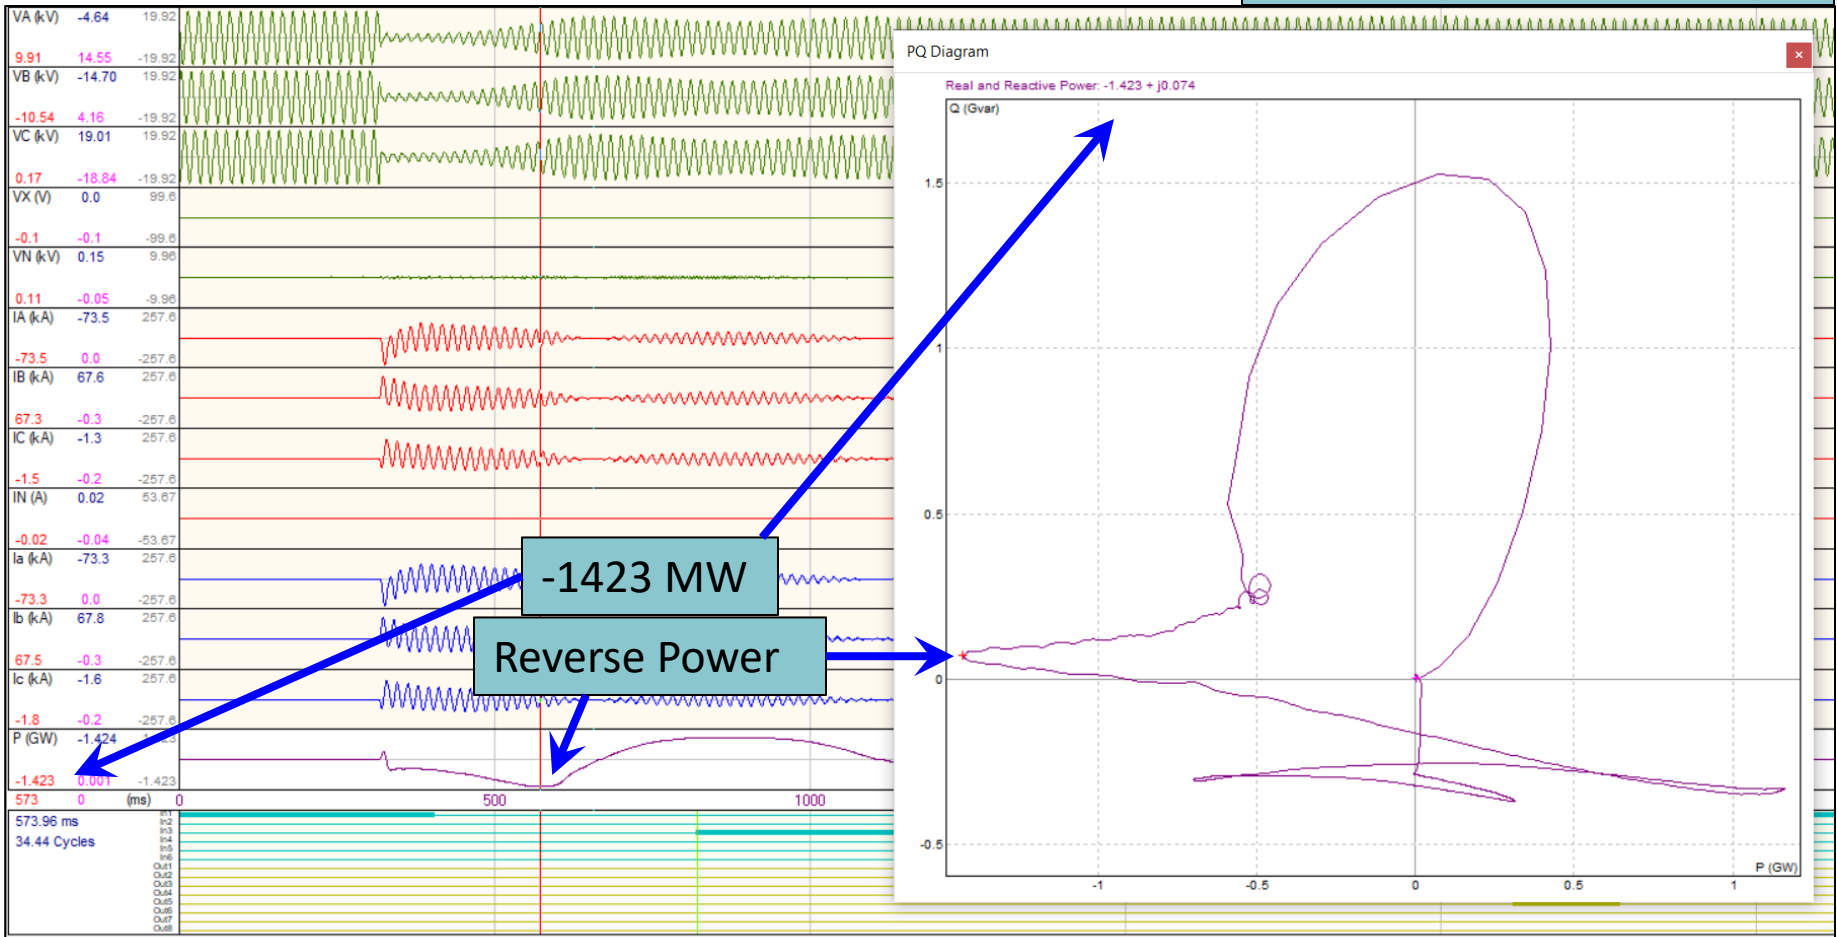
View of Primary Quantities

**-1423 MW
Reverse Power**

Tripped Functions

Tripped at: 03:11:48.203

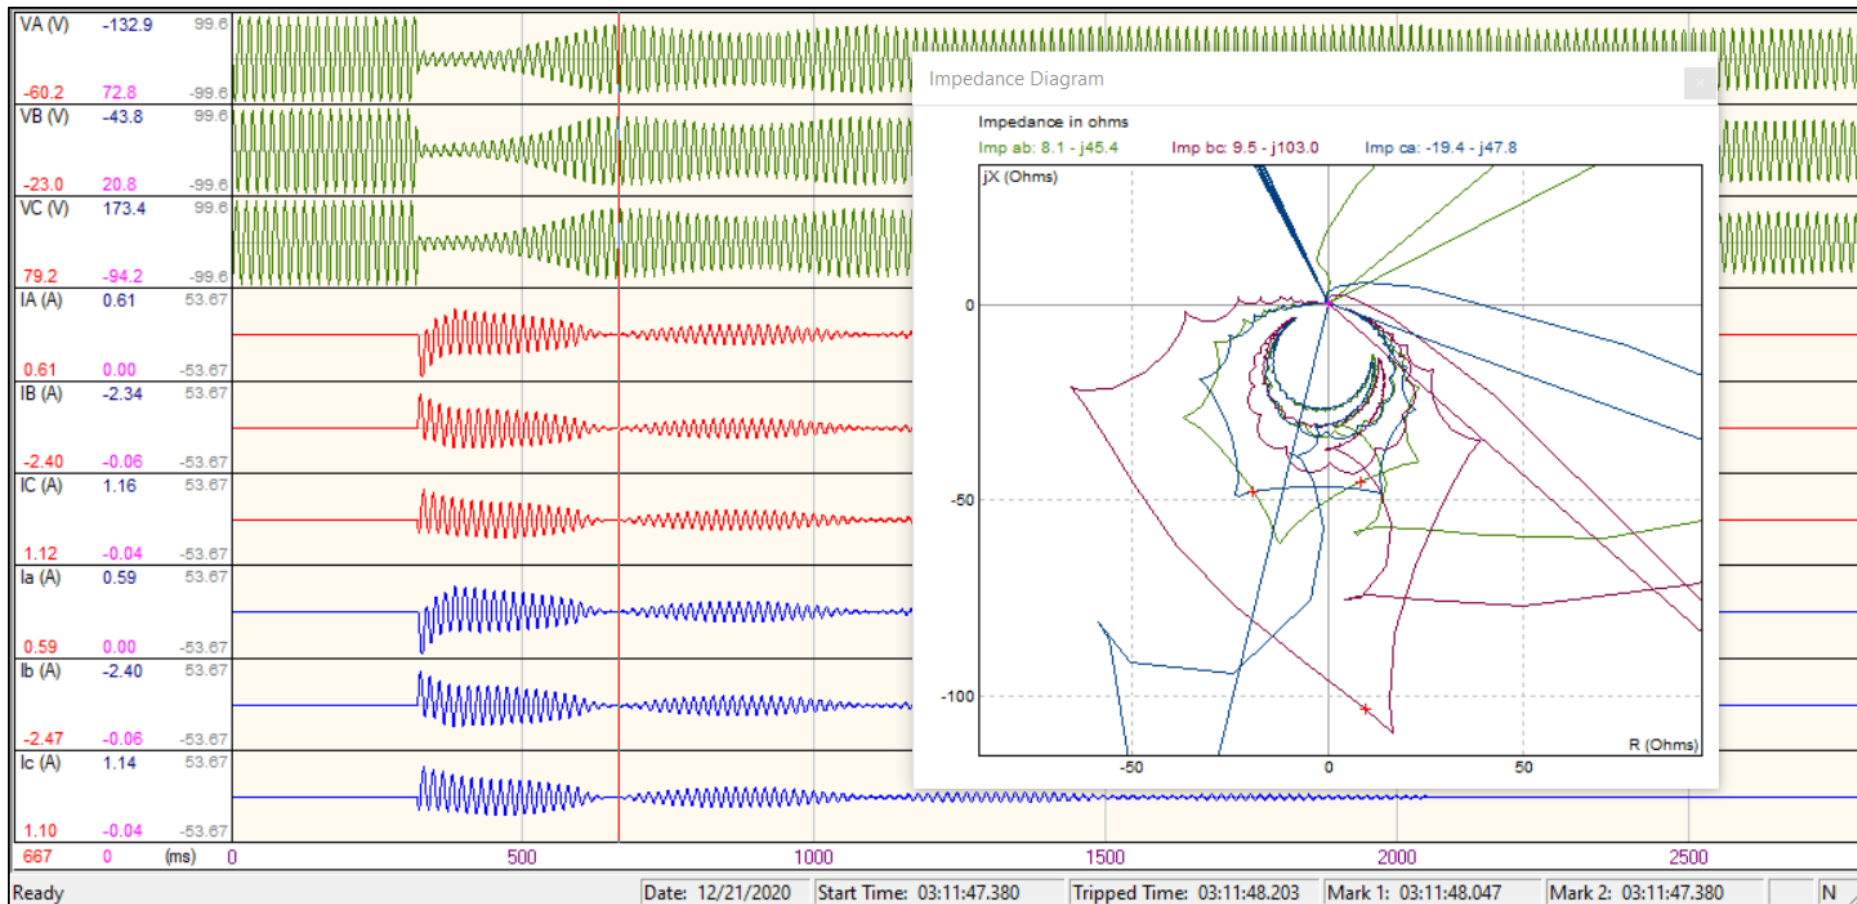
78 Out of Step protection was disabled in this application; however, even if it was enabled and if it was set using typical criteria it would not have seen this event as the event locus would not have entered a 78 permissive mho circle and traverse both 78 blinders in sequence i.e. the electrical center of the swings below do not pass thru the gen/GSU zone.

- The max current from the oscillography showed 21.64 Asec.

- $$I_{pu} = \frac{I_{actual}}{I_{base}} = \frac{21.64}{4.12} = 5.25 \text{ pu} \quad (5.25 \text{ times nominal current})$$

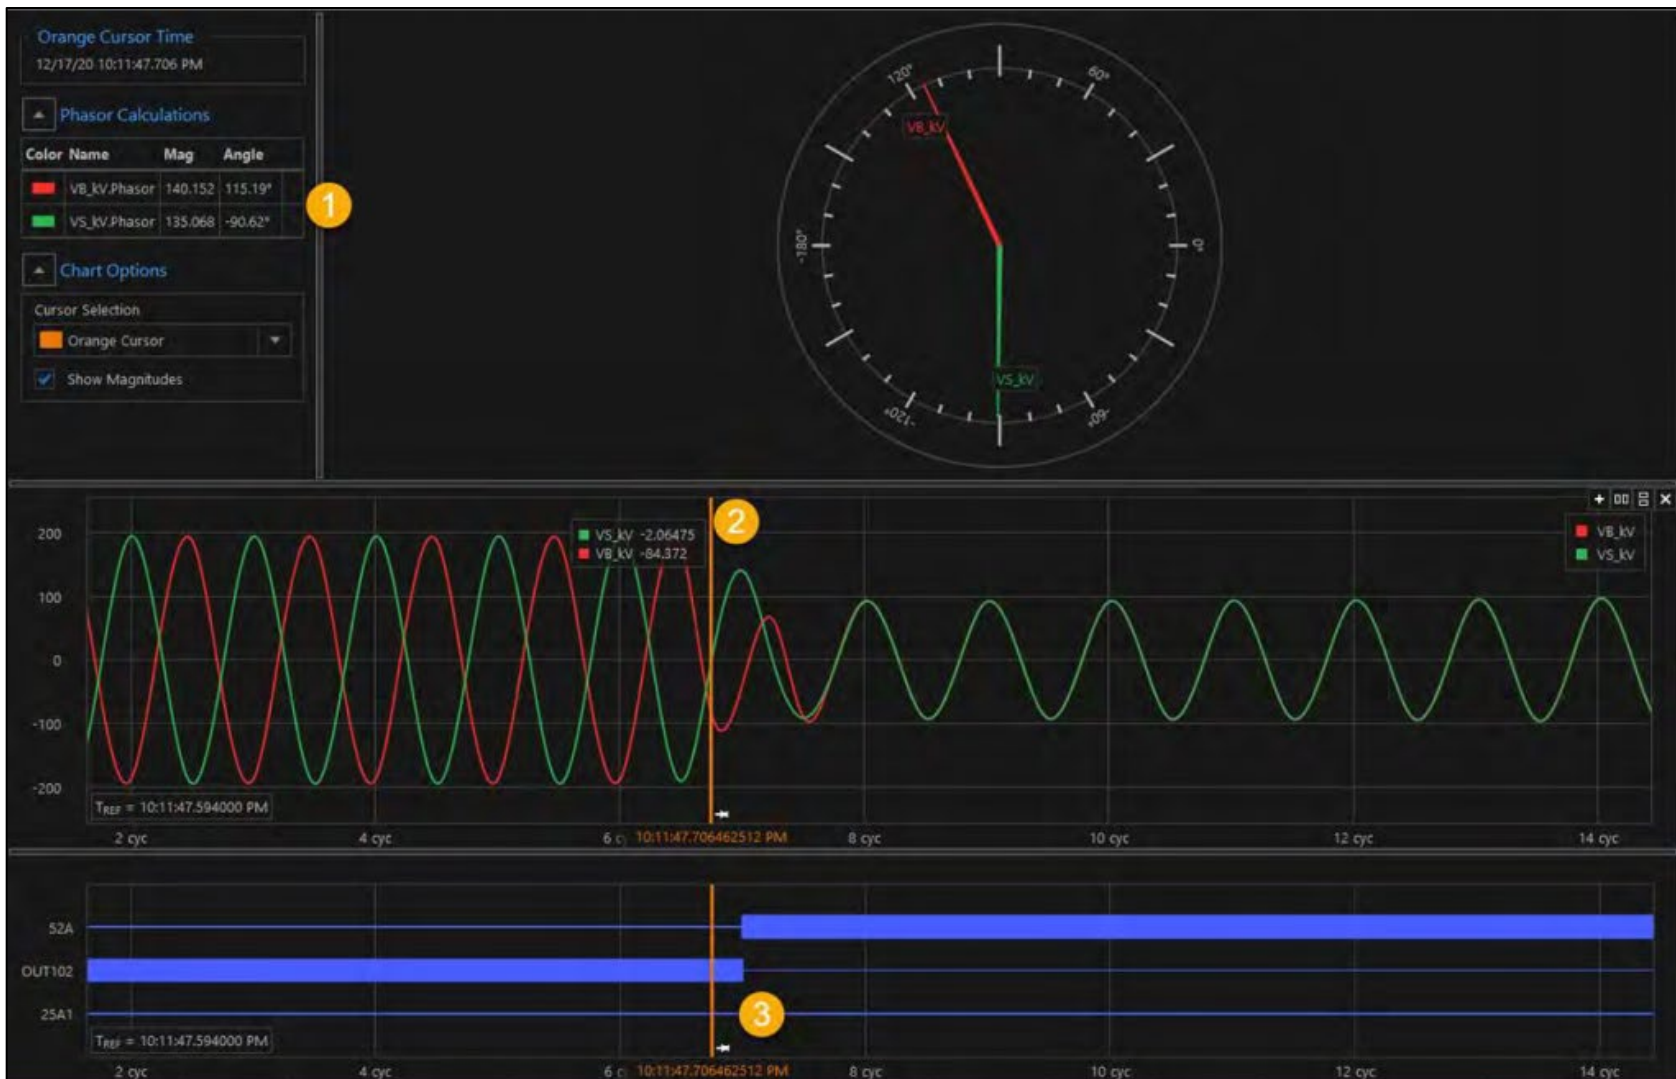
1. Phase Angle Difference between VB_kV and VS_kV phasors at time of event
2. Waveform showing difference between System and Generator at time of event
3. OUT102 command to Breaker Close coil is not supervised by the 25A1 element which is shown with the 52A feedback

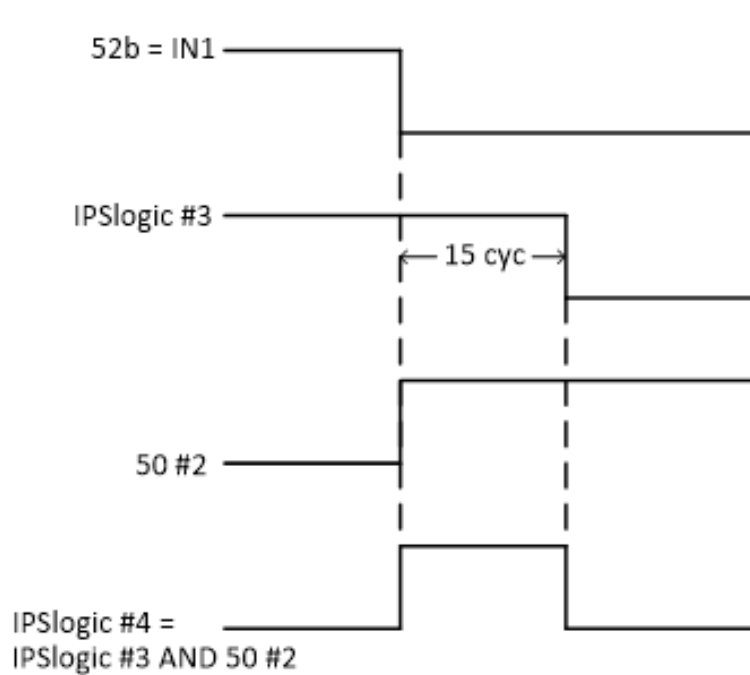
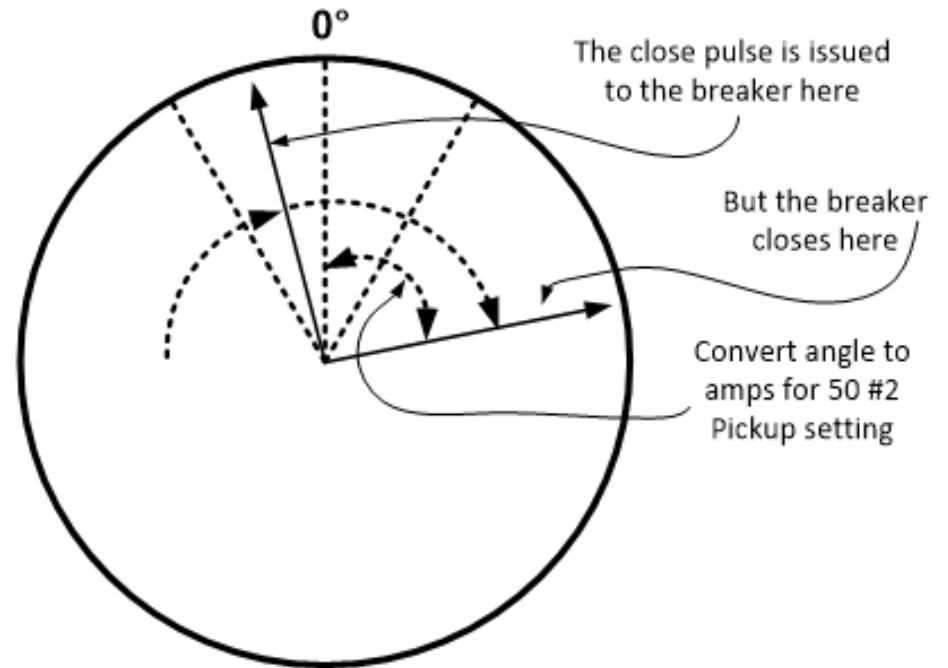
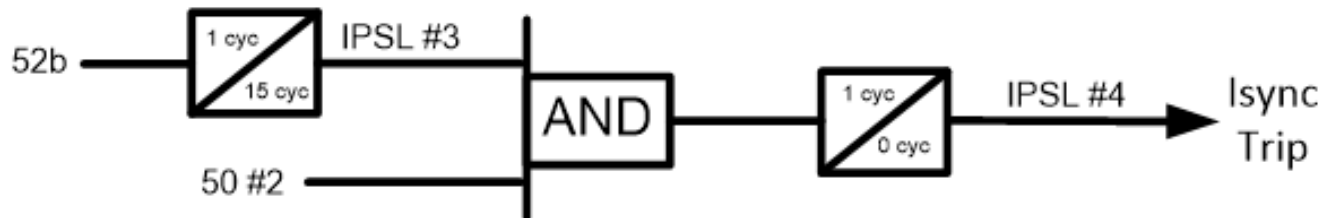
- Current-based** Isync Trip protection scheme:

- A **current-based** out-of-phase synch close protection will immediately trip after the breaker closes out of phase.
- It is not necessary to BF trip back a zone as the closure has already occurred so can just trip the subject breaker itself.
- An **angle-based** out-of-phase synch close protection is another method which operates based on the measured angle after the final 25A close pulse is issued.
- BF trip back a zone once the “damage” angle is measured.
- Saves damage as it does not have to wait for the breaker to close and once it does close, it closes onto a dead bus.
- Should be programmed in the same device that is doing 25A.
- Could cause unnecessary outage if the breaker never does close so tripping back a zone is unnecessary.

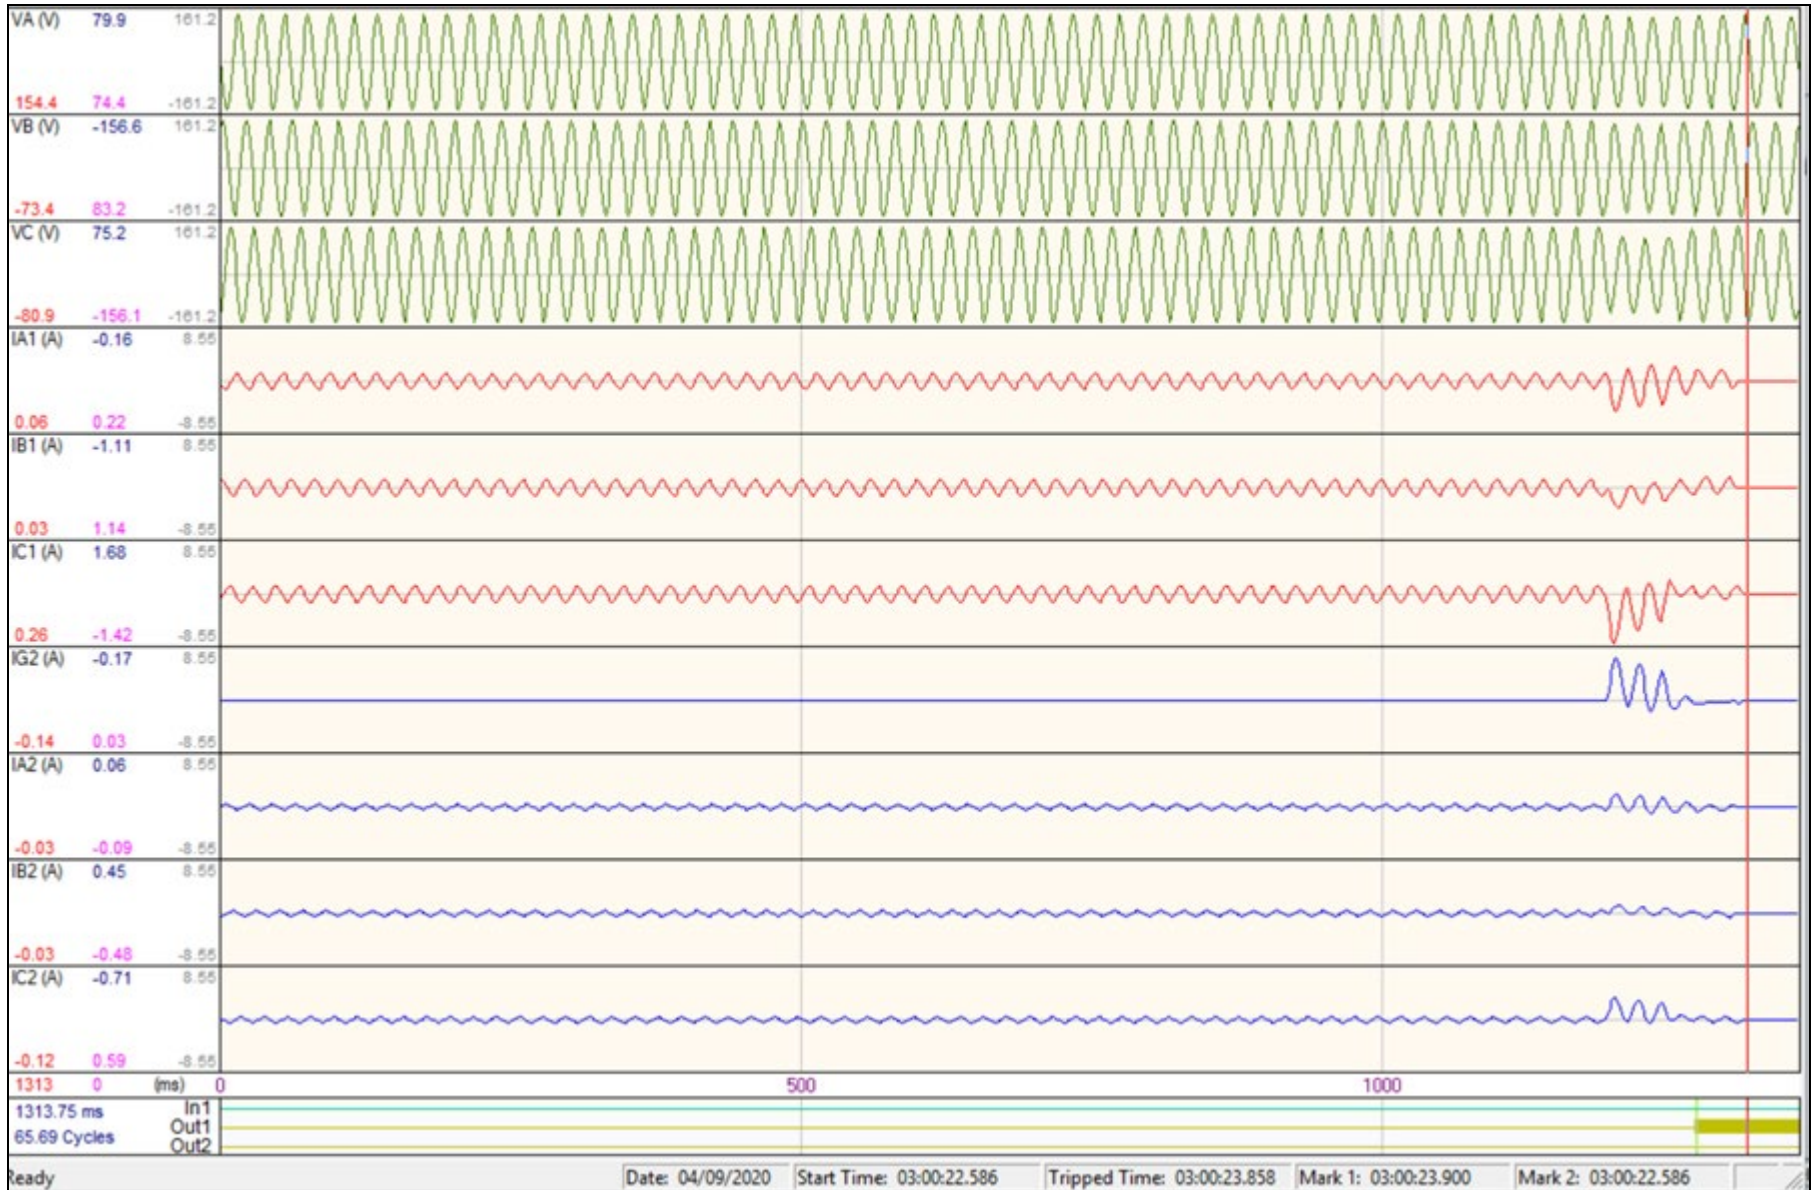
Looking at the RMS tracings of the waveforms, the current and voltages are running per normal, then:

the voltages dip

and the phase currents increase

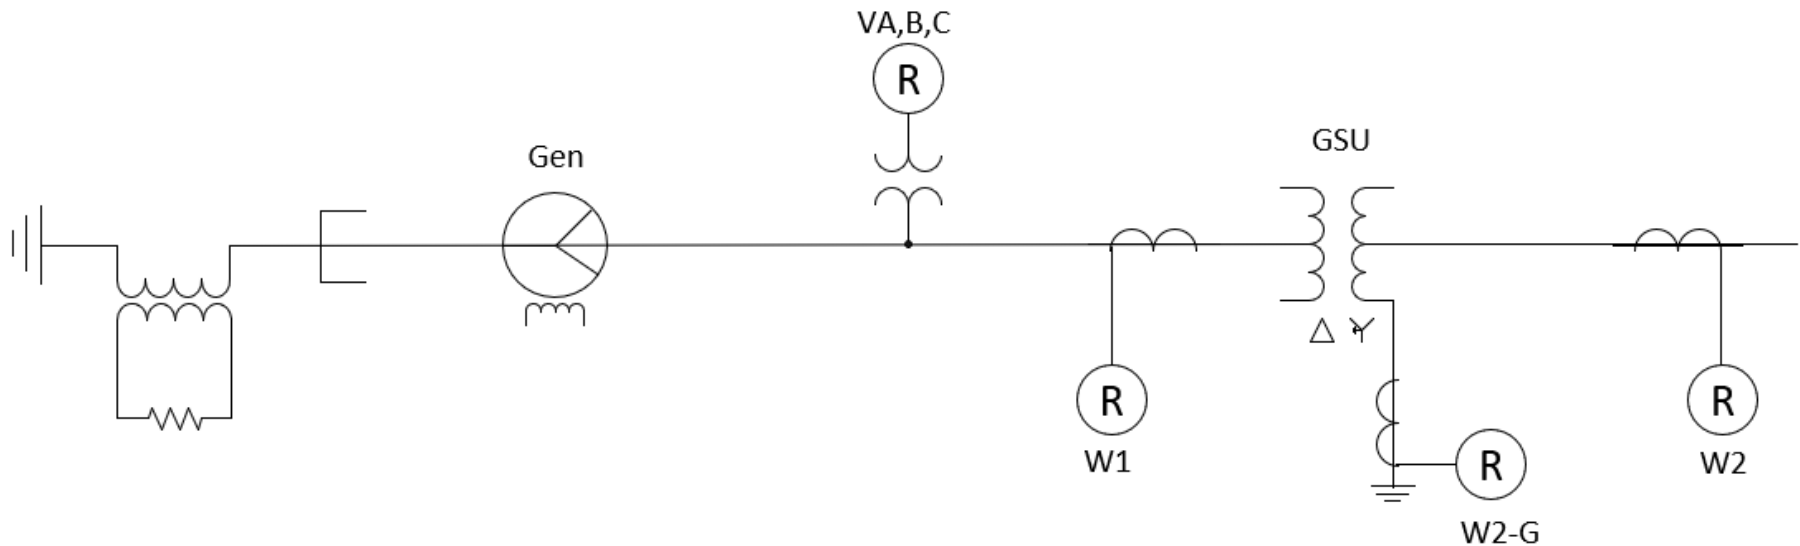
- Why did it trip?
- Was it an internal GSU fault?

- Here we can see that the phase currents are 180° out of phase which would be consistent with some type of an external event.
- But why did it trip for an external event?

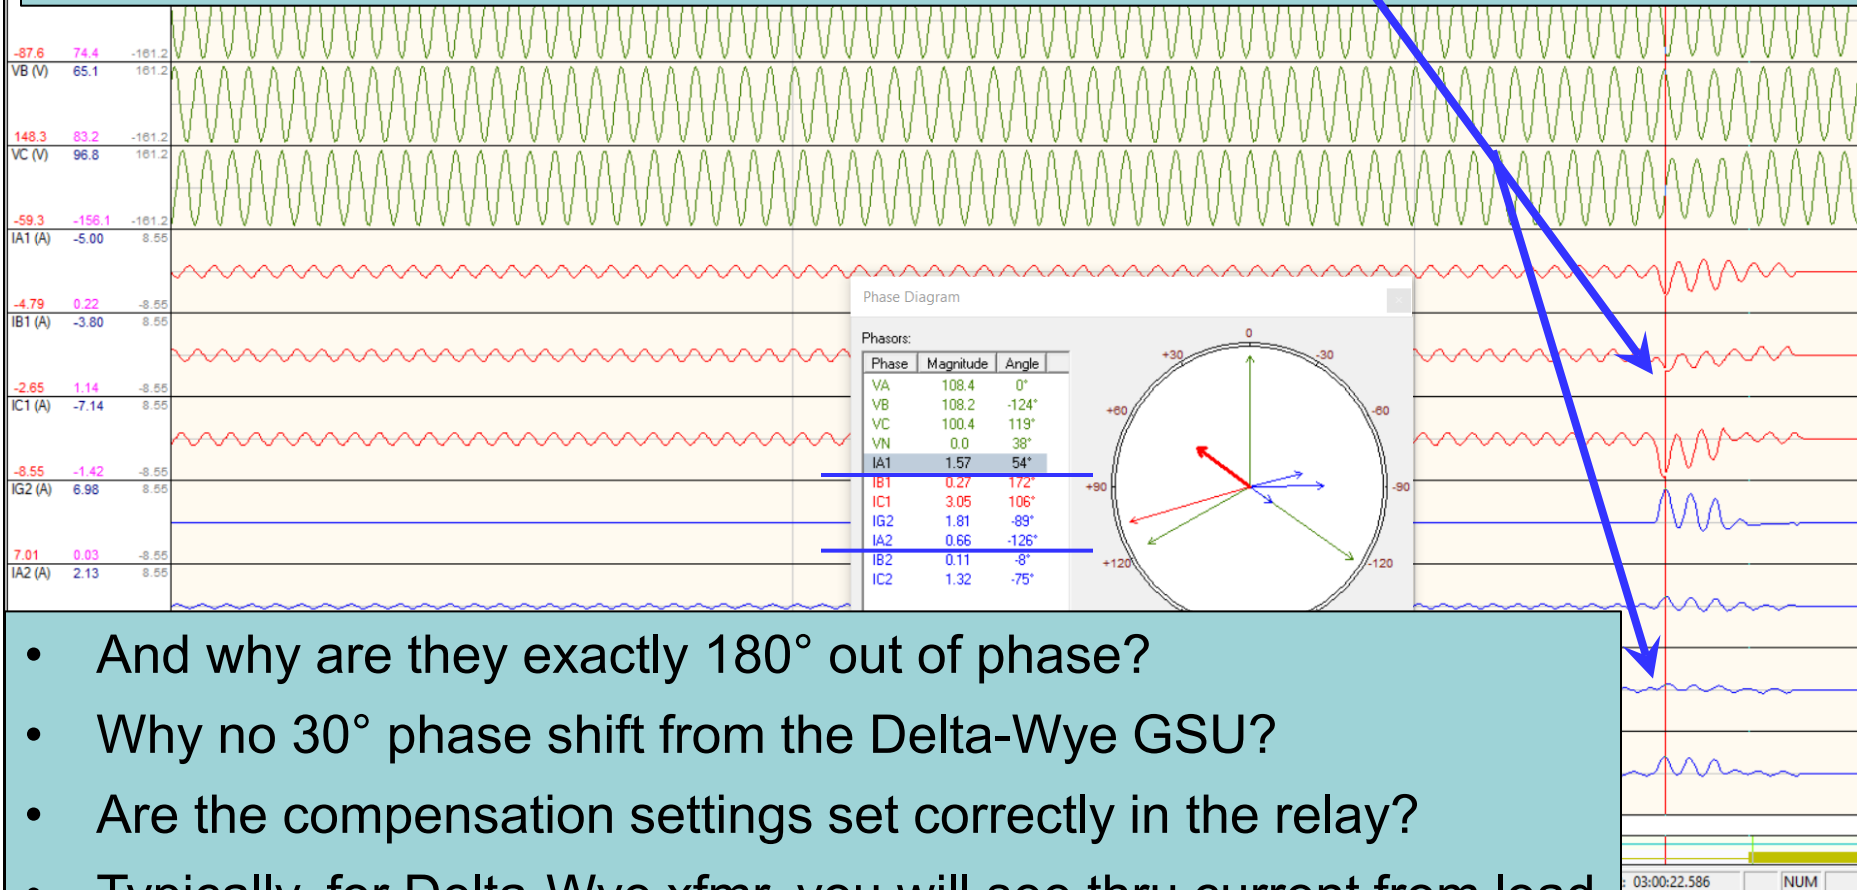
- And why are they exactly 180° out of phase?
- Why no 30° phase shift from the Delta-Wye GSU?
- Are the compensation settings set correctly in the relay?
- Typically, for Delta-Wye xfmr, you will see thru current from load or external event be 150° (Dab) or 210° (Dac) apart – HS Wye leads LS Delta by 210°.

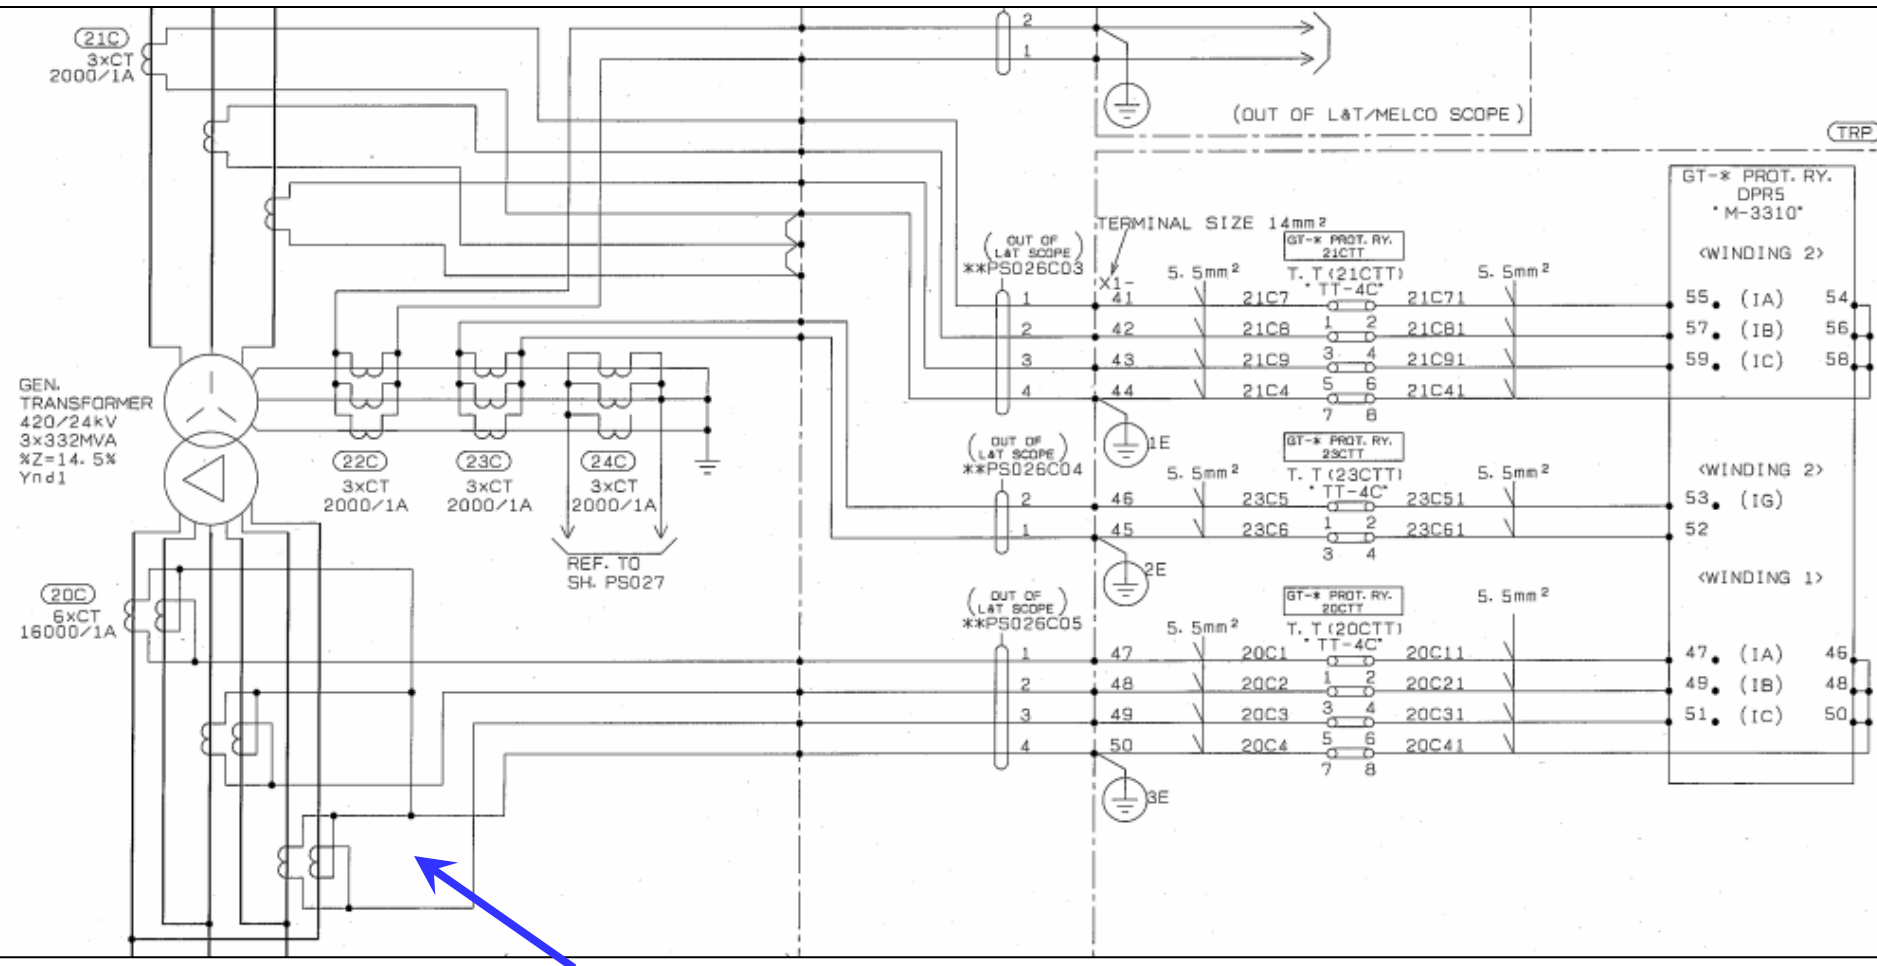
- 3-line:

- Delta side CTs are inside the Delta: **that's why no 30° phase shift was set**
- Now, check if the CT Tap settings are correct.

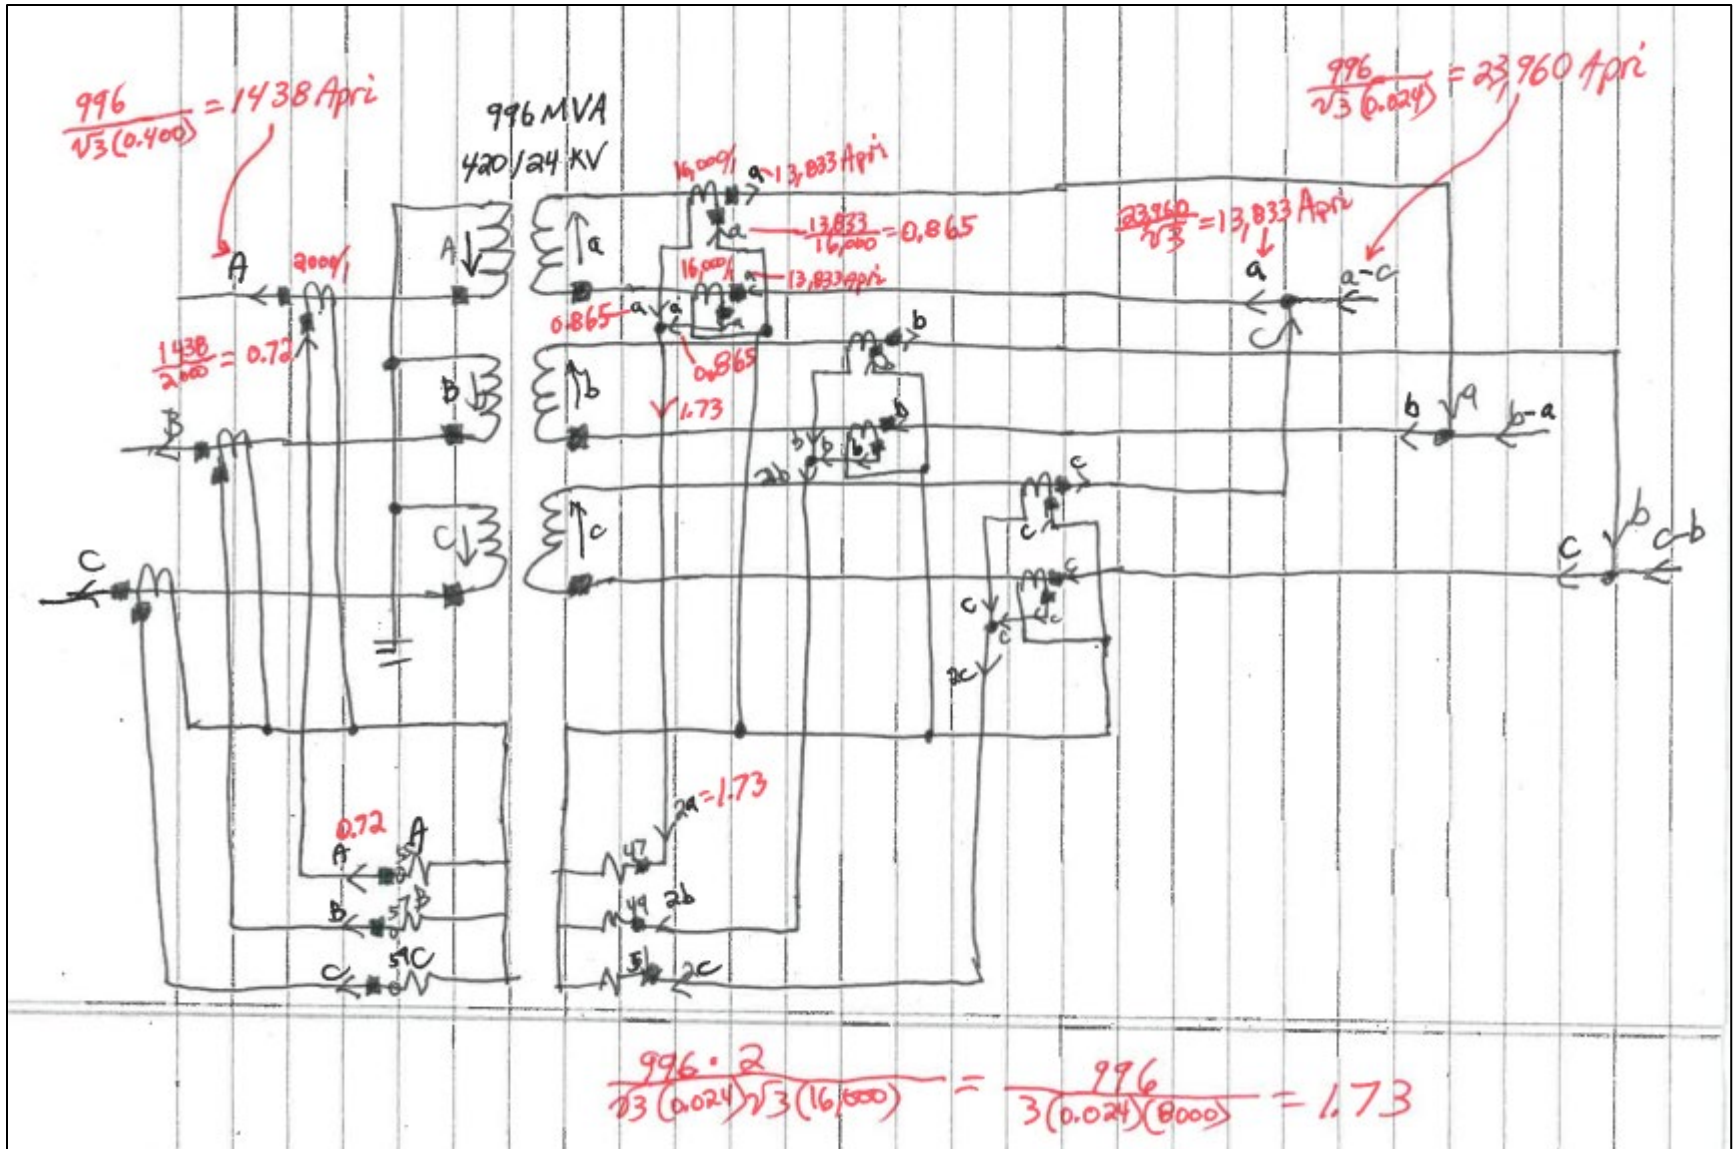
- So yes, the CT Tap settings appear to be set correctly as well.

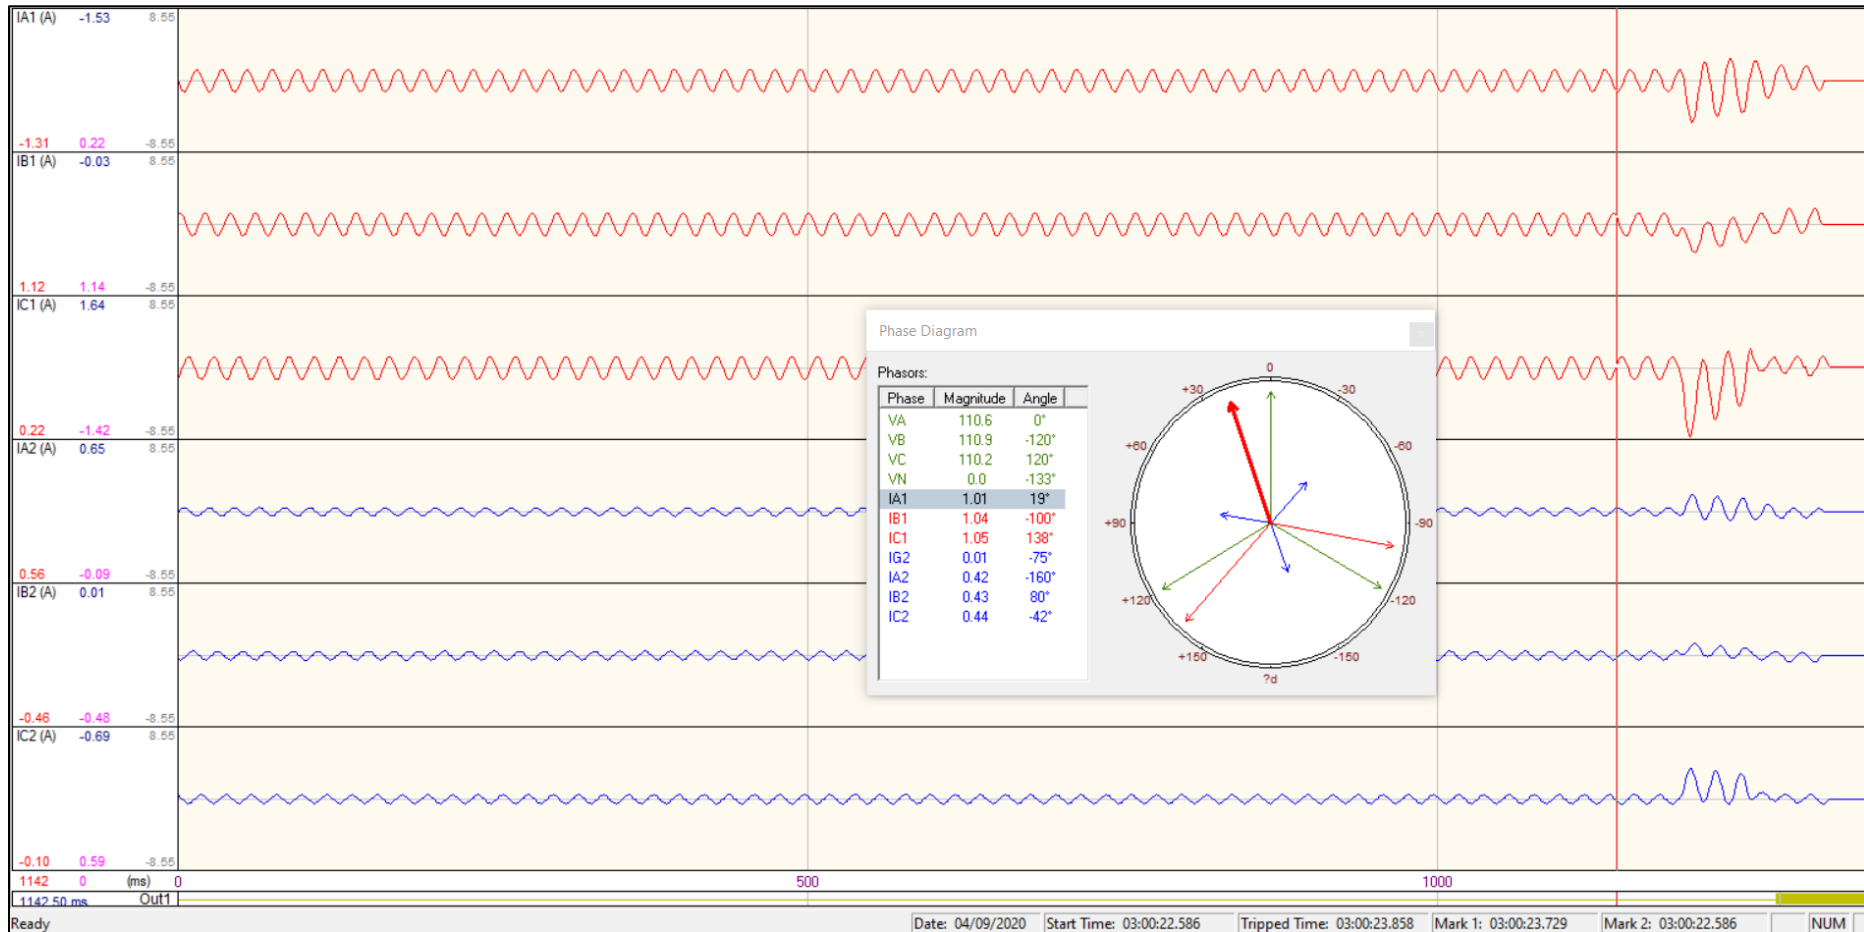
- Look at pre-fault area to confirm CT Tap settings are correct.

- $1.01 * \frac{0.72}{1.74} = 0.42 A$, so yes Tap settings are correct.

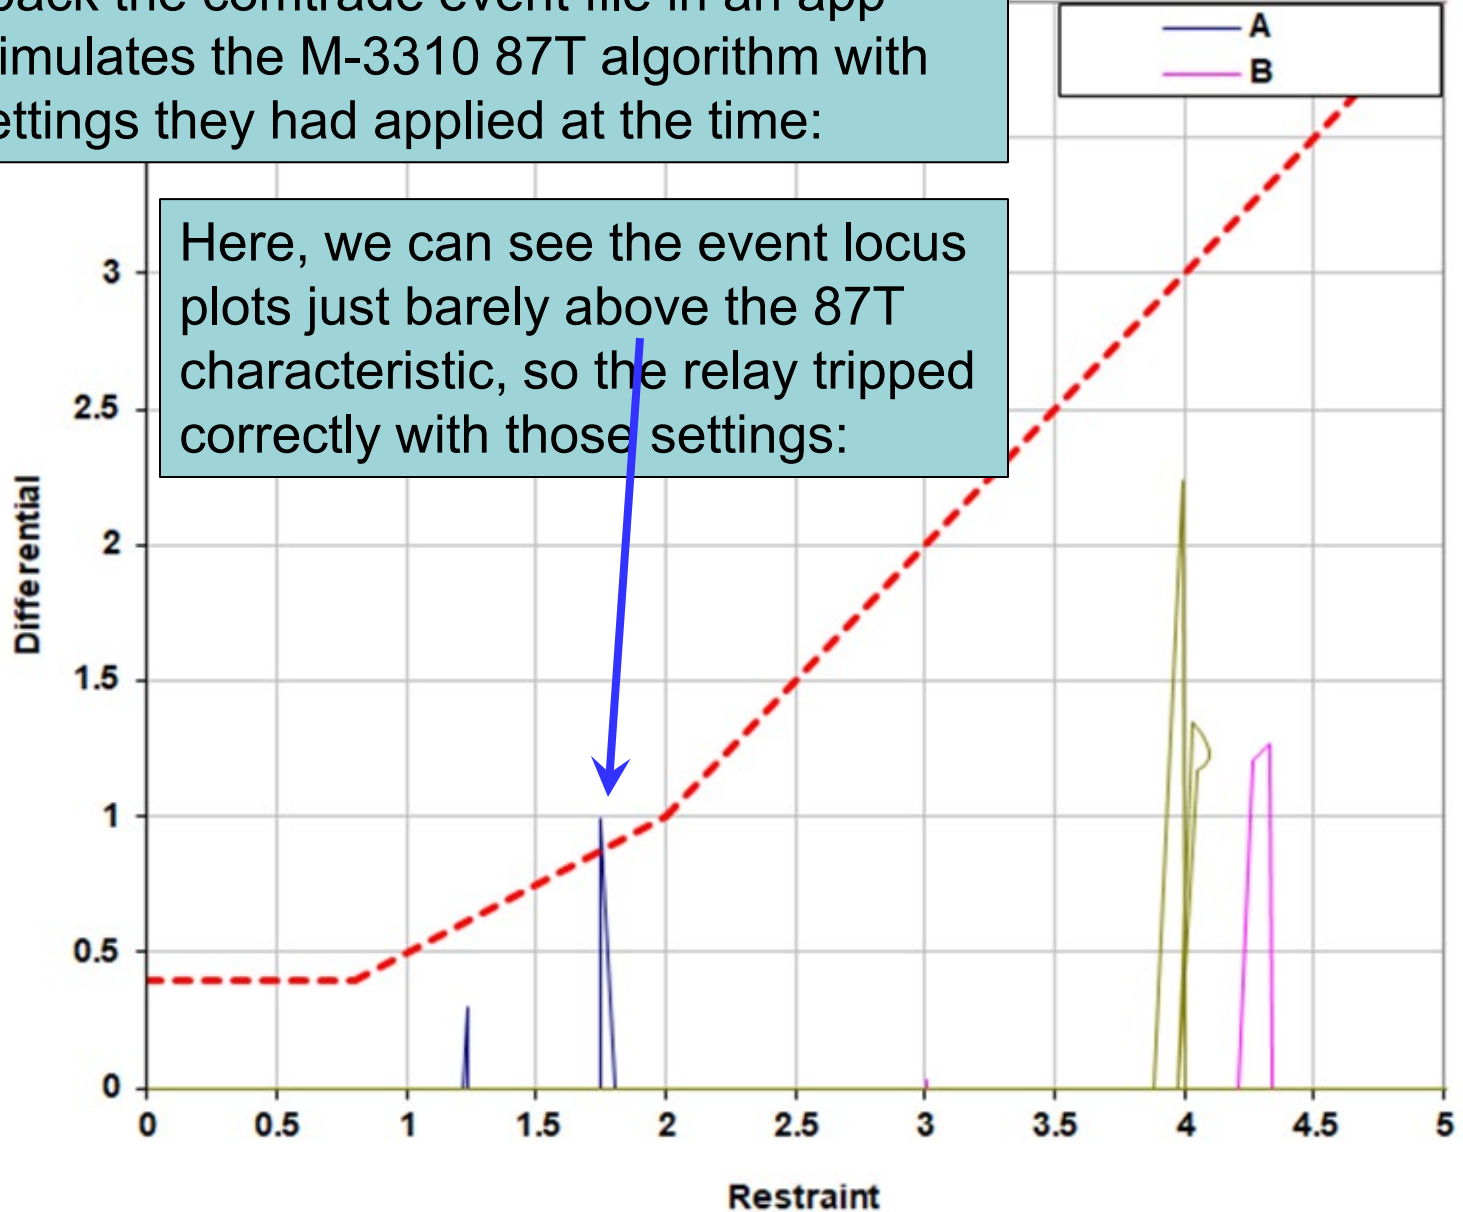
- Play back the comtrade event file in an app that simulates the M-3310 87T algorithm with the settings they had applied at the time:

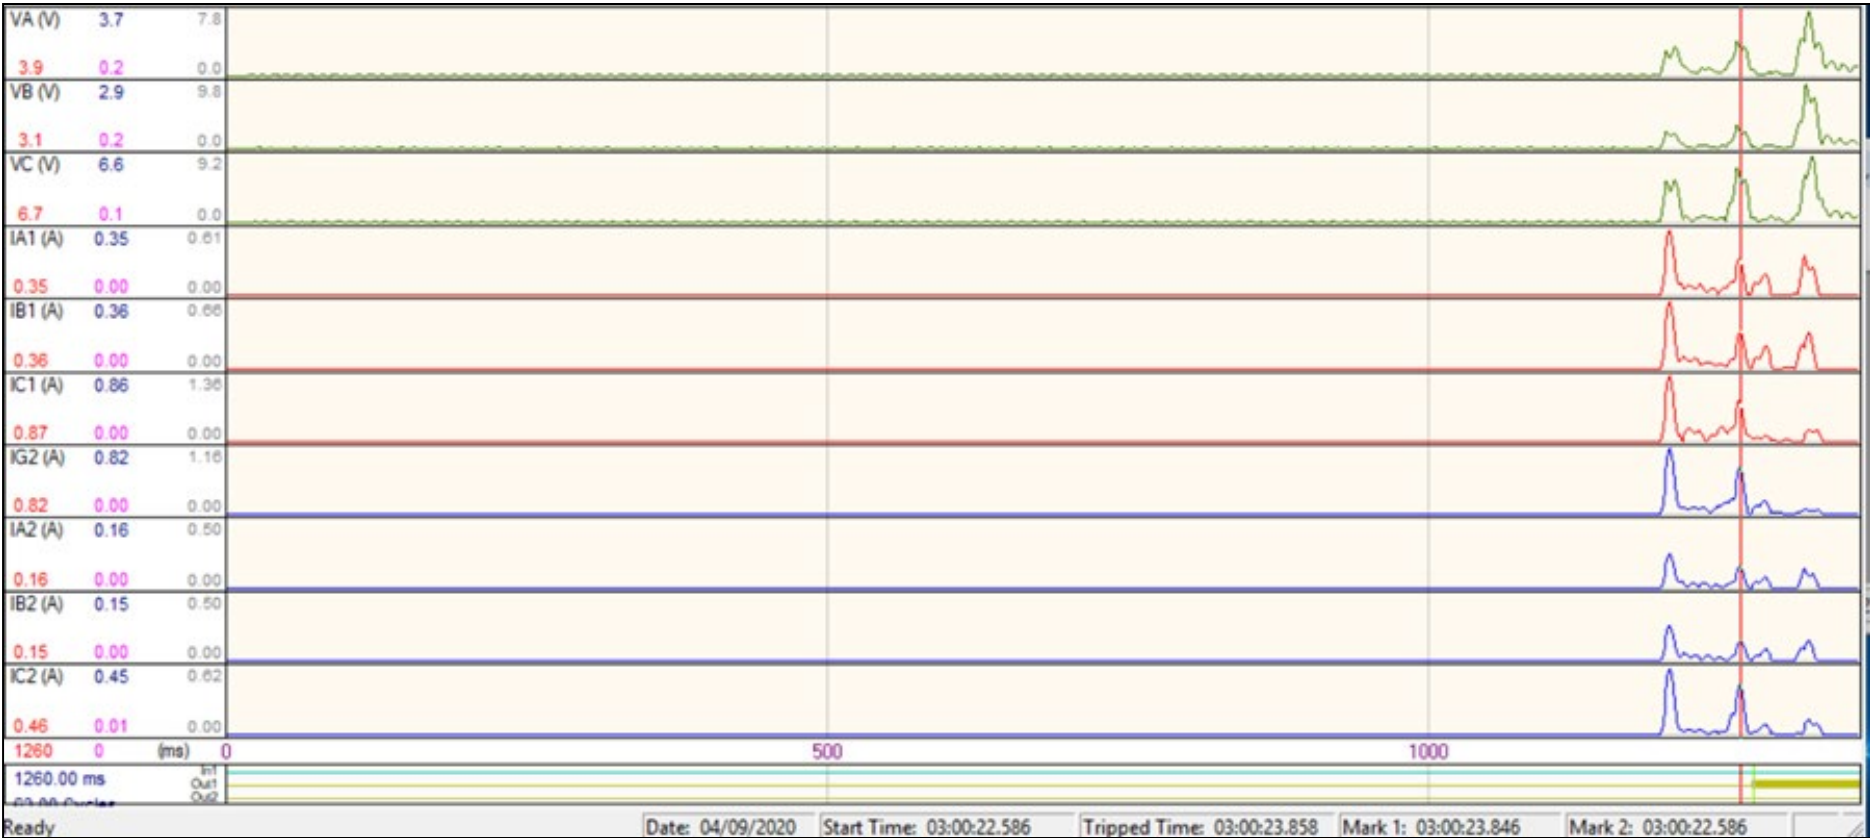
- Look at the 2nd harmonic signature:

- Clue – trip occurred when there was a fault out on the transmission system.
- So why did this GSU protection relay trip for a transmission line fault?
